ASB 70-04-17

SUBJECT: POWERPLANT SYSTEMS – Engine Systems – One-Time Inspection of Power Turbine Shaft/Torque Reference Tube Magnetic Insert Braze.

ENGINE - Power Turbine Module - Power Turbine Shaft/Torque Reference Tube Magnetic Insert Braze Inspection

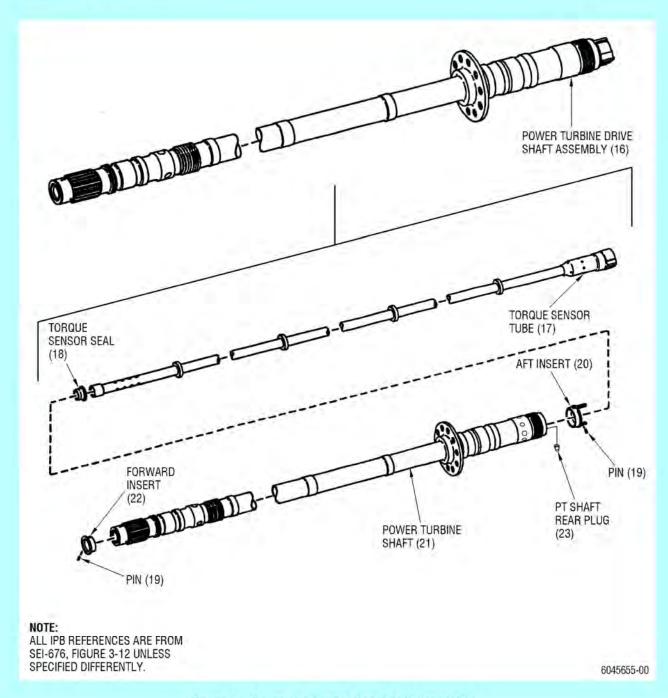
Figure 2. Power Turbine Drive Shaft Assembly

Multiple PT drive shaft assemblies were shipped with inadequate braze coverage on the end of the PT shaft reference tube magnetic insert joint.

Inadequate braze coverage within the torque reference tube magnetic insert joint can become compromised leading to improper torque and speed indications.

- (2) Following the GE proprietary inspection procedure FST-2572 Phase Array Ultrasonic Inspection Procedure for the torque reference tube, perform the braze inspection to quantify the percentage of braze.

- (a) If percentage of braze is greater than or equal to 42%, the engine may be returned to service.
  - (b) If percentage of braze is less than 42%, tag the engine as failed PT shaft UT inspection and return the engine or PT module to a depot for repair or replacement of the PT drive shaft assembly.
