INSPECTION SERVICE BULLETIN
BAe 146 SERIES/AVRO 146-RJ SERIES AIRCRAFT

SERVICE BULLETIN No.ASB.32-A189

TITLE: LANDING GEAR - MAIN LANDING GEAR SIDESTAY - INSPECTION OF THE
OUTER LINK (LH AND RH) FOR CRACKS AND DIMENSIONAL CHECKS.

REVISION: 2

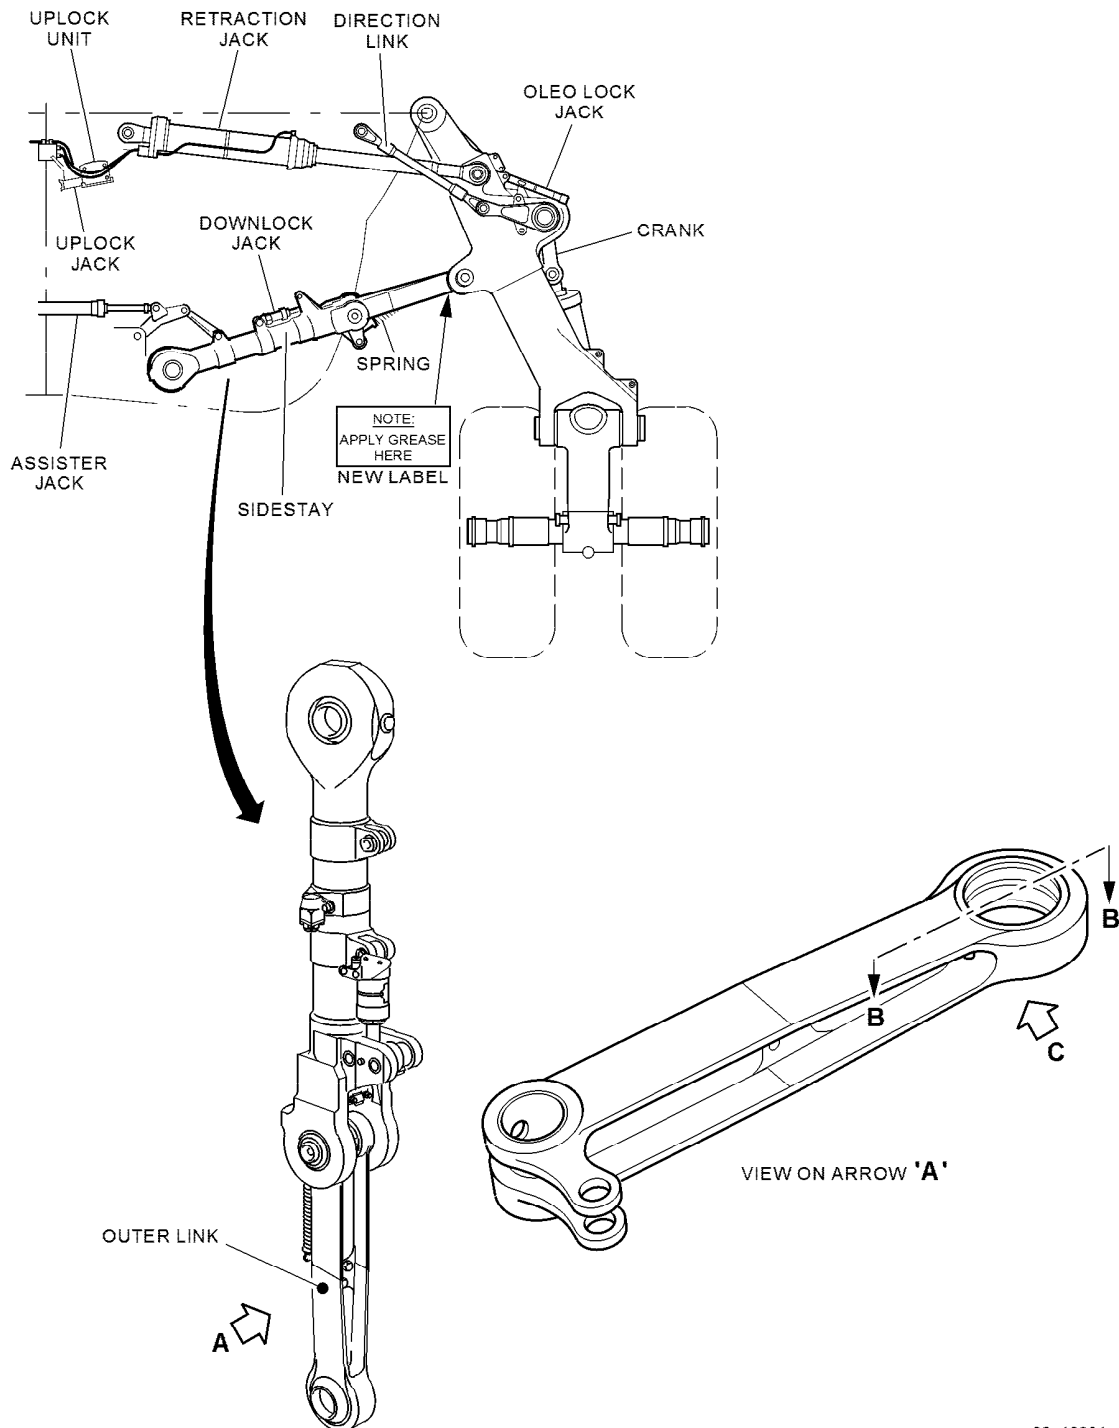
INSPECTION OF MLG SIDESTAY OUTER LINK
DRAWING 1.

An operator recently reported, during routine maintenance,
cracking on the shoulders of the MLG sidestay outer link.

Failure of a MLG sidestay outer link could result in the collapse
of the MLG, which could lead to a runway departure with
corresponding aircraft damage and possible loss of life depending
on the operational environment.

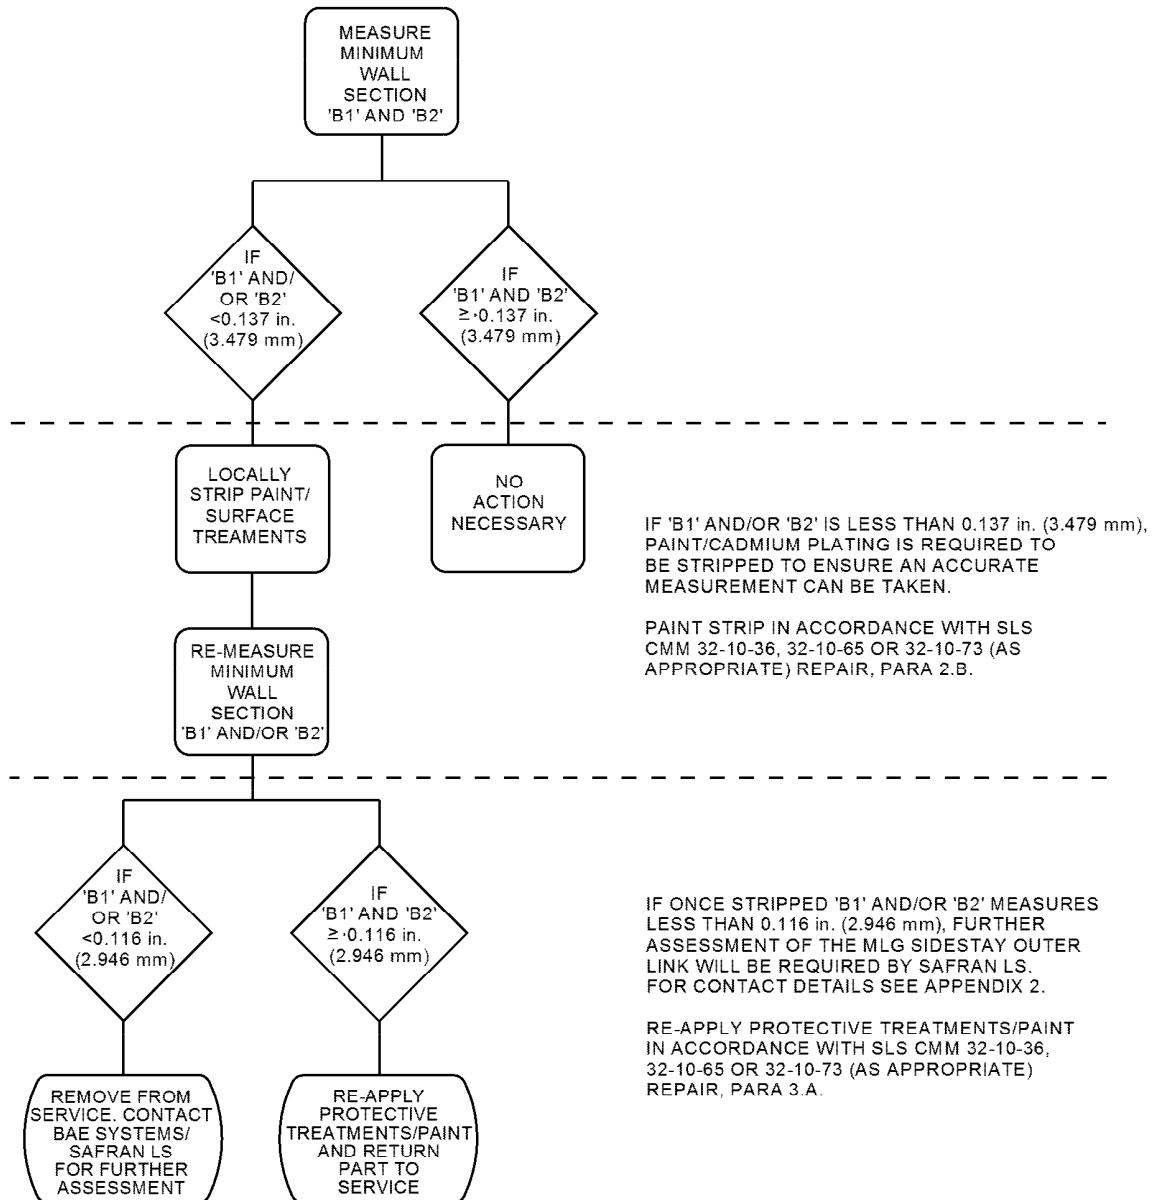
MLG SIDESTAY OUTER LINK DIMENSIONAL ASSESSMENT DRAWING 3.

UPPER SURFACE		LOWER SURFACE	
Dimension (Inches) as per Drawing 2.	LH	RH	LH	RH
Dimensions (in inches) to be recorded to 3 decimal places, using appropriate measurement equipment.	B1 =	B1 =	B1 =	B1 =
	B2 =	B2 =	B2 =	B2 =
<p>If B1 and B2 are ≥ 0.116 inches with protective treatments removed, then no further action required.</p> <p>If B1 and/or B2 are < 0.116 inches with protective treatments removed, then contact Safran Landing Systems before return to service.</p> <p>Safran Landing Systems UK Ltd. Cheltenham Road East, Gloucester, GL2 9QH, United Kingdom. Tel: +44(0) 1452 712424 Web: safran-landing-systems.com</p>

(c) Determine the status of the MLG sidestay outer link in accordance with the dimensional assessment flowchart in Drawing 3. Record in accordance Appendix 2 of ASB 32-A189.

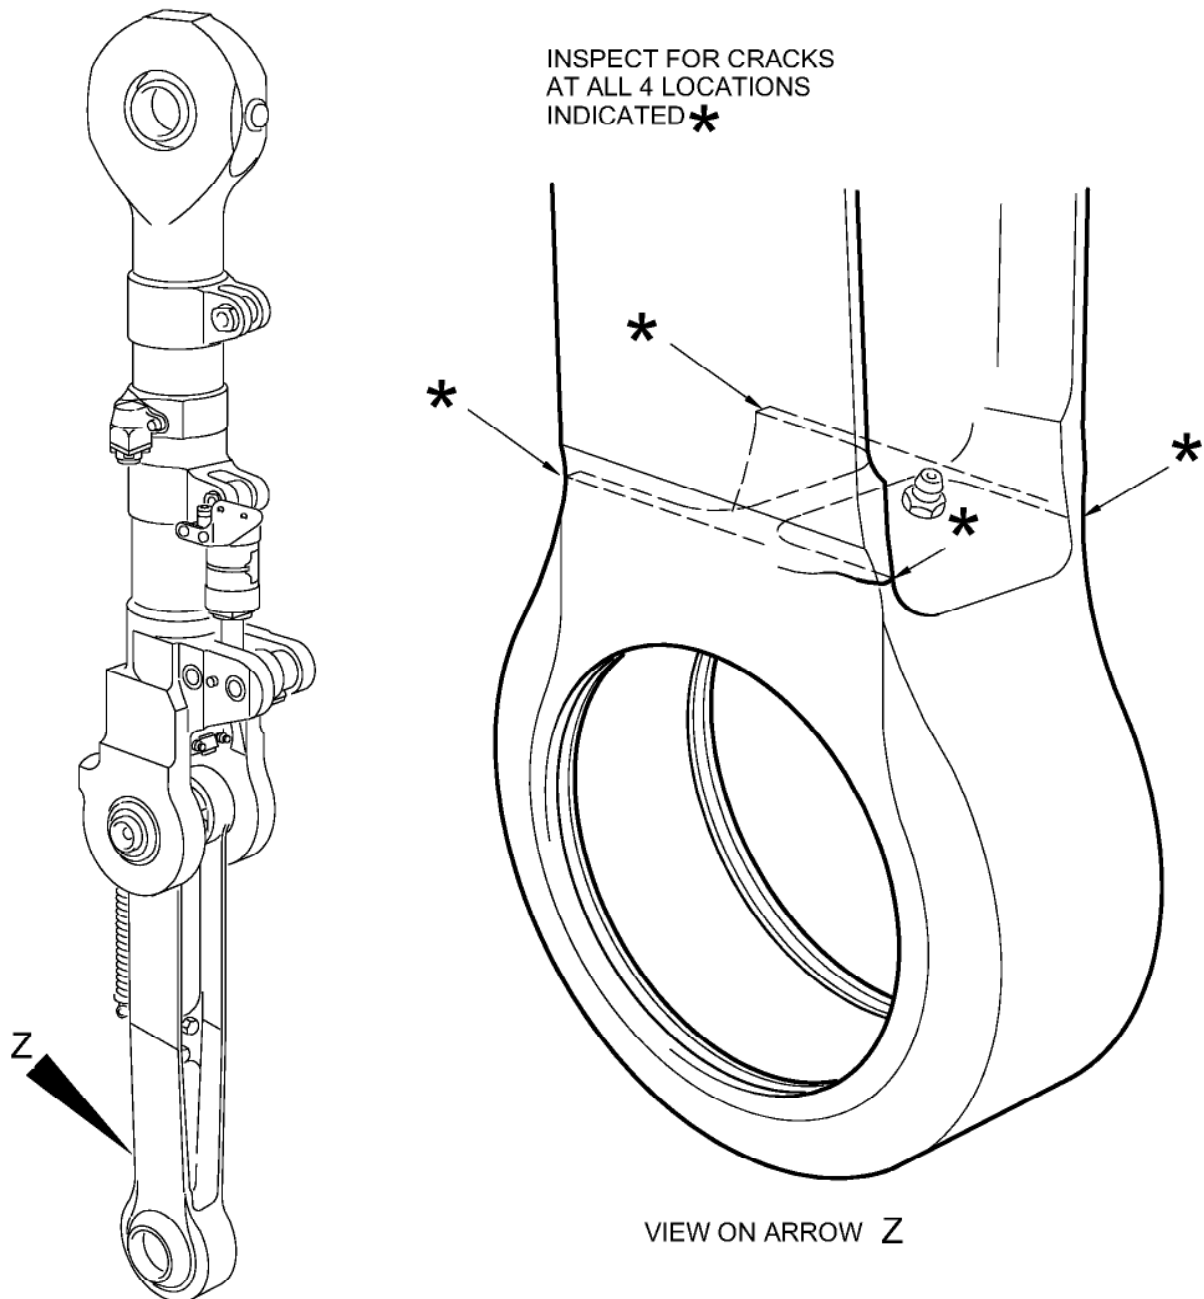
Figure 2 - Location of Inspection

(1) Introduction of a repetitive inspection for cracks in the outer link, as cracks on the shoulder of outer links have been identified.

- 3.1. Following chemical and Scotchbrite local removal of paint and cadmium, thoroughly pre-clean the areas shown in Figure 2 using cold hydrocarbon or chlorinated hydrocarbon cleaning fluid.
- 3.2. Visually inspect the test areas to ensure a suitably smooth surface finish for high sensitivity fluorescent penetrant inspection and freedom from grease, corrosion, debris, metal smearing or mechanical damage which could interfere with the inspection.
- 3.3. Carefully apply thixotropic penetrant to the test area by brush and allow a contact time of 25 minutes. Use only enough penetrant for the area being inspected to avoid over application.
- 3.4. Wipe off surplus penetrant with clean dry cloths or tissues.

- (1) To inspect the outer link (Refer to CMM 32-10-36, 32-10-65, 32-10-73 and Figures 1 and 2 of this Service Bulletin)
- (2) Clean the outer link (4-150 or 4-160, CMM 32-10-36) or (4-150 or 4-160, CMM 32-10-65) or (4-150 or 4-160, CMM 32-10-73); refer to CLEANING in the applicable CMM.
- (3) Perform a detailed visual inspection (using 10x magnification) of the outer link (4-150 or 4-160, CMM 32-10-36) or (4-150 or 4-160, CMM 32-10-65) or (4-150 or 4-160, CMM 32-10-73) to check for any signs of cracks, with specific focus on the four areas defined in Figure 2.
- (4) If there is any indication of cracking, remove the outer link (4-150 or 4-160, CMM 32-10-36) or (4-150 or 4-160, CMM 32-10-65) or (4-150 or 4-160, CMM 32-10-73) and contact Safran Landing Systems for further advice.
