NORTHERN DISTRICT OF CALIFORNIA, SAN FRANCISCO DIVISION

Case No. 14-CR-00175-WHA

**DECLARATION OF [REDACTED] IN
SUPPORT OF RESPONSE TO ORDER
REQUESTING INFORMATION ON
DIXIE AND BADER FIRES**

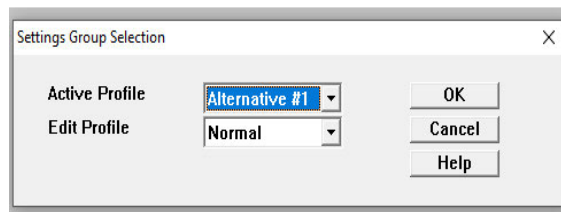
17 5. The following is a true and correct screenshot of the setting group selector data in
18 the “bucks creek 1101_2_asfound_07212021.f6s” file:

23 This data shows that “Alternative #1” was the active setting group profile when the “bucks creek
24 1101_2_asfound_07212021.f6s” file was downloaded on July 21, 2021.

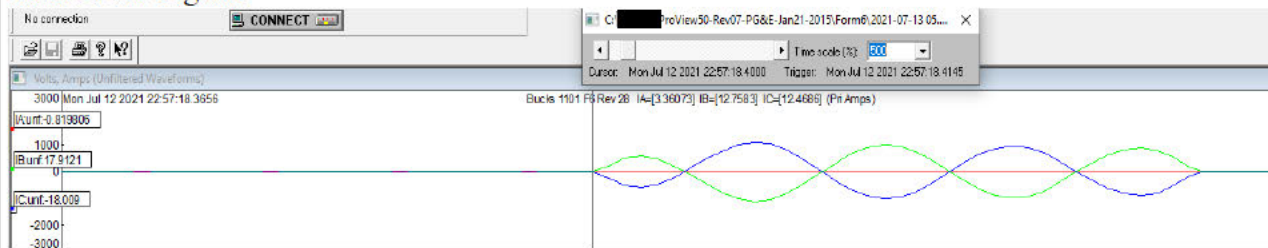
12. The event file contains the recorded oscillography data for that phase to phase fault event. The following is a true and correct screen shot reflecting the time and amperage recorded in the oscillography data when I placed my cursor at the time interval where the phase to phase fault event begins:

This indicates that the phase to phase fault event involved just two of the three phases and began at approximately 22:57:18.4000 on July 12, 2021. The oscillography, however, uses Coordinated Universal Time (“UTC”), which is seven hours behind Pacific Daylight Time. Adjusting for this fact and for the difference between the internal clock of the line recloser and the internal clock on the laptop downloading the data would make the time when the current exceeded the “minimum to trip” approximately 6:47:46.7000 a.m. on July 13, 2021.

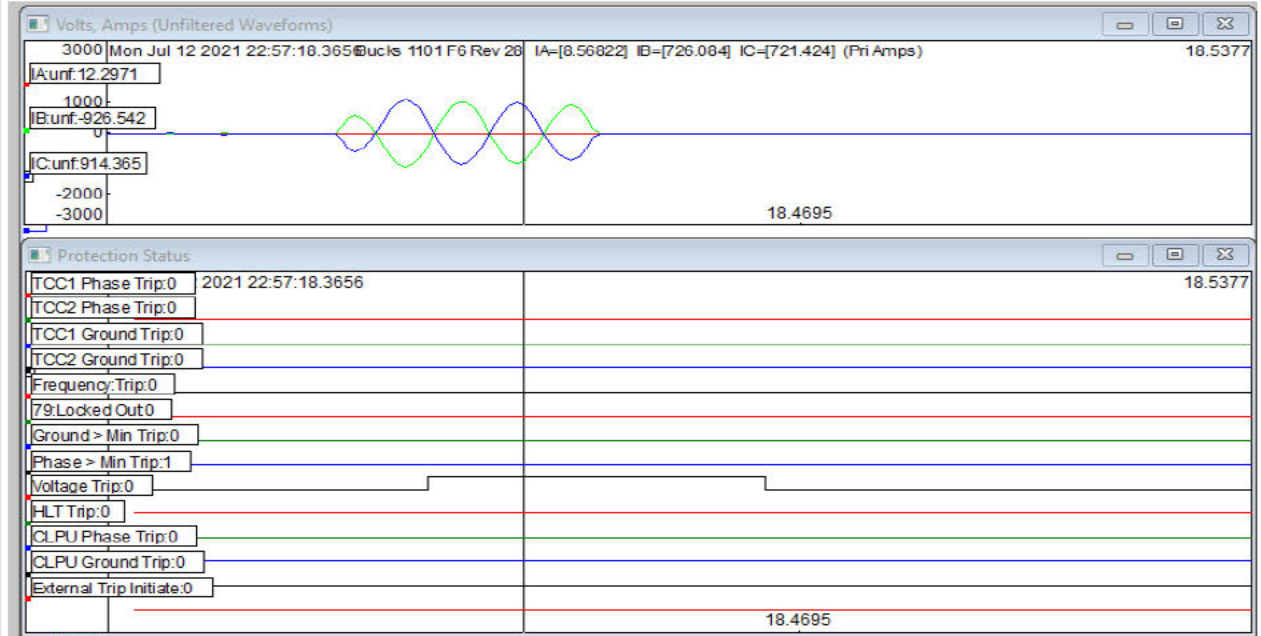
14. The following is a true and correct screen shot reflecting the time and amperage recorded in the oscillography data when I placed my cursor at the time interval when the amperage in the phase to phase fault event is at its maximum:

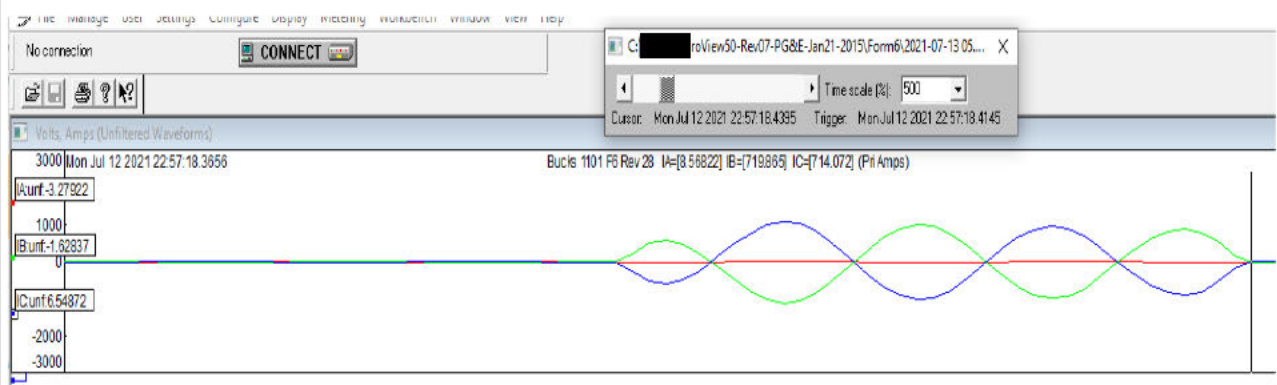
15. The following is a true and correct screen shot reflecting the time and amperage recorded in the oscillography data when I placed my cursor at the time interval where the phase to phase fault event ends:

This indicates that the phase to phase fault event ended at approximately 22:57:18.4395 on July 12, 2021. The oscillography, however, uses Coordinated Universal Time ("UTC"), which is seven hours behind Pacific Daylight Time. Adjusting for this fact and for the difference between the internal clock of the line recloser and the internal clock on the laptop downloading the data would

1 make the time when the current exceeded the “minimum to trip” approximately 6:47:46.7395 a.m.
 2 on July 13, 2021 (0.0395 seconds after it began).

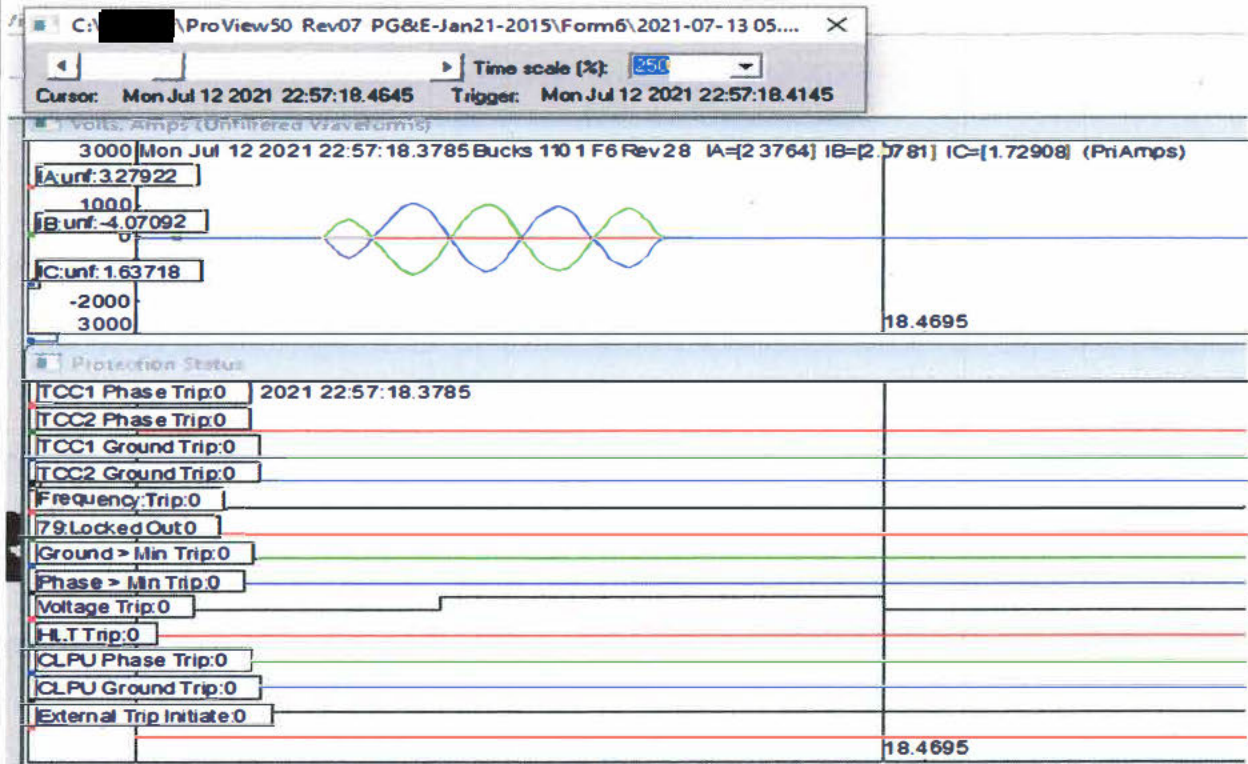
3 16. The following is a true and correct screen shot reflecting the time and amperage recorded
 4 in the oscillography data when I placed my cursor at the time interval when the above “minimum
 5 to trip” element in the controller de-asserts:
