12 April 2021

## Saki Drill Pad and Trench Site Inspections Ahead of Fieldwork

Frontier Resources Limited (**Frontier** or the **Company**) is pleased to announce the completion of a geotechnical site investigation of the proposed drilling pads at Saki Gold Prospect. The field investigation was conducted by Frontier's consultant geologist and field technical engineer to assess the surface conditions and slope stability of proposed drill pads (Figure 1) to ensure their safety against potential landslides. A number of the drill pads were relocated to safer sites (Figure 2).

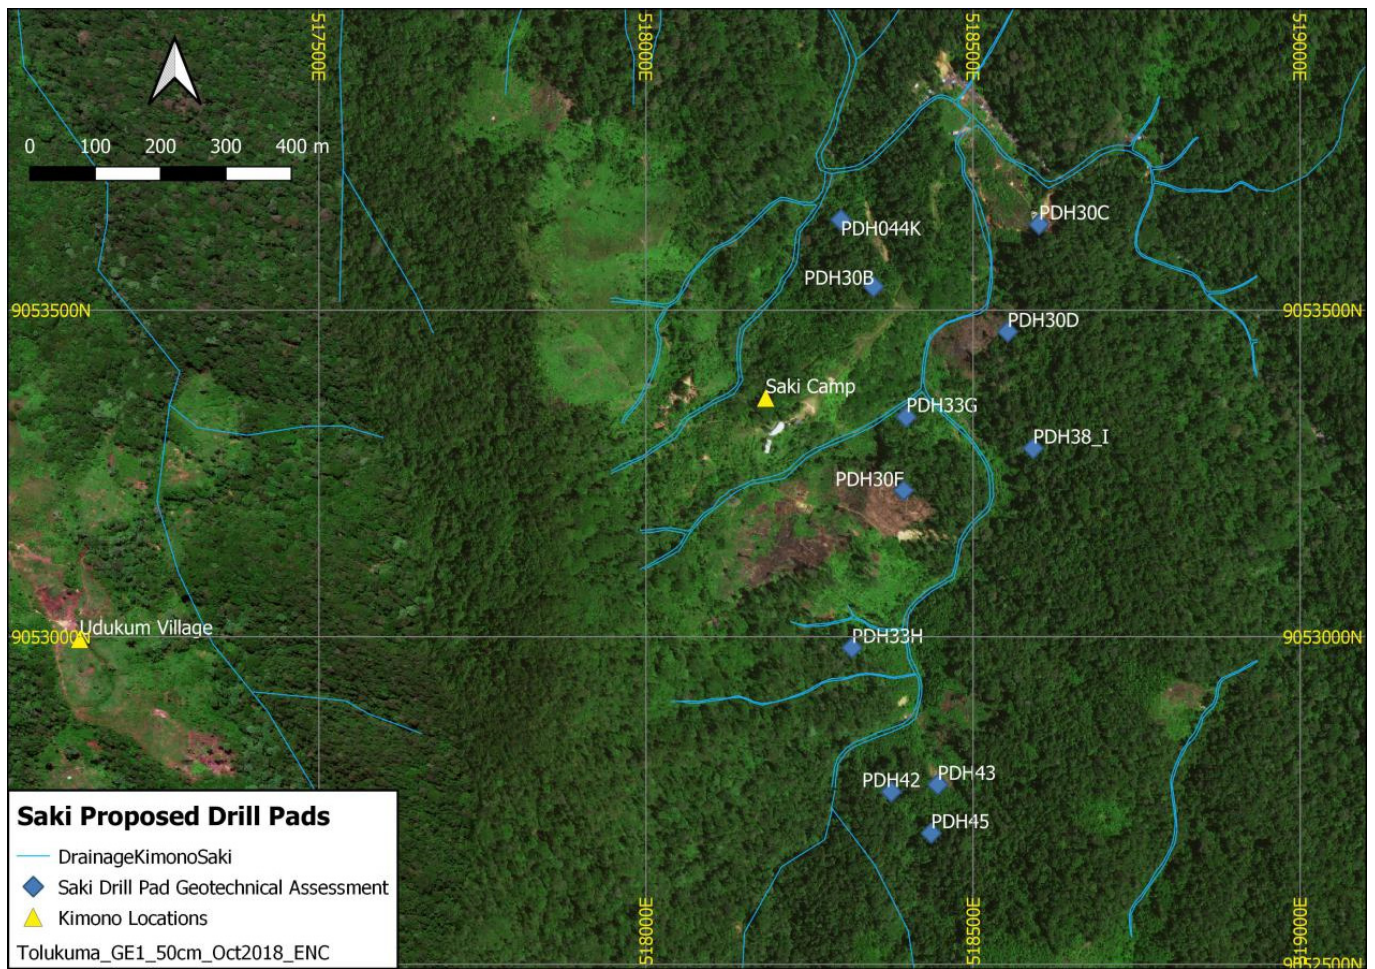
Figure 2: Relocated Drill Pad Locations (PDH30C, E-F and H)

The geotechnical site investigation identified potential geohazards (landslips, tension cracks, wedge failures etc) that required immediate corrective safety measures. Four (4) drill pads were identified to be in high risk zones (landslips, steep gullies) and were relocated to safer areas (Figure 2). Two drill pads (PDH30D and PDH38I) with medium risk rating have nearby landslide (35m down hill) and active soil creeping respectively and needs to be monitored during pad clearance.

**2. Drill Pad# PDH30C (518601e, 9053631n):** The proposed pad has been relocated 31m north of the original proposed site. The original site is within a steep gully that is 40m above a recent landslide. It may need to be re-located again following a major landslide in late December 2020.

**4. Drill pad PDH30E & F (518394e, 9053224n):** Original proposed site unfavourable due to massive landslide. Pad relocated 24m north towards to a stable gentle slope (20°). Slope stability okay. Saprolite and brown-orange soil. Large area which will require 1 week of pad construction.

**6. Drill Pad# PDH33H (518315e, 9052983n):** Original site is unsuitable so pad has been relocated 27m north west up to the ridge. Favourable site along bush track and near ridge top. Ground is stable, composed of competent pyroclastics. Slope stability okay. 2-3 weeks pad construction required.

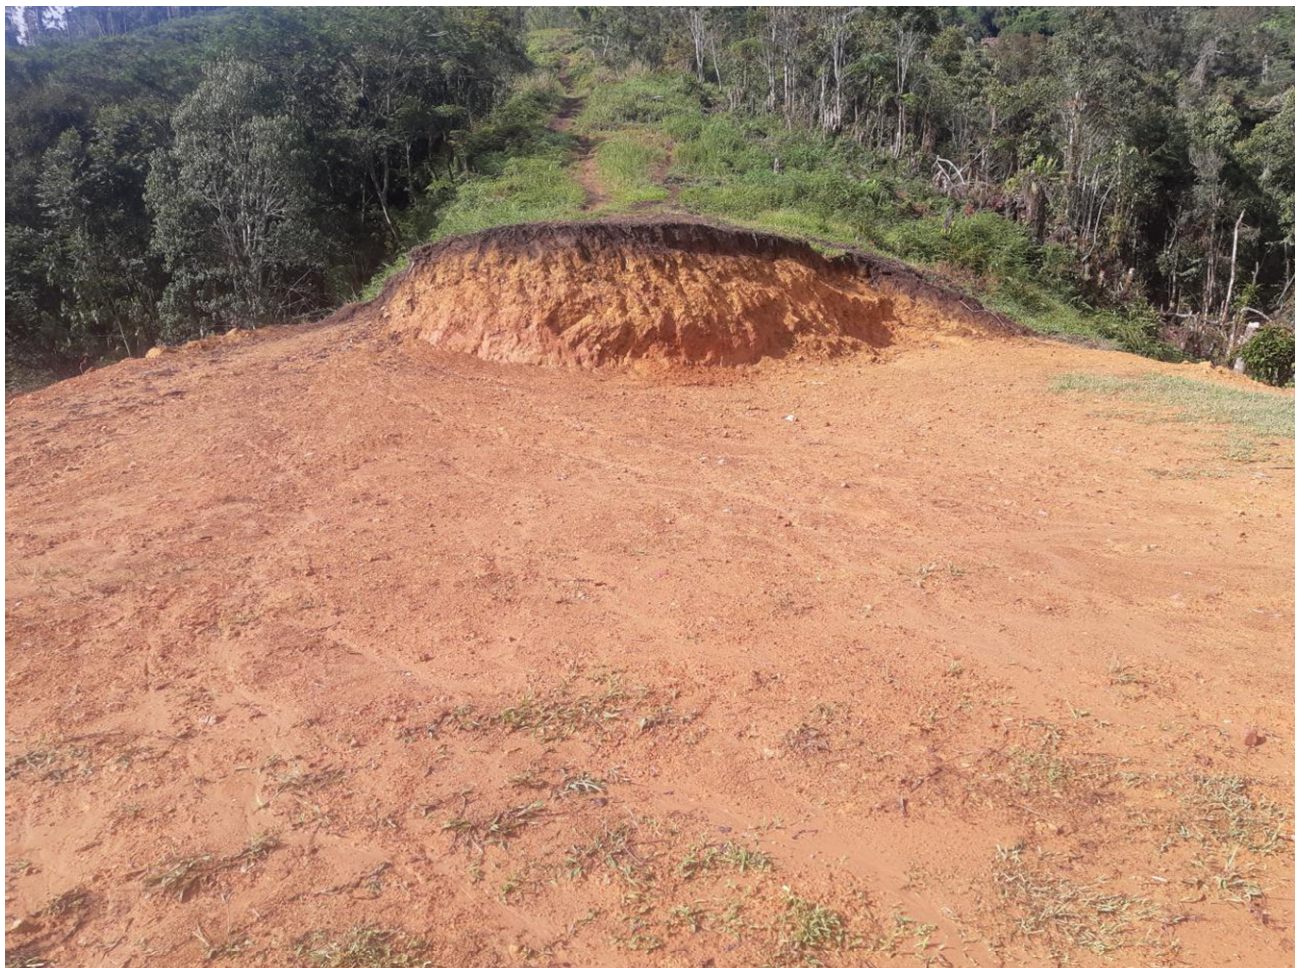
Photo 1: Constructed Drill Pad PDH30A & B Completed and Ready for Drilling.

**1. Drill Pad# PDH30A & B (518348e, 9053536n):** Site had been cleared by the locals and currently used as a helipad and is on stable ground. The pad is on a gentle slope so there is no major risk of landslides within the pad vicinity. The pad dimension is 20m X 14m, completed and ready for drilling (Photo 1).

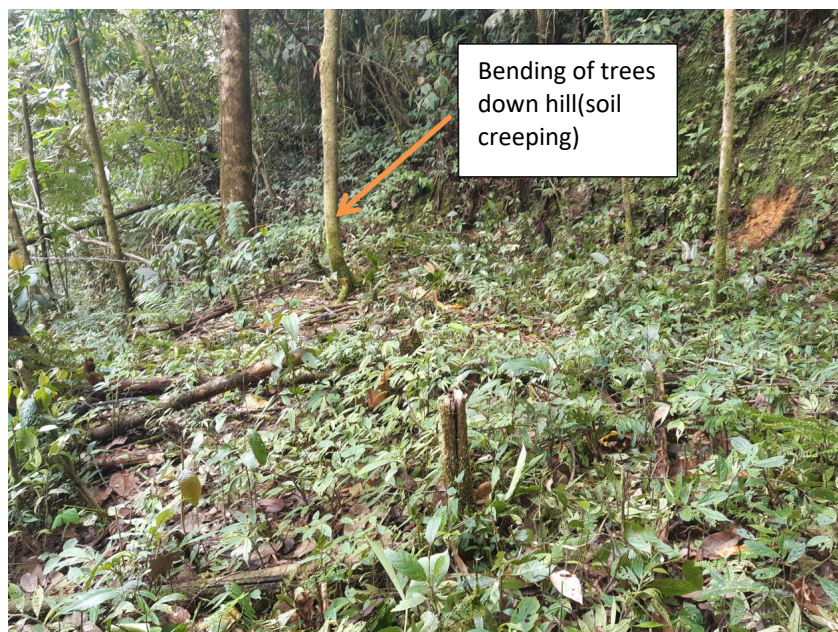
**Photo 3: Pad PDH38I with Soil Creeping Shown by Slight Bending of Trees**

**7. Drill Pad# PDH38I (518592e, 9053289n):** On a ridge on totally oxidised and weathered pyroclastics but still competent. No signs of landslips but some bit of soil creeping shown by trees (Photo 3). Pad dimension is 11m X 5m and needs extensions of 3m X 3m with 1 week of digging required to complete.

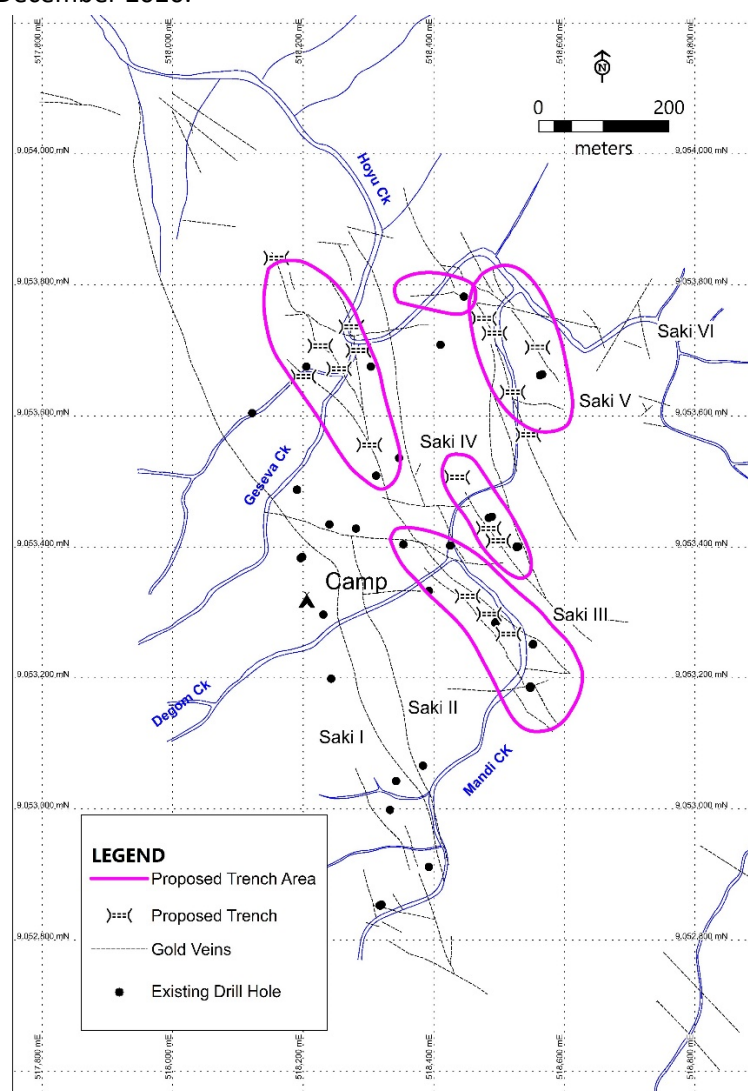
**Figure 3: Saki Prospect Vein System and Proposed Trench Sites**

During this inspection of drill pad sites, a series of proposed trench sites were also inspected (Table 1) to ensure their location is suitable to sample and define mineralised Saki vein extensions (Figure 3). Due to a landslide in December 2020, geologists are currently revising the location of trench and drill pad sites at the Saki V vein to a safe location away from the landslide area, which was inspected by Frontier geologists with MRA Officers in late December 2020.
