Pipeline Investigation Report: PIR-23-02

Marathon Pipe Line LLC Pipeline Rupture and Crude Oil Release

Edwardsville, Illinois
March 11, 2022

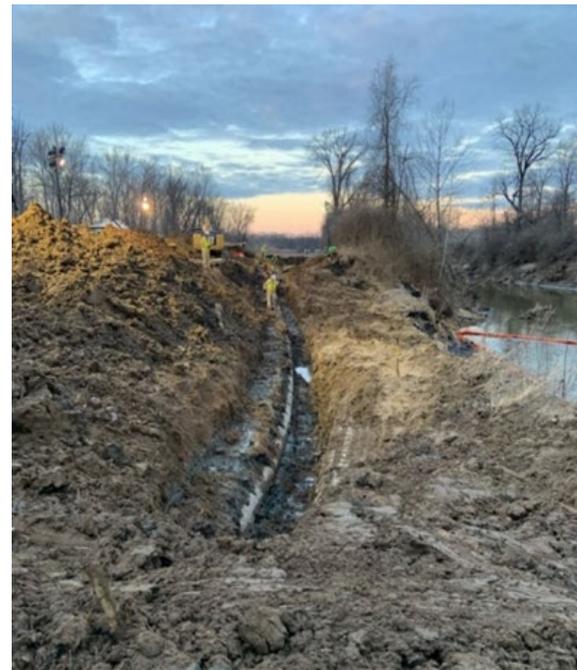
On March 11, 2022, at 8:15:21 a.m. local time, a 22-inch diameter crude oil pipeline operated by Marathon Pipe Line, LLC (Marathon) ruptured at a girth weld in Edwardsville, Illinois, resulting in the release of about 3,500 barrels of crude oil, some of which entered Cahokia Creek.¹ (See figure 1.) The rupture occurred at milepost 6.2 on the Woodpat pipeline, the northernmost of three parallel pipelines sharing one right-of-way and the closest to the creek.² Figure 2 shows the alignment of Cahokia Creek, a tributary of the Mississippi River. No injuries or fatalities

Figure 1. Ruptured pipeline and Cahokia Creek. (Source: Marathon.)

While on scene, the National Transportation Safety Board (NTSB) observed complete circumferential separation at a girth weld at the rupture origin. The NTSB retained three sections of the Woodpat pipeline for metallurgical testing, which was completed by a third-party contractor directed by the NTSB.²² Inspections of the fractured girth weld revealed weld defects. Scanning electron microscopy was performed on the fracture features of the girth weld, and those features exhibited characteristics consistent with overstress fracture.²³

The National Transportation Safety Board determines that the probable cause of the Edwardsville, Illinois, crude oil pipeline rupture was an overstress fracture of a girth weld from external loads caused by slope instability that had not been completely mitigated by Marathon before the accident.

On March 15, 2022, Marathon installed about 60 feet of new pipe to replace the sections that had been removed and restarted the pipeline at 7:31 a.m.

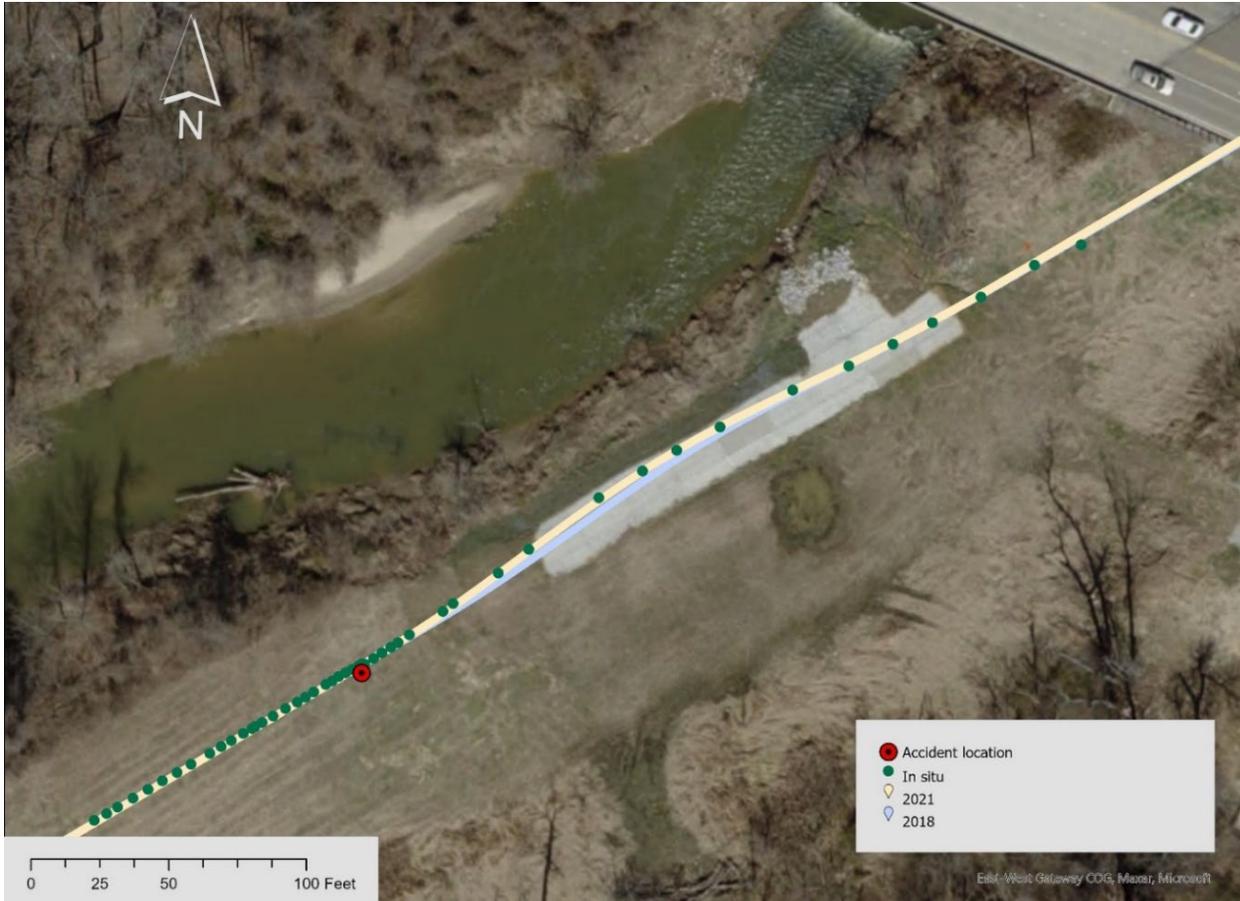
After the accident, a hydrotechnical analysis and slope stability assessment determined the earth movement at the rupture location was due to scouring in the creek that was localized on the bank near the rupture location because of large, woody debris.²¹ The assessment determined that the slope instability had continued after the revetment mats and riprap were installed in 2014 and 2017.

The day after the rupture, Marathon performed GPS surveys of the Woodpat pipeline after the rupture. Figure 3 displays the results from the 2022 GPS surveys (green dotted line) with data from the IMUs conducted in 2018 (blue line) and 2021 (yellow line).

Figure 3. IMU data for Woodpat pipeline from 2018 and 2021 and 2022 postaccident GPS survey.

Marathon performed a failure analysis on the ruptured girth weld using the 2012, 2018, and 2021 IMU assessments. As part of the failure analysis, Marathon completed a numerical analysis using calibrated models established by the 2018 and 2021 IMU data and postaccident data to conduct a strain analysis and collect deviation-from-straight values.²⁴ (See table 2.) The failure analysis indicated increased strain approximately 10

feet from the rupture location, with maximum total strain near the ruptured girth weld between 0.61 and 0.83 percent, and a deviation-from-straight value of just over 8 feet.²⁵
