Issued May 22, 2023

MIR-23-09

## Collision between Bulk Carrier *Bunun Queen* and Offshore Supply Vessel *Thunder*

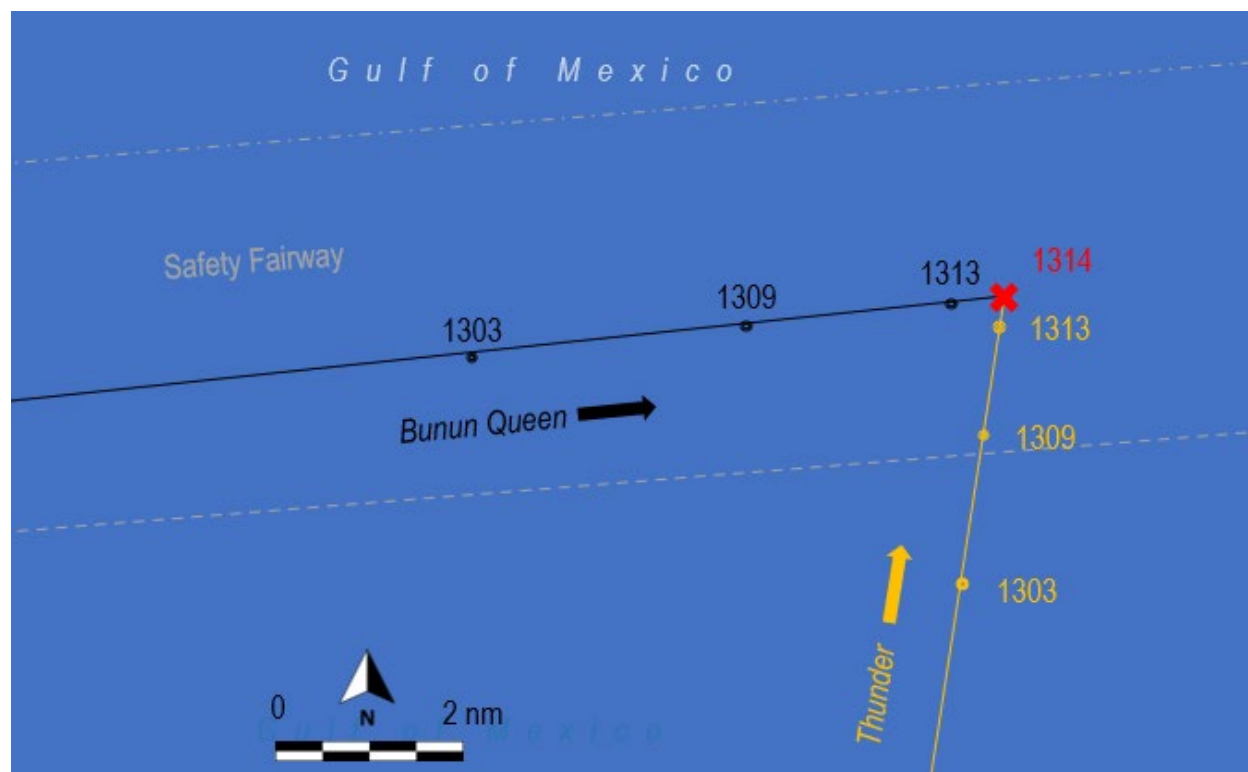
**Figure 3.** Tracklines of the *Bunun Queen* and *Thunder* leading up to the collision, based on VDR data.

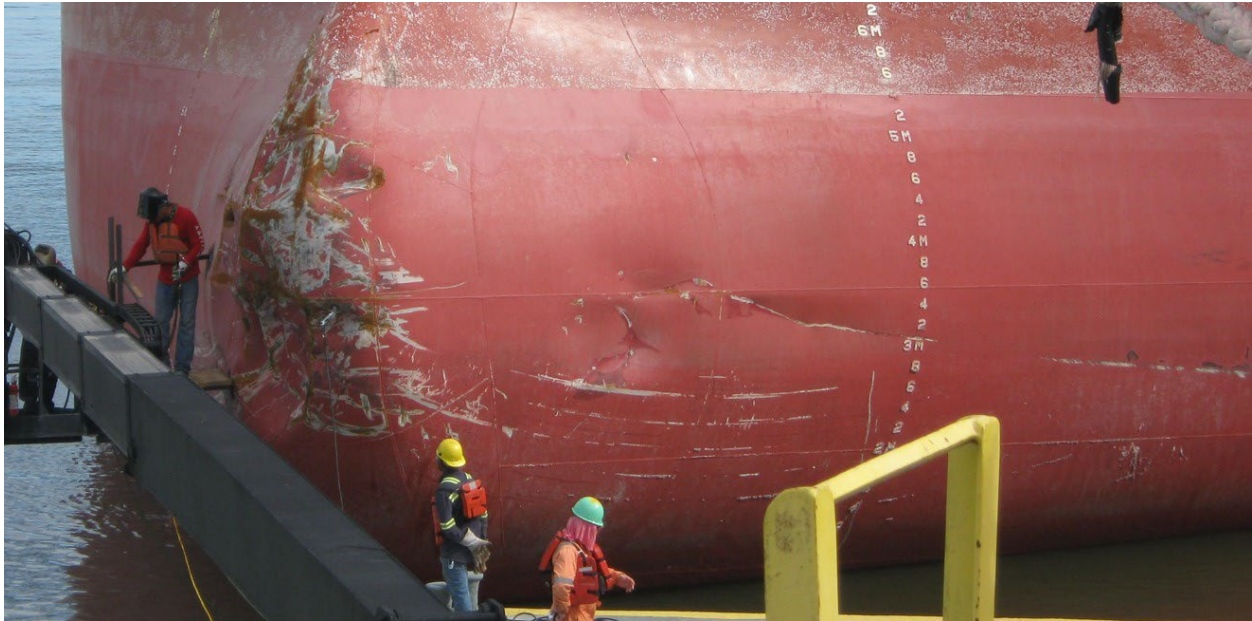
Damage to the *Bunun Queen's* port bow consisted of indentations and deformation of the shell plating above the waterline at water ballast tank no. 1 port. The vessel's bulbous bow sustained multiple dents, a crack, and a hull fracture of the shell plating, which caused water to enter the forepeak tank. The cost of repairs was about \$680,000.

**Figure 4.** Damage to the bulbous bow of the *Bunun Queen*. (Source: US Coast Guard)

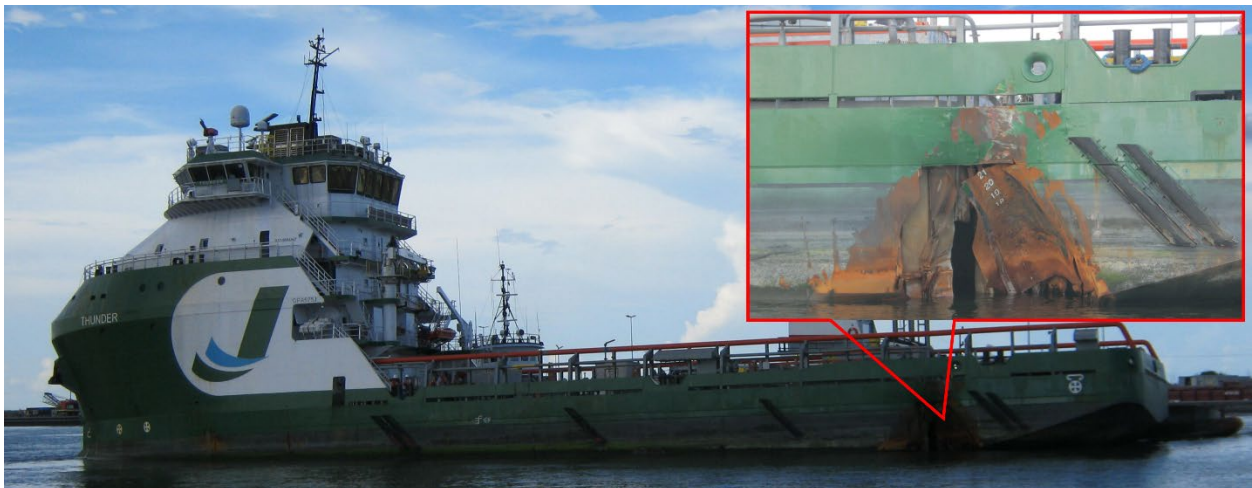
The *Thunder* sustained damage to its port side aft consisting of a large penetration above and below its waterline that caused flooding in the port side propulsion room, the port cargo tank (empty at the time), a void space, and the no. 7 port ballast tank. The cost of repairs was about \$11,598,078.

**Figure 5.** The *Thunder* being towed to a dock in Port Fourchon after the collision. The inset shows the damage to the aft port side of the vessel. (Source: Coast Guard)
