March 19, 2024

MIR-24-06

Contact of *Susan K* Tow with Natchez-Vidalia Bridge

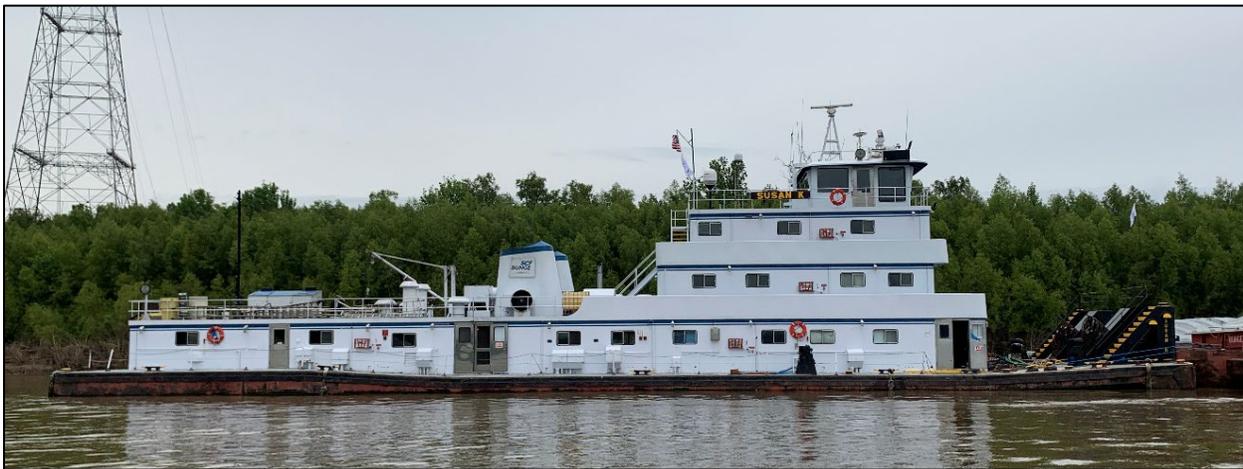
On April 23, 2023, about 2242 local time, the towing vessel *Susan K* was pushing 25 barges downbound on the Lower Mississippi River when the tow struck the center bridge pier on the Natchez-Vidalia Bridge, which connects the cities of Natchez, Mississippi, and Vidalia, Louisiana.¹ One barge sank, and two other barges were damaged; the *Susan K* was undamaged. No pollution or injuries were reported. Damage to the barges and cargo was estimated at \$2 million.

Figure 1. *Susan K* after the contact.

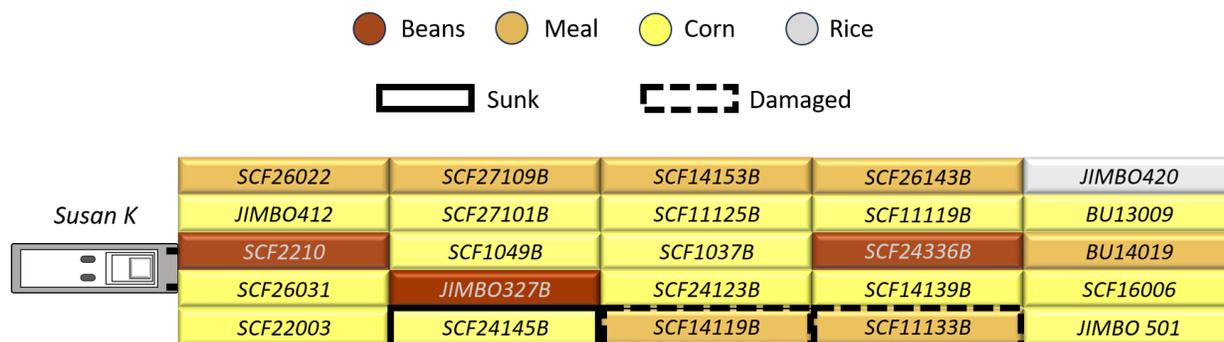
At the time of the contact, the *Susan K* was pushing 25 barges, each 200 feet long by 35 feet wide, carrying various agricultural products. The tow comprised five strings of five barges and had an overall length of 1,260 feet (see figure 3).

Figure 3. *Susan K* tow arrangement and cargoes, with outlines indicating barges damaged or sunk in the casualty.

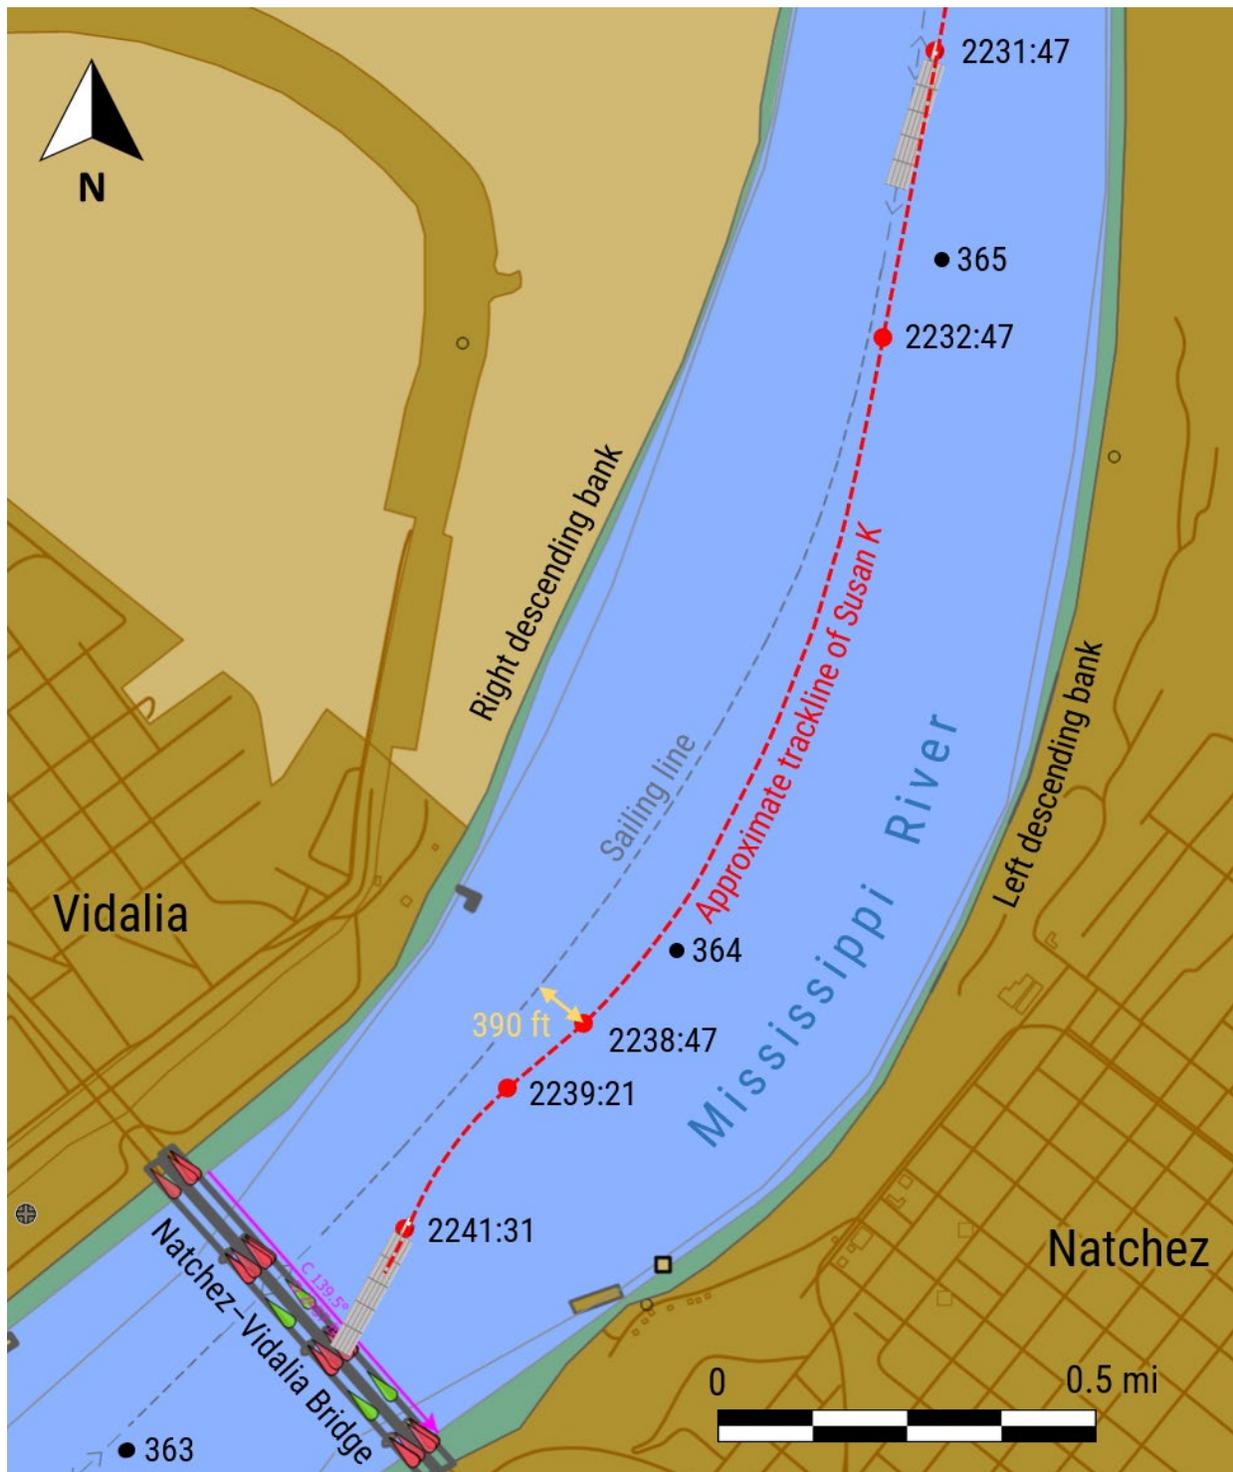
made a “judgment call” to attempt to steer the tow through the eastern (left-descending-bank side) channel under the bridge (see figure 5).

Figure 5. AIS positions of the *Susan K*, as indicated by red dots. The NTSB approximated the trackline of the *Susan K* due to limited AIS data. (Background source: Rose Point electronic chart system)

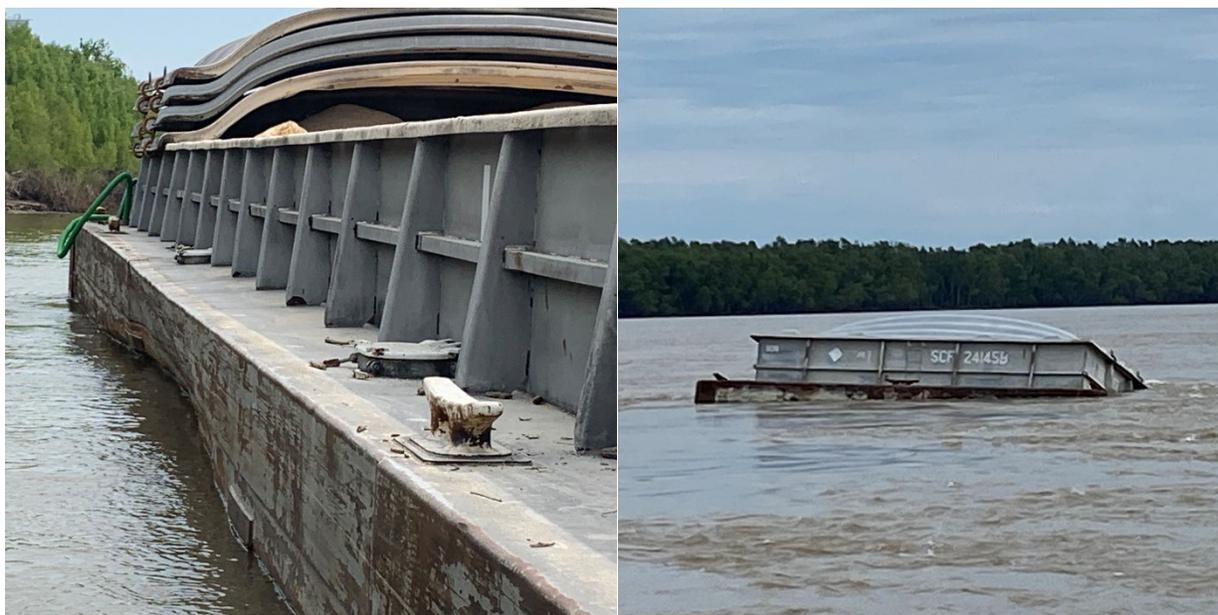
Deck plating and bulkheads on the second and third barges in the starboard string, *SCF11133B* and *SCF14119B*, were dented or deformed when the barges made contact with the bridge pier. The hull of the fourth barge, *SCF24145B* (which was carrying corn) was breached; after drifting downriver about 6 miles, the barge partially sank (see figure 6). The barge was later salvaged.

Figure 6. Left, hull indentation on barge *SCF14119B*. (Source: NTSB) Right, partially sunken barge *SCF24145B*. (Source: US Coast Guard)
