April 15, 2024

MIR-24-08

Capsizing of Dredging Vessel *WB Wood*

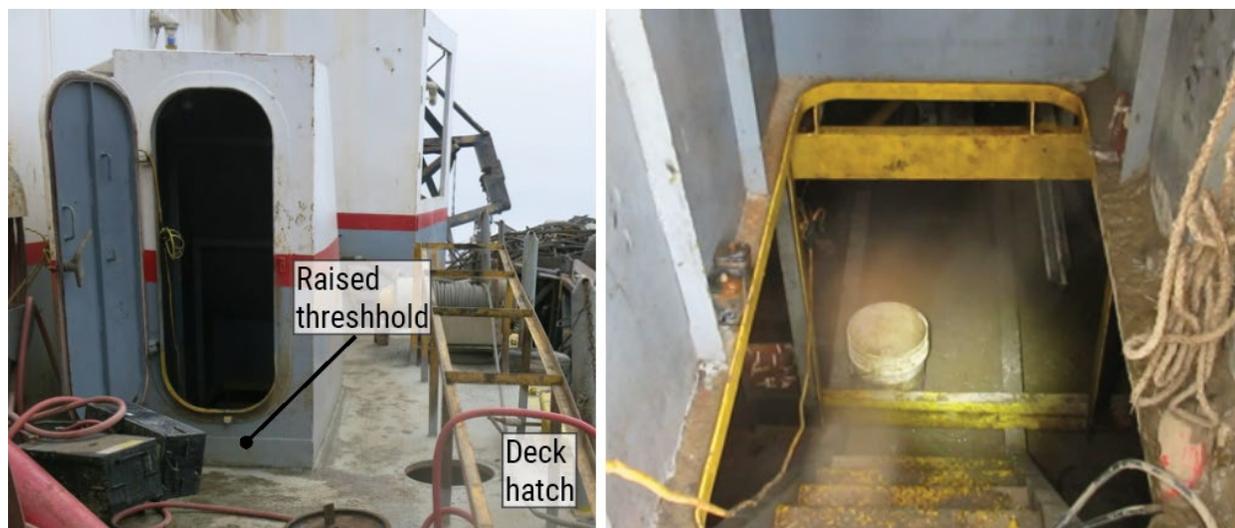
The night leverman went down to the main deck to investigate the cause of the list. When he opened the watertight door leading down to the starboard storage space, he saw that the space was completely full of water (up to the door threshold). He did not see an oil film or smell fuel. He recalled that, at the time, there was river water on the main deck aft, but water was not entering the storage space through the watertight door, which had a raised threshold (see figure 4).

Figure 4. Postrecovery photos of the door to the starboard storage space and the starboard aft void deck hatch, viewed from the starboard aft main deck looking forward (*left*), and the storage space interior from the main deck door looking down and forward (*right*).

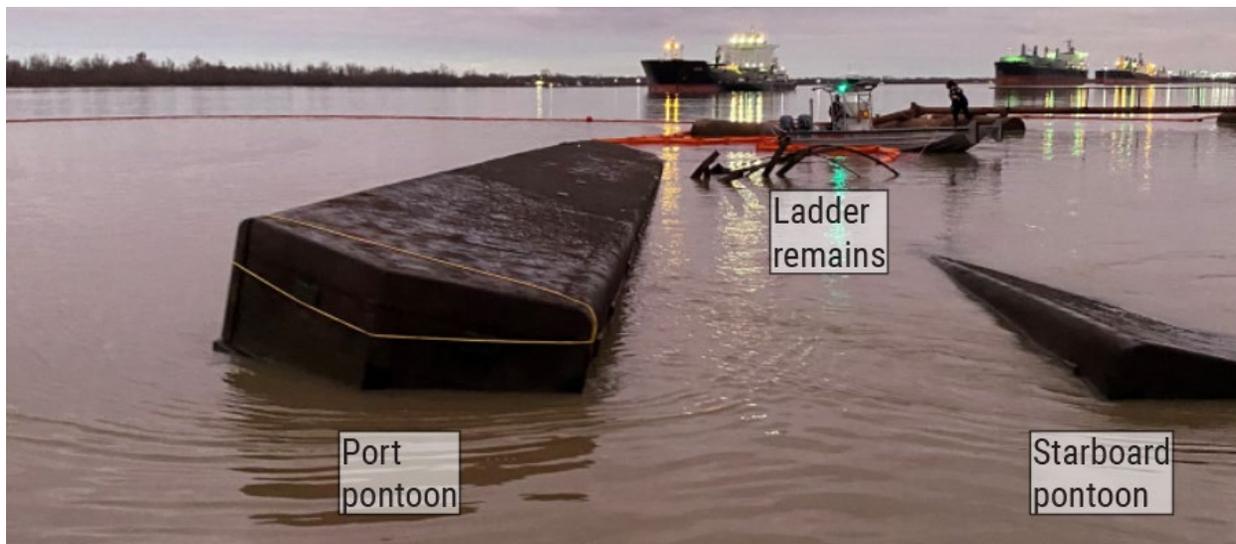
Figure 5. The overturned hull of the *WB Wood* with its port pontoon on the left and the starboard pontoon on the right the morning after the capsizing. (Source: US Coast Guard)

After the casualty, the *WB Wood* remained afloat, upside-down. Both pontoons retained buoyancy at their forward ends, but the vessel's aft end was completely submerged. The ladder had completely sheared off during the rollover with its remaining lattice, still attached to the hull, bent in the direction of the starboard side and aft. About 5,500 gallons of diesel oil and 100 gallons of hydraulic oil were reported to be on board at the time of capsizing; a boom was deployed to contain the pollution.

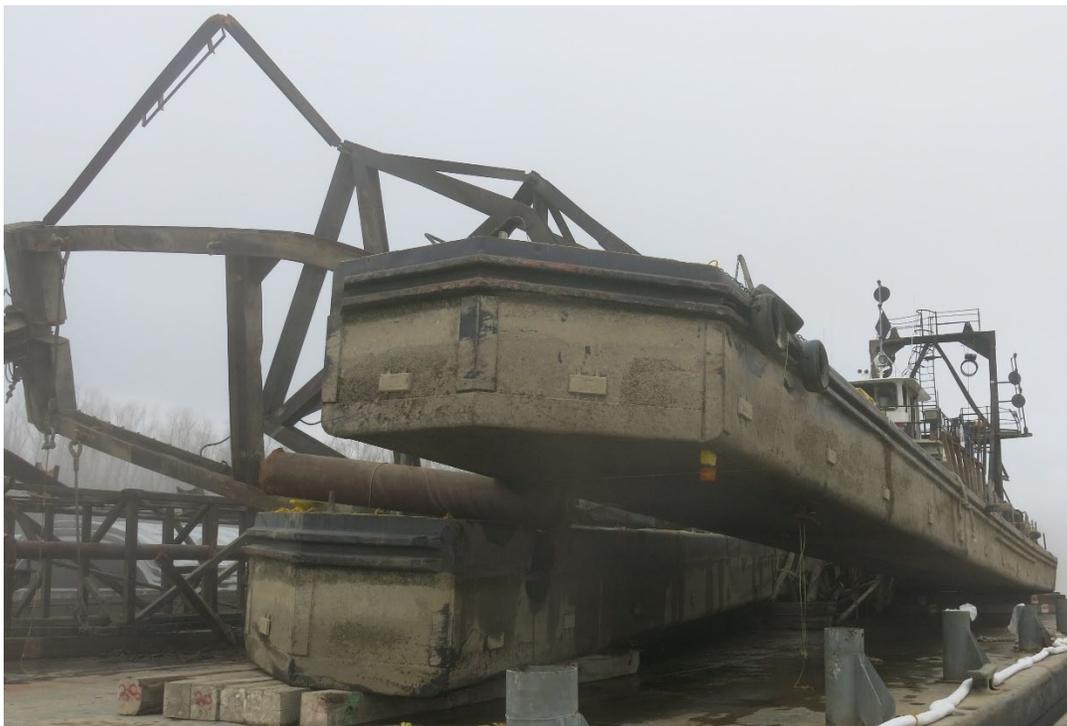
Recovery activities further damaged the wreckage. On January 28, a marine salvage company recovered the *WB Wood* and placed it onto a barge for examination (see figure 6). During the recovery operations, the starboard-side pontoon was bent downward and inward towards the centerline to where it was in contact with the port

pontoon, and the portside ladder weld seam to the port trunnion was separated from the structure (the starboard side was still in place).

Figure 6. Postrecovery photo of the *WB Wood* on the deck of a barge.

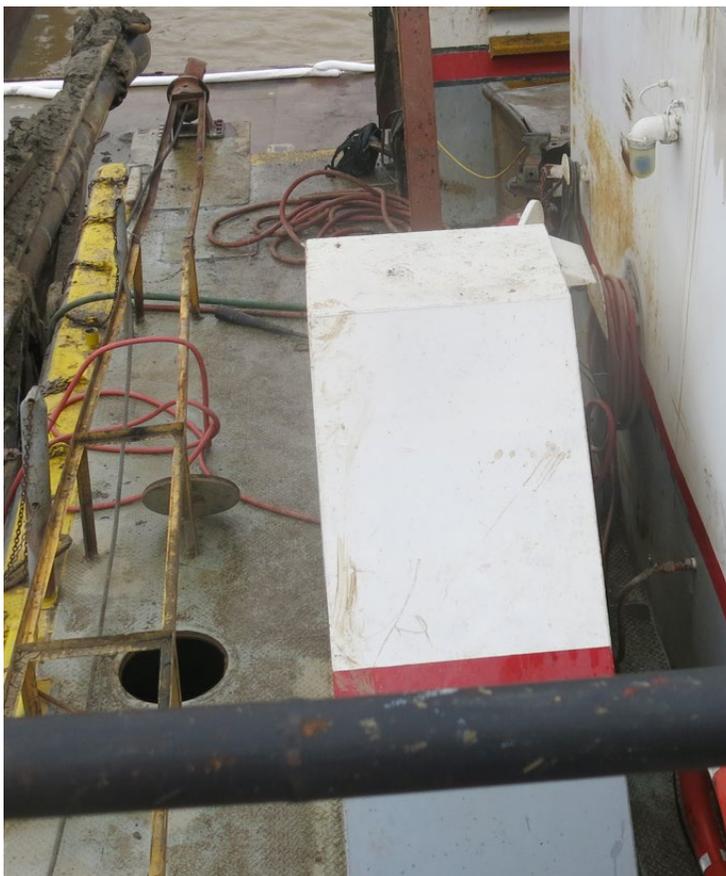
Six exterior flush hatches (not raised or with coamings) were located on the aft main deck of the *WB Wood*: one about midship for the aft rake void, one about midship for a void aft of the engine room, two on the port side outboard for two unnamed voids, and two on the starboard side, one for the starboard aft void and one for an unnamed void (see figure 3 and figure 7). Both the day and night levermen told investigators that none of the hatches were open in the time leading up to the casualty.

Figure 7. Postrecovery photo showing the flush hatch for the starboard aft void. Hatches were opened for salvage operations.

Six flush hatches on the aft main deck allowed access to the dredge's voids and spaces, including the starboard storage space. The condition of the hatches and their gaskets, presalvage, was unknown. On the *WB Wood's* first job (at an unknown date) following a drydock about 8 months before the casualty, a flooding of three aft compartments occurred (including the starboard storage space). The port side hatch gaskets were subsequently replaced; the supervisor believed that the gaskets for the hatches on the aft deck had "dried up" and been compromised during the drydock period. However, the starboard-side gaskets were not replaced, and, due to the vessel's minimal freeboard, may have frequently been under water during dredging operations. Leaky or compromised starboard gaskets could have allowed water to enter the aft voids and spaces. Therefore, the initial starboard list and increasing stern trim, which would have put the starboard gaskets under water, would have allowed for water across the aft deck to work its way through any compromised flush hatch gaskets on the aft starboard side and flood into the spaces below.

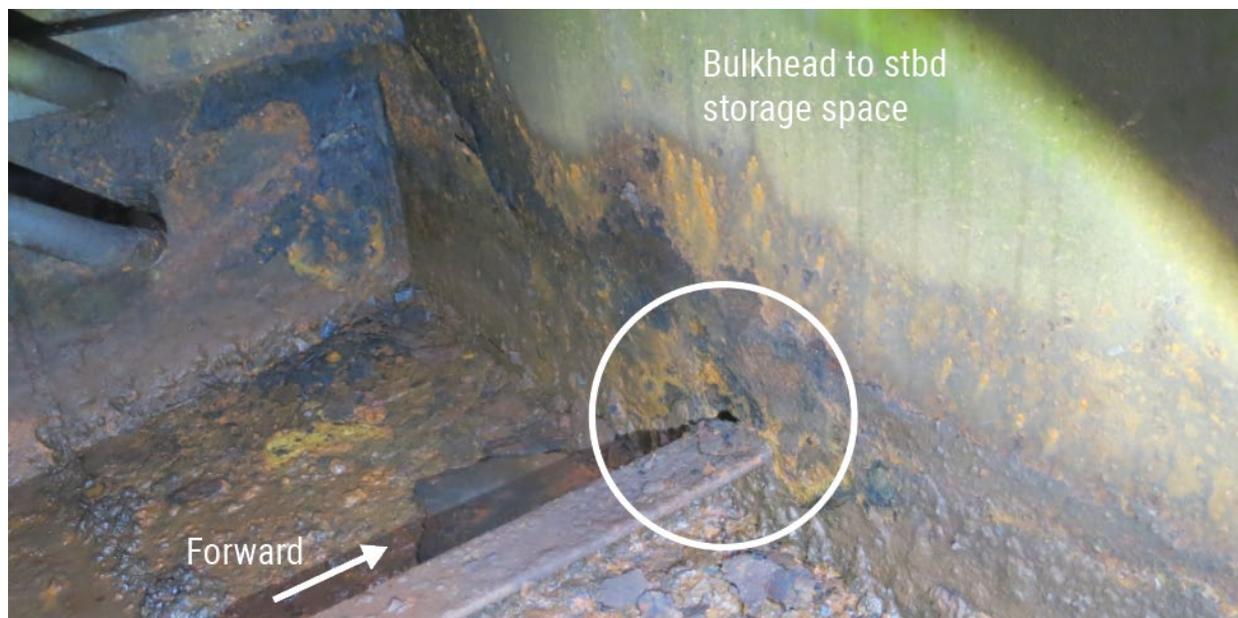
In the starboard aft void, along the forward transverse bulkhead separating that space from the starboard storage space, there was rust and scale extending from the bilge up about 10 inches across the entire bulkhead. At the bottom of the bulkhead, investigators found multiple small wastage holes at the weld joining the transverse bulkhead and the floor plate (figure 8). There were no observable signs of damage or deteriorated steel to the exterior hull plating in this space.

Figure 8. Rust, rust scaling, water accumulation markings, and a wastage hole (circled in white) in the transverse bulkhead between the starboard aft void (inboard forward corner) and the starboard storage room forward of it (viewed from the starboard aft void)

After the vessel was recovered, investigators found water marks, corrosion, wastage holes, and rust scale along the bottom 10 inches of the transverse bulkhead at the forward of the aft starboard void space, indicating that water normally pooled there. Although the wastage holes were small and went undetected by the vessel's crew, if the starboard storage space flooded first, the water level in the starboard aft void would eventually increase from communication with the storage space. (Conversely, if the starboard aft void flooded initially, the water level in the starboard storage space would

Vessel crews should regularly check tanks and voids that are adjacent to the vessel's hull to identify hull integrity issues (such as potential corrosion and steel wastage, and watertight integrity deficiencies) that can lead to flooding. The presence of water can indicate an issue with watertight integrity or wastage and should be addressed. Vessel operators should ensure crews have procedures for anticipating, preventing, and addressing the potential for water ingress and flooding, including establishing scheduled checks. Bilge alarms set to detect water at a low level in voids and other spaces are another means to ensure early detection.

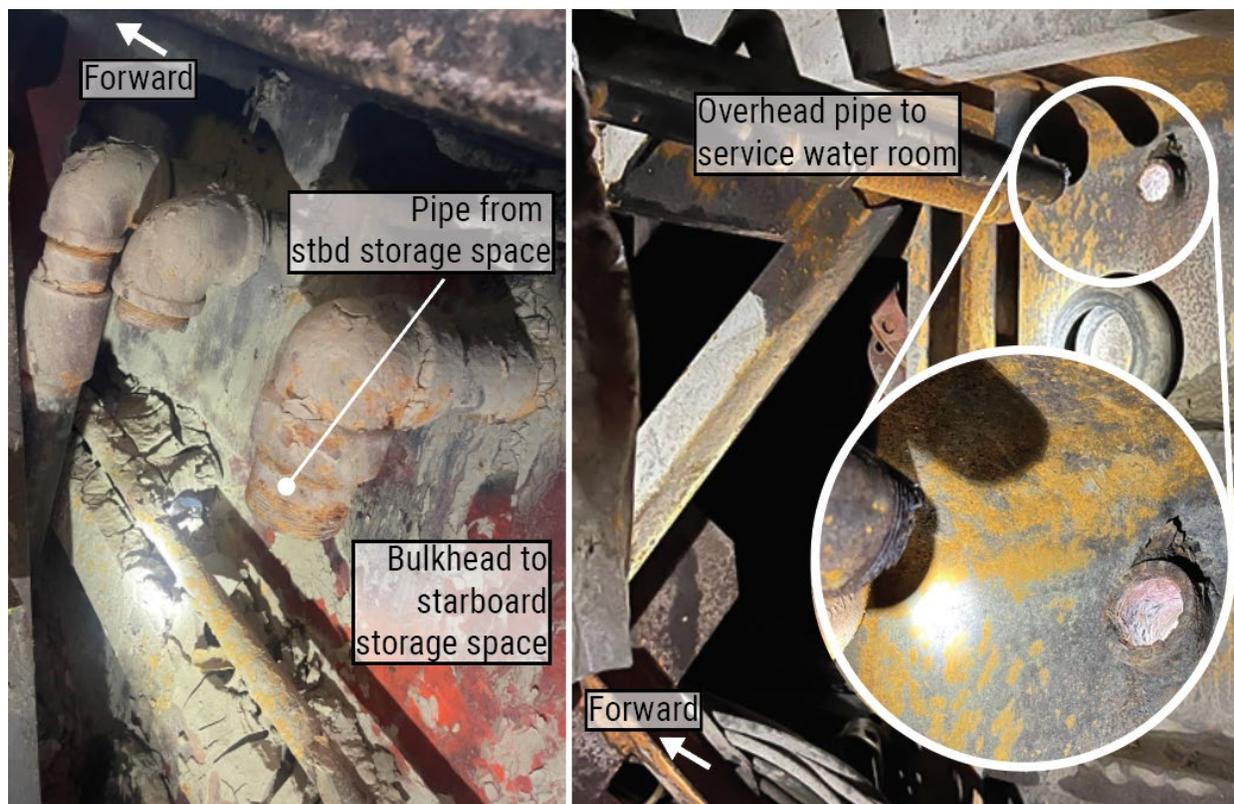
In the starboard storage space, investigators found an open 2-inch through-hull pipe on the starboard-side hull plating, near the top of the space. The center of the through-hull pipe was measured about 5 inches below the main deck. The pipe threading showed rust, scale, and dirt accumulation on the inboard side. Nearby, a 2-inch pipe in the overhead of the space led athwartships from the storage space through the longitudinal bulkhead into the adjacent service water room (see figures 9 and 10). In the starboard storage space, this pipe's threading, near the through-hull, was fractured. According to the day leverman, the pipe "needed work" so it was taken out of service at an unknown point and an overboard check valve was put in place. Investigators found a 2-inch check valve in the bilge in the bottom of the compartment.

Figure 10. Left: The longitudinal bulkhead separating the service water room from the starboard storage space (viewed from the top of the service water room, facing forward). Right: The starboard storage space showing the overhead pipe and the 2-inch pipe through-hull pipe. Inset: A closeup of the end of the overhead pipe and the unsecured through-hull pipe. (Source: Coast Guard)

Postrecovery, a 2-inch through-hull pipe into the starboard storage space was found to be open, as its overboard check valve was missing (the presence of rust, scale, and dirt accumulation on the inboard side of the through-hull pipe threading indicated that the valve had been missing before the casualty). Based on investigators' measurements, the center of the through-hull pipe was likely no greater than 5 inches above the dredge's normal waterline, so waves, a list to starboard, and/or an increase in stern trim could have submerged the opening, allowing water to enter the storage space. Further, the night leverman found this space to be fully flooded 2 hours before the capsizing but did not know where the water had come from. As the quantity of water increased in that space, the list to starboard would have increased and the aft freeboard would also have decreased. Thus, it is likely that the initial starboard list was caused by flooding through the unsecurable through-hull pipe into the starboard storage space.
