## **ALERT SERVICE BULLETIN**

**407-21-124**

**MODEL AFFECTED:** 407

**SUBJECT:** FUEL SYSTEM STANDPIPE ASSEMBLY 407-062-032-103, ONE-TIME INSPECTION AND REWORK OF.

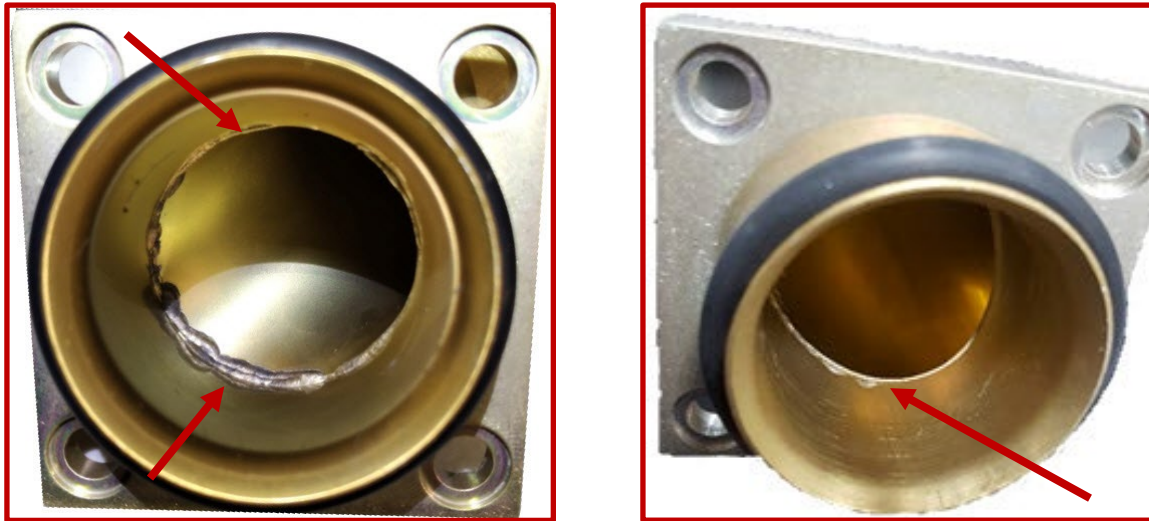
Bell has been made aware of a quality escape from our current supplier of the fuel system standpipe assembly 407-062-032-103. Some standpipes may have been delivered with sharp edges at the internal weld joints (Figure 1). If not corrected, this could lead to fuel quantity system wiring damage and loss of, or erratic, fuel quantity indication.

3. Inspect interior of fuel system standpipe for evidence of sharp edges of the two internal weld joints (Figure 1).
  - a. If no sharp edges are present, go to step 4.

**Figure 1 – Examples of Non-Conforming Internal Welds Joints**

- b. If sharp edges are present, lightly deburr edges of weld joints using aluminum oxide abrasive cloth or paper (commercial) (Figure 2). Make sure not to exceed 0.015 inch (0.38 mm) depth into the tube material at a 45 degree angle to the weld joints.

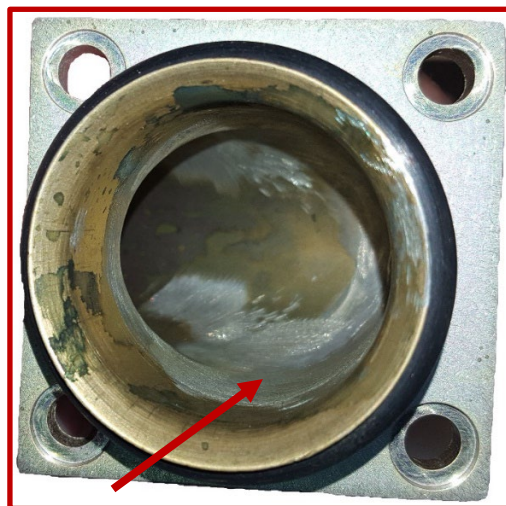
**Figure 2 – Example of Internal Weld Joint After Deburring**
