Service Bulletin

Doors - Emergency Exit - Inspection for a Rigging Pin on the Overwing Emergency Exit Door (OWEED) Slide Mechanism

BD500-522004
Issue No. 001

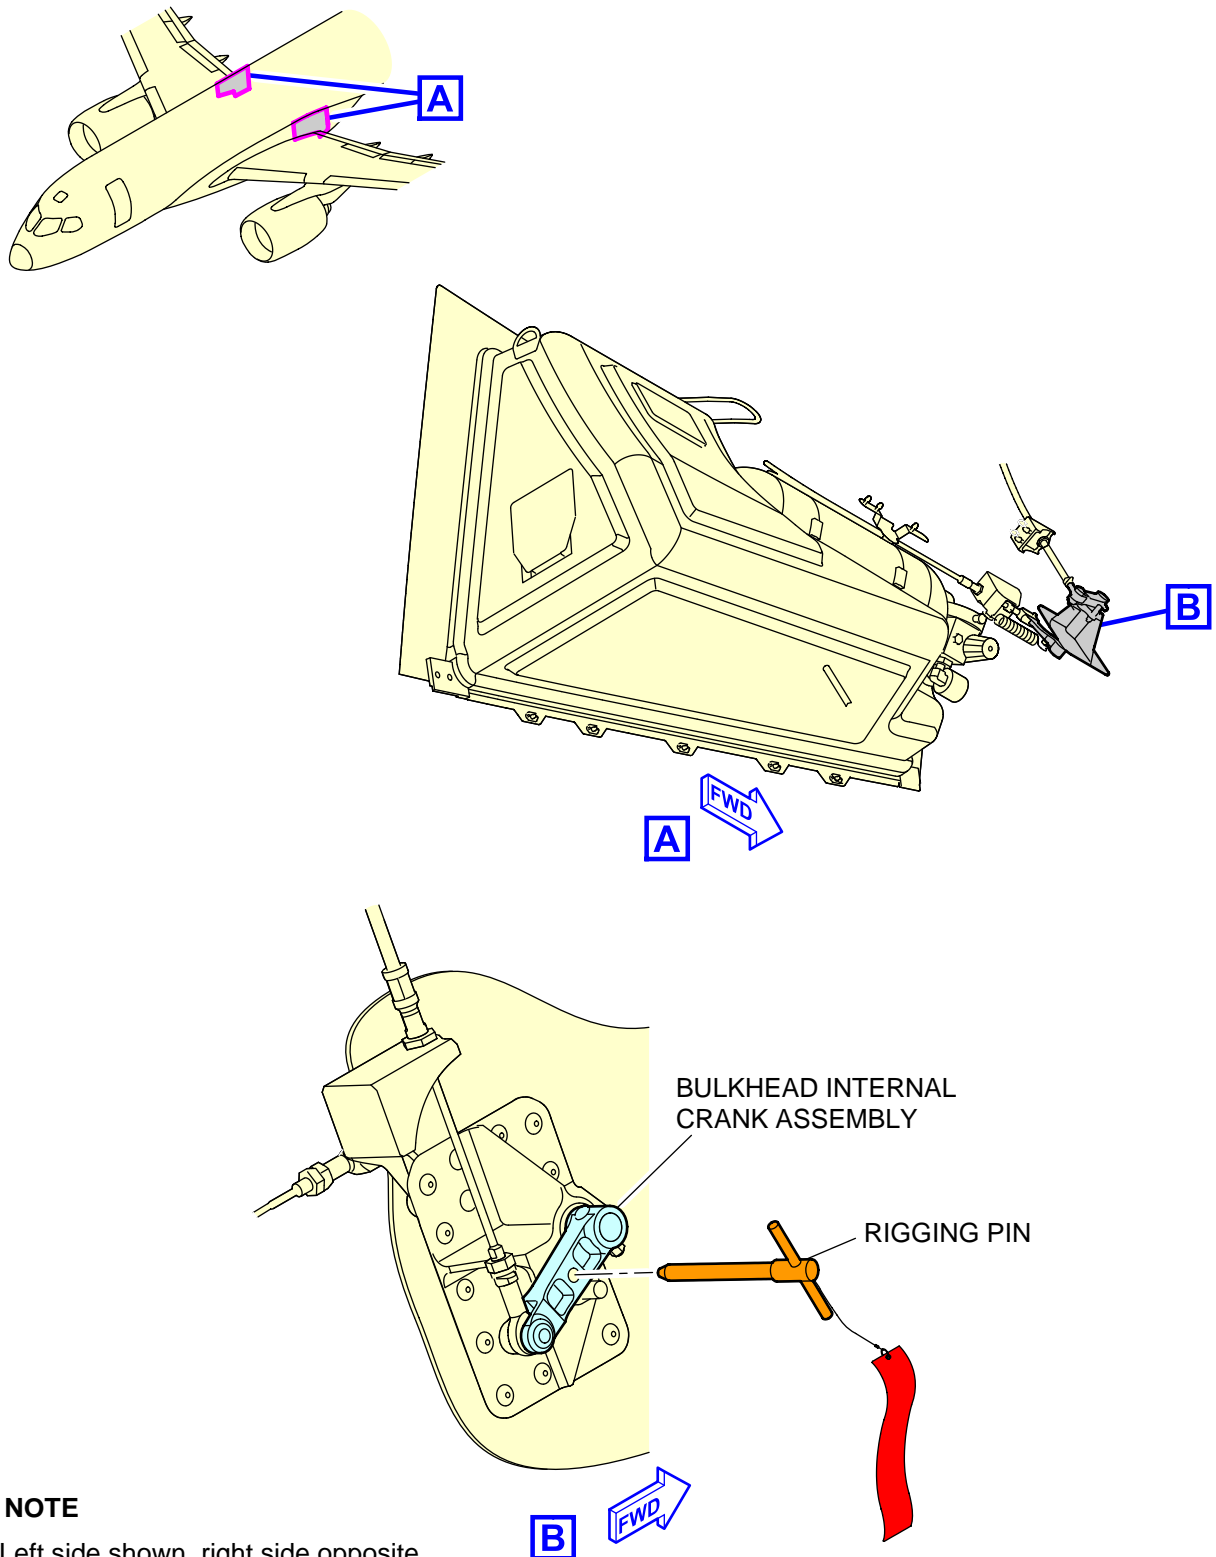
ICN-BD500-A-J522004-F-3AB48-95963-A-001-01
Figure 1 Overwing Emergency Exit Door (OWEED) Slide Mechanism Rigging Pin

It is possible that rigging pins are installed in the bulkhead internal-crank assembly of the left and right slide mechanisms of the OWEED. This will prevent the deployment of the off wing evacuation slides.

NOTE
Left side shown, right side opposite.

- 3.1 If it is not possible to complete all the instructions in this service bulletin because of the configuration of the aircraft, speak with a CRC representative at 1 866 A220 CRC (1-866-222-0272) or 1-450-476-7676 or e-mail at A220_crc@abc.airbus for analysis and to get an approved disposition to complete this service bulletin.
- 3.2 Examine the left OWEED slide mechanism as follows:
Refer to Fig. 1.

-
- 3.2.1 Make sure that the rigging pin is not installed on the bulkhead internal-crank assembly of the OWEED slide mechanism.
 - 3.2.2 If there is a rigging pin installed, remove it.
 - 3.3 Examine the right OWEED slide mechanism as follows:
 - Refer to Fig. 1.
 - 3.3.1 Make sure that the rigging pin is not installed on the bulkhead internal-crank assembly of the OWEED slide mechanism.
 - 3.3.2 If there is a rigging pin installed, remove it.
