MODEL BD-700-2A12 (BD-700)

ATA 26-22

SPECIAL CHECK – BAGGAGE-COMPARTMENT FIRE EXTINGUISHERS – INSPECTION OF THE BAGGAGE BAY PUSH-TO-DISCHARGE SWITCH

Basic Issue: Feb 10/2023 700–26–7505

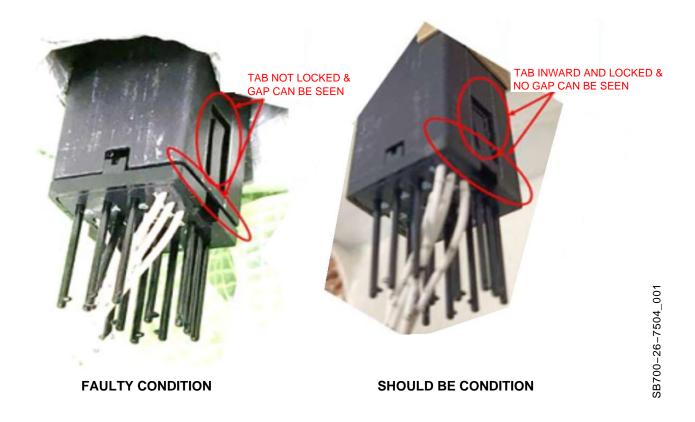
Internal Portion of the Baggage Bay Push-to-Discharge Switch Figure 5

During execution of a Functional Test Procedure (FTP), the baggage bay discharge Push-Button-Annunciator (PBA) switch was partially engaged and failed to make electrical contact. Further investigation showed that in some cases, the PBA was making contact but was not fully engaged and the tabs were not fully locked, so while the PBA passes FTP, vibration could eventually lead to the loss of electrical contact. This results in the loss of capability for the PBA to discharge the halon in the baggage compartment.

- (1) Do a visual inspection of the PBA switch assembly, Part No. 49431–030, for proper installation. Refer to Figure 5.
 - (a) Make sure that the tabs of the electrical connector are inward and locked, and no gap is seen between the connector and the switch.

- (b) If the tabs of the electrical connector are not engaged, engage the tabs.
- (2) If the operation test of the PBA <u>passed</u> in Paragraph 2.A., no further action is necessary. Go to Paragraph 2.D. Close–out.
