SERVICE BULLETIN 670BA–24–040

SUBJECT: Electrical Power – Air Driven Generator – Replacement of Locking Cam Screw and Cam Nut Assembly

NUMBER: 670BA-24-040

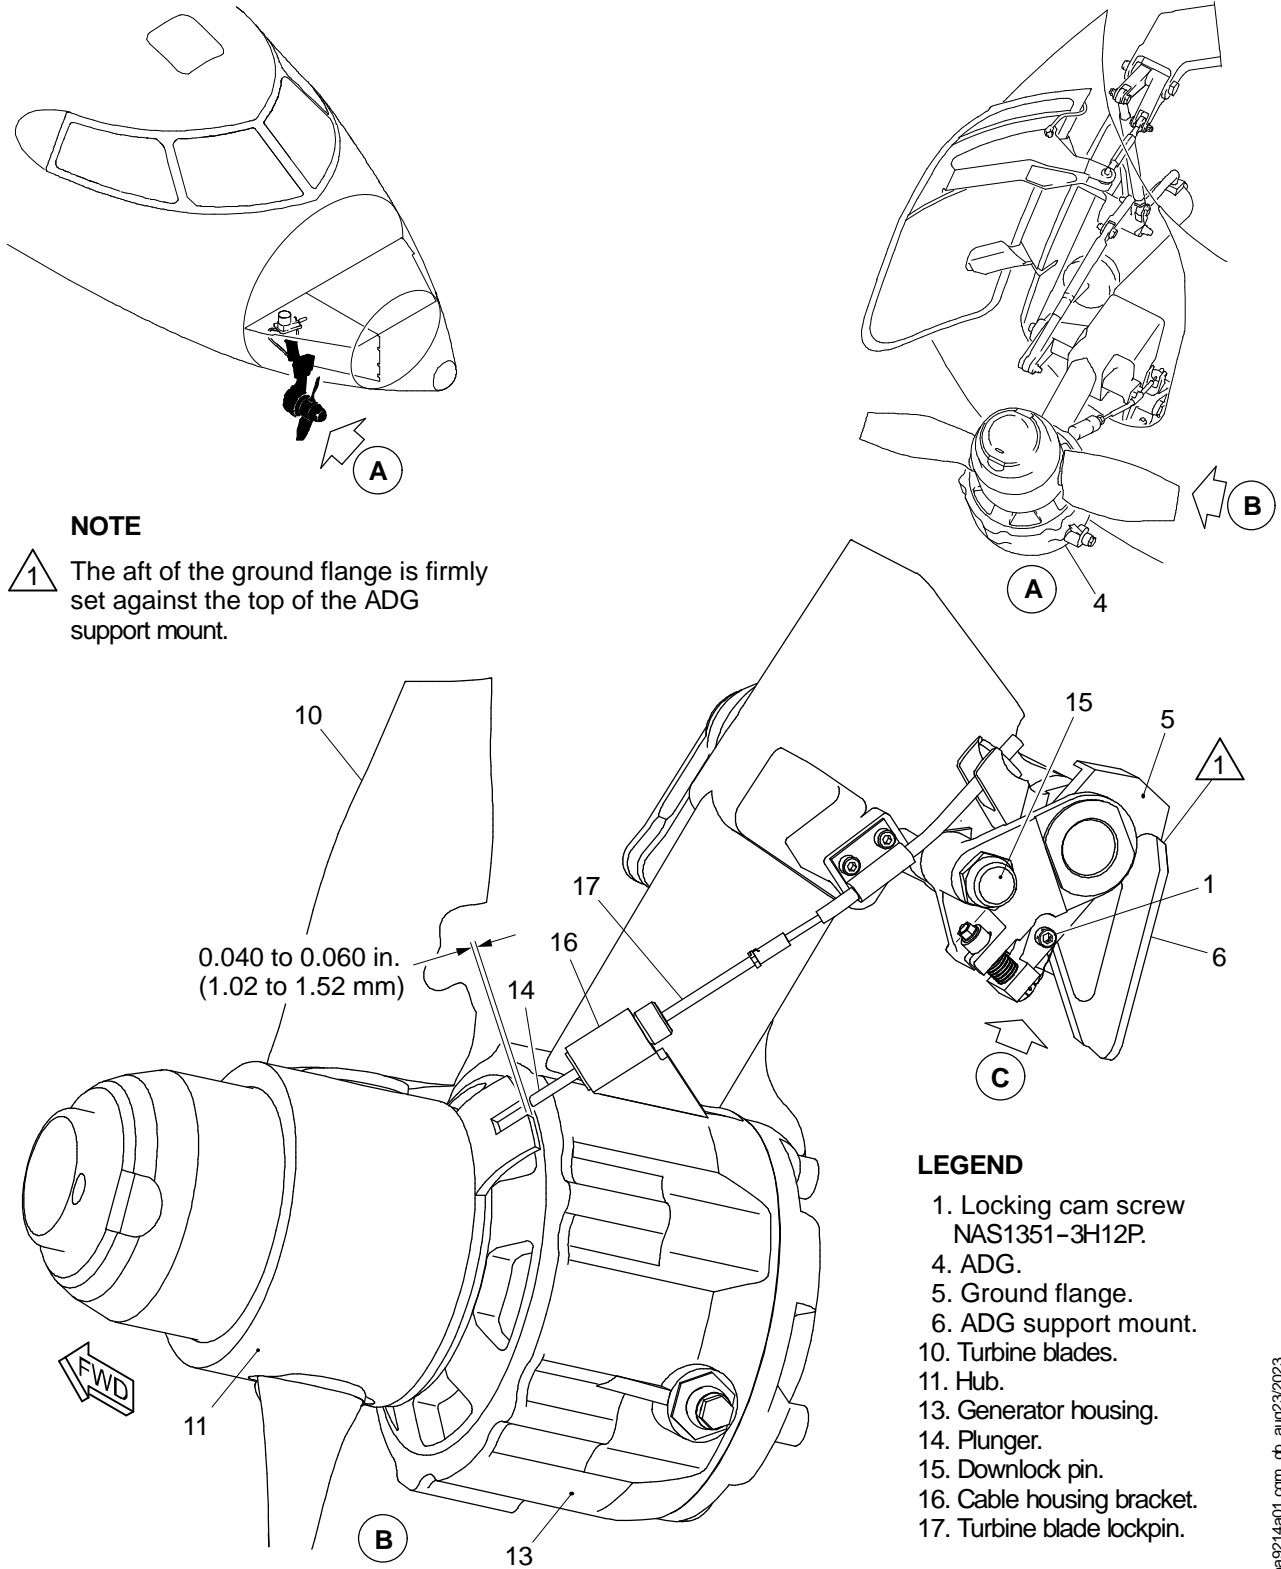
**Locking Cam Screw and Cam Nut Assembly Replacement
Figure 1 (Sheet 1 of 2)**

On the air driven generator (ADG) downlock mechanism, the locking cam screw, the cam nut with the screw thread self–locking insert may have been over–torqued during initial installation. This may cause the loss of the ADG downlock mechanism functionality.

- 1 The aft of the ground flange is firmly set against the top of the ADG support mount.

- (2) Remove and replace the locking cam screw (1) and the cam nut assembly (2) as follows:

- (a) Remove and discard the lockwire or safety cable from the locking cam screw (1) and the bolt (3) (refer to AMM 20–51–00–000–802 or AMM 20–51–00–000–807).
- (b) Remove and discard the locking cam screw (1) and the cam nut assembly (2) from the ground flange (5).
- (c) Install a new locking cam screw (1) with a new cam nut assembly (2) on the ground flange (5).

2 Lightly move the ADG (4) forward to firmly set the aft of the ground flange (5) against the top of ADG support mount (6) as shown on view B.

4 Torque the locking cam screw (1) to 51–56 lbf in. (5.8–6.3 N•m).

5 Make sure that the aft of the ground flange (5) is firmly set against the top of the ADG support mount (6) and there is no free play.

6 Check and, if necessary, adjust the nut (7) to get a clearance of 0.329 to 0.389 in. (8.36 to 9.88 mm) between the lower ends of the ground flange (5) and the downlock flange (8) as shown on view C.
