**SERVICE BULLETIN**

**N° 139-724**

**DATE:** July 27, 2022

**ATA 64 – TAIL ROTOR DAMPER BRACKET INSPECTION**

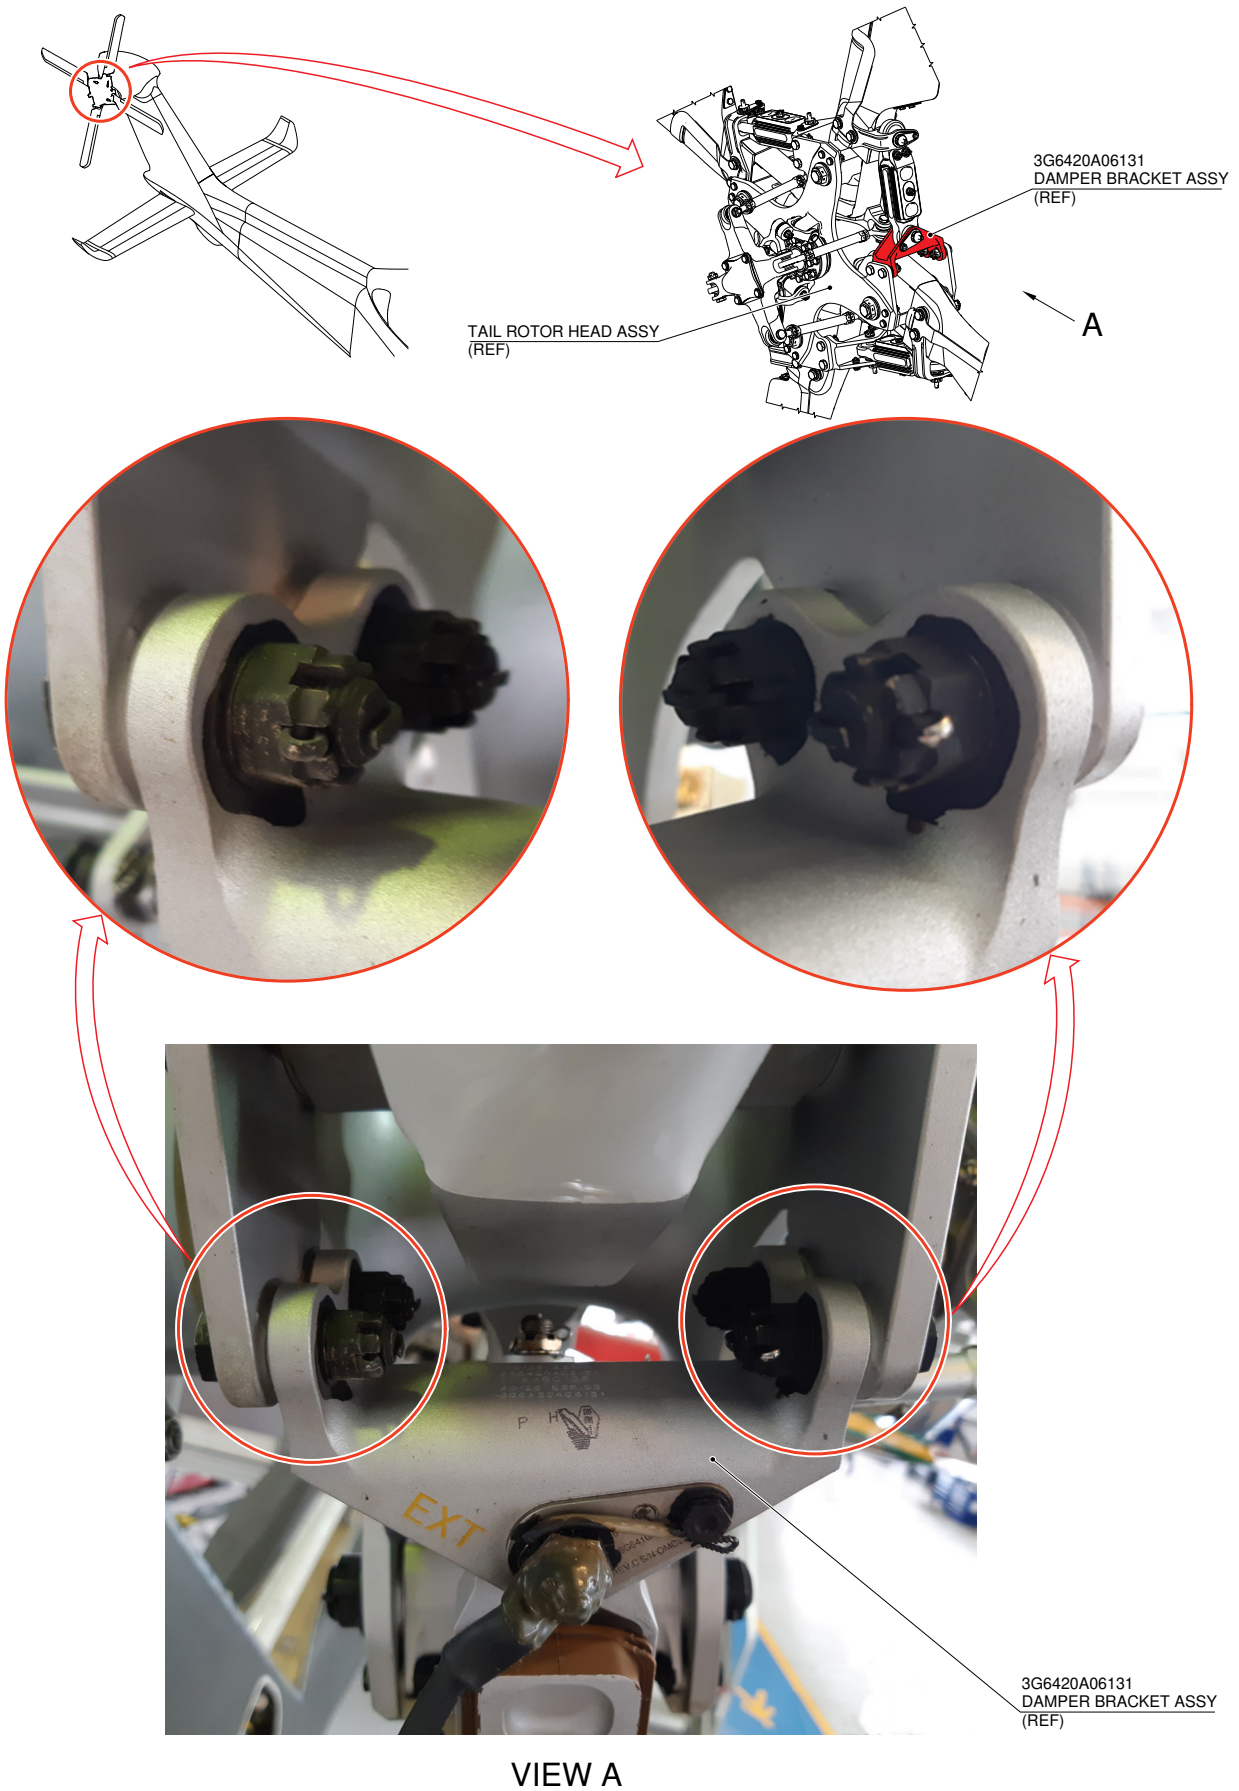
**Figure 1**

3. With reference to Figure 1, gain access to the component P/N 3G6420A06131 or P/N 4G6420A04432 (as applicable) object of the inspection.
4. With reference to Figure 1 (View A) perform a detailed inspection for cracks and for corrosion of the TR damper bracket P/N 3G6420A06131 or P/N 4G6420A04432 (as applicable) in accordance with the following procedure:
  - 4.1 Properly illuminate the area to be inspected (using a flash light, a mirror and a magnifying glass 10 power).
  - 4.2 Clean the area to be inspected with the Cheesecloth (C028) and the Aliphatic naphtha (C059) or Cleaning solvent (C010).

- 4.3 With reference to Figures 1 and 2, accurately examine the surface of the bracket,

paying particular attention to the area around the four holes.

5. In case of cracks replace the TR damper bracket according to the following procedure:
  - 5.1 In accordance with the applicable steps of AMP DM 39-B-64-11-02-00A-520A-A or AMP DM 39-C-64-11-02-00A-520A-A disconnect the blade damper attachment assy P/N 3G6410A03631 from the blade assy (without removing the lag damper from the damper attachment assy).

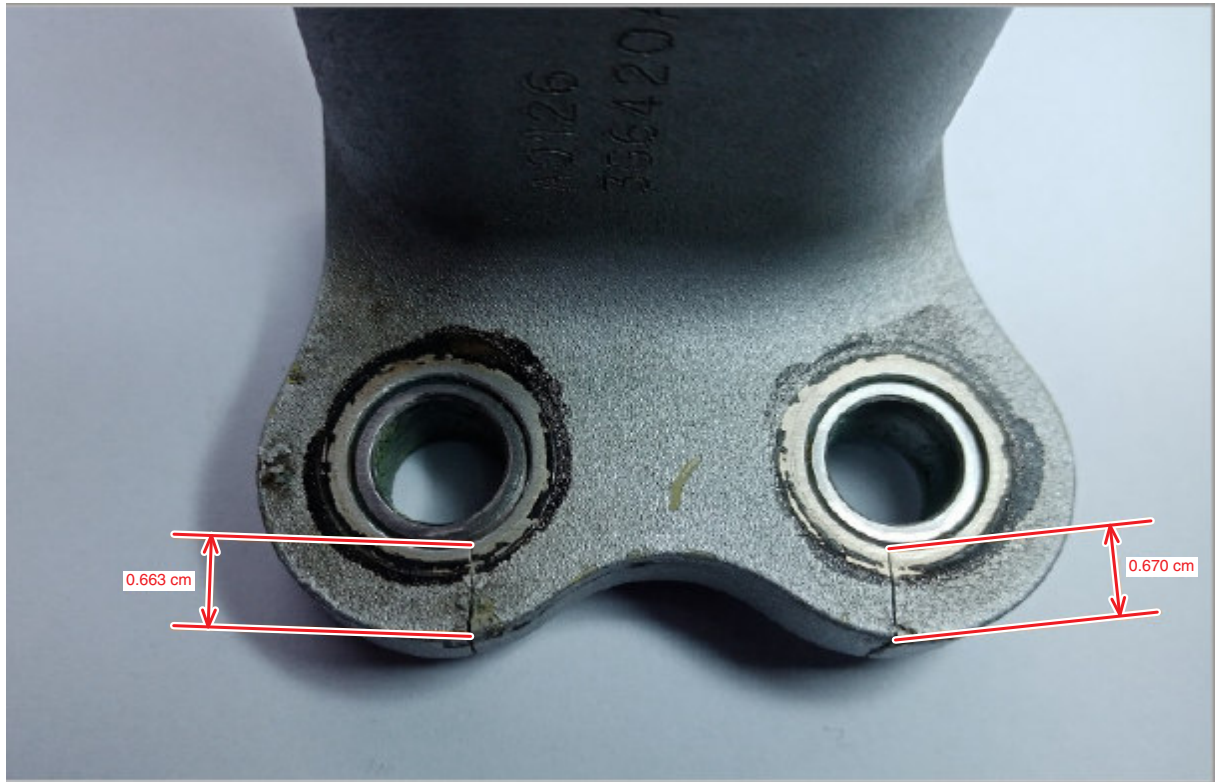
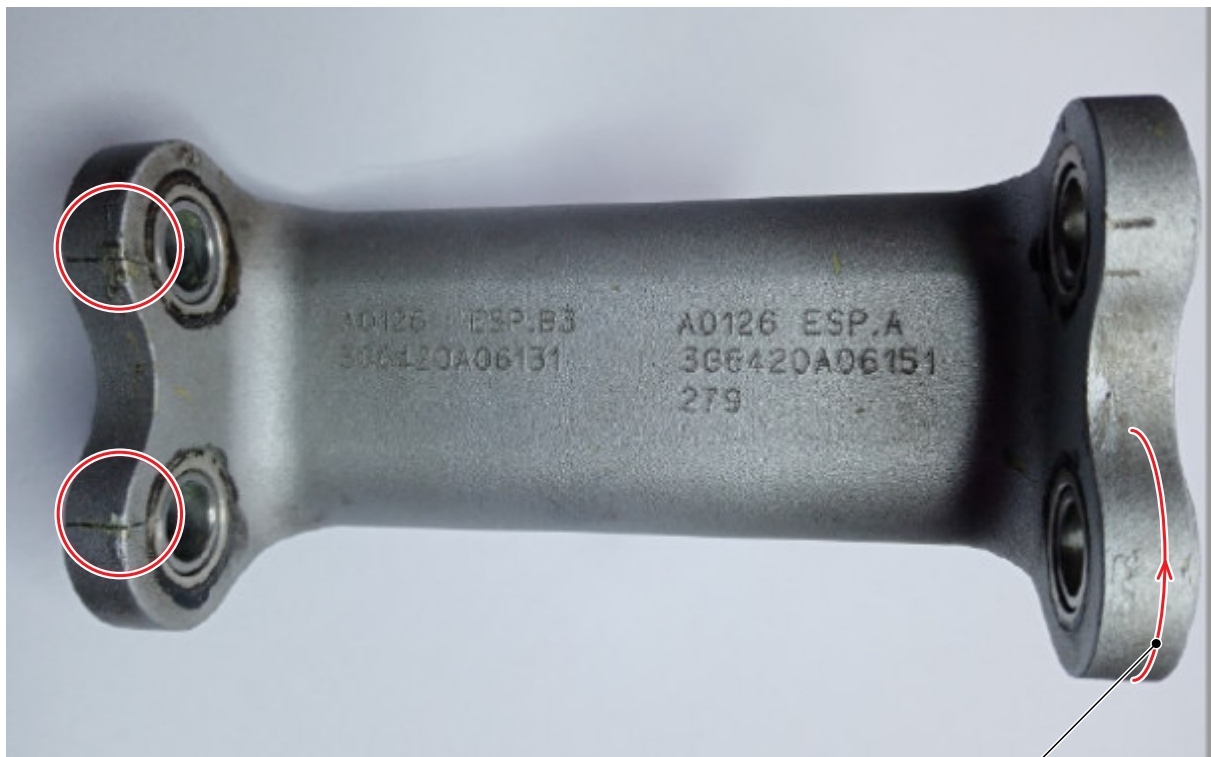
**Figure 2**

Refer to Figure 2 for an example of the cracks that might be found during the inspection.

- The Scotch Brite must be used only in the direction of the circumference of each bracket eyelet (ref. to Fig. 2 “polishing direction”);
- The Scotch Brite must be used only with your hands.
