October 2, 2024

MIR-24-31

Engine Room Fire aboard Yacht *Savage*

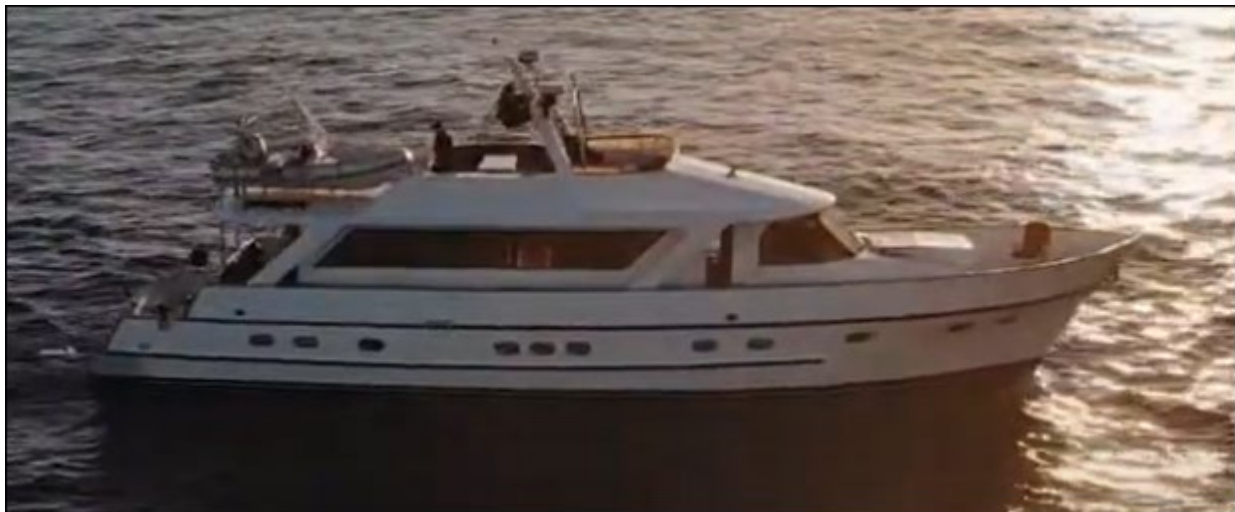
Figure 1. *Savage* underway at unknown date before the fire. (Source: Captain Ethan Hanks, NBD Marine Services LLC)

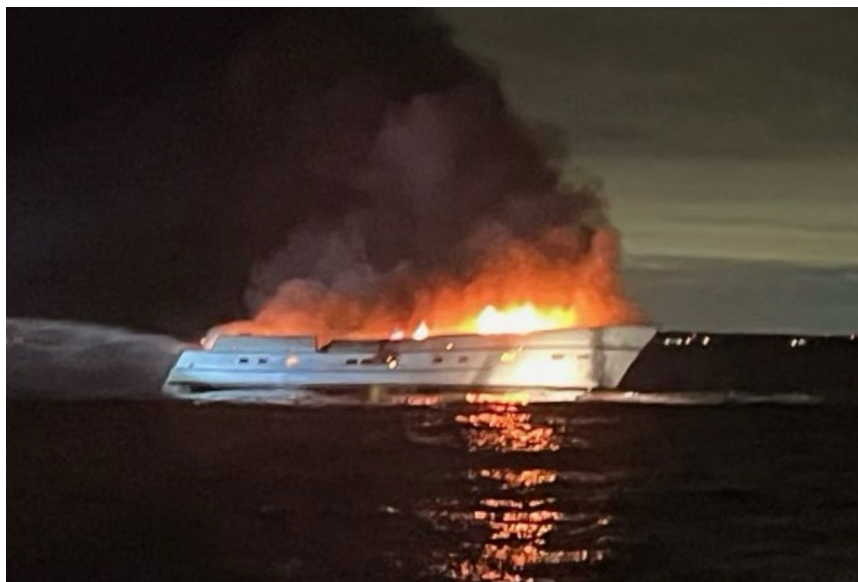
The captain estimated that they abandoned the vessel about 3 minutes after seeing the first flame (see figure 3). The captain said he did not think the fire was electrical, and he believed that the fire originated on the starboard side of the engine room. He estimated that something falling onto the exhaust of an operating engine could have started the fire. The first mate also stated he believed the fire started in the engine room and that the vessel previously had an exhaust problem on one of the engines.

Figure 3. The *Savage* during the casualty. (Source: Virginia Beach Fire Department via US Coast Guard)

Based on crew statements, the fire originated in the vessel's engine room. Potential ignition sources include the operating diesel propulsion engines and electrical generator, and other equipment. The extensive damage to the vessel precluded examination of components, and, therefore, the exact ignition source could not be determined.
