Contact of Yacht *Atlantis* with Floating Dredge Pipe Pump-Out Cube

On May 25, 2024, about 1130 local time, the yacht *Atlantis* was transiting north in the Atlantic Ocean about 1.5 miles east of St. Augustine Beach, Florida, when the vessel struck a floating dredge pipe pump-out cube associated with a beach renourishment project (see figure 1 and figure 2).¹ The contact compromised the hull, causing the yacht to flood and eventually sink. There was one minor injury, and no pollution was reported. The damage to the pump-out cube was estimated at \$20,000. The *Atlantis*, with an estimated value of \$2 million, was declared a total loss.

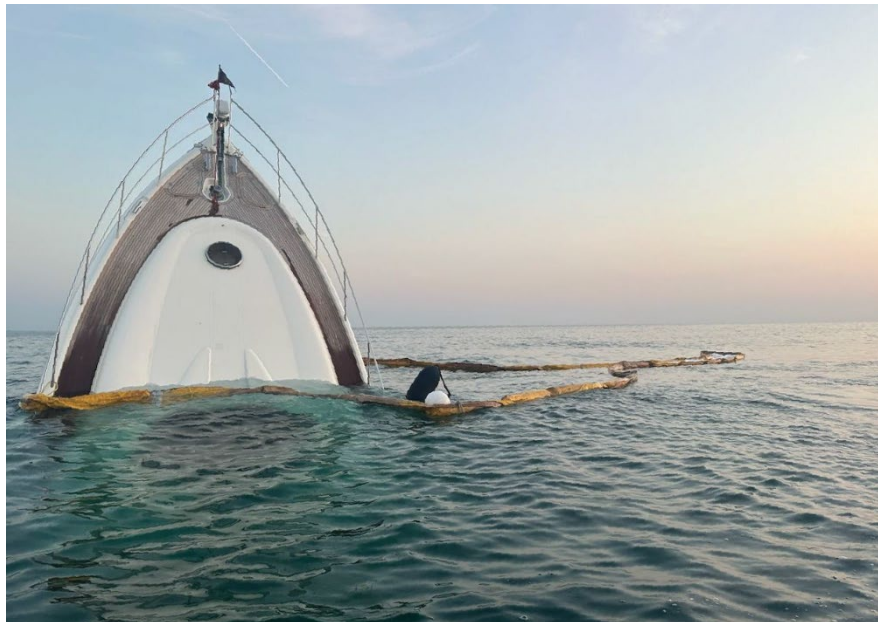
Figure 1. *Atlantis* following the contact on May 25, 2024. (Source: Florida Fish and Wildlife Conservation Commission)

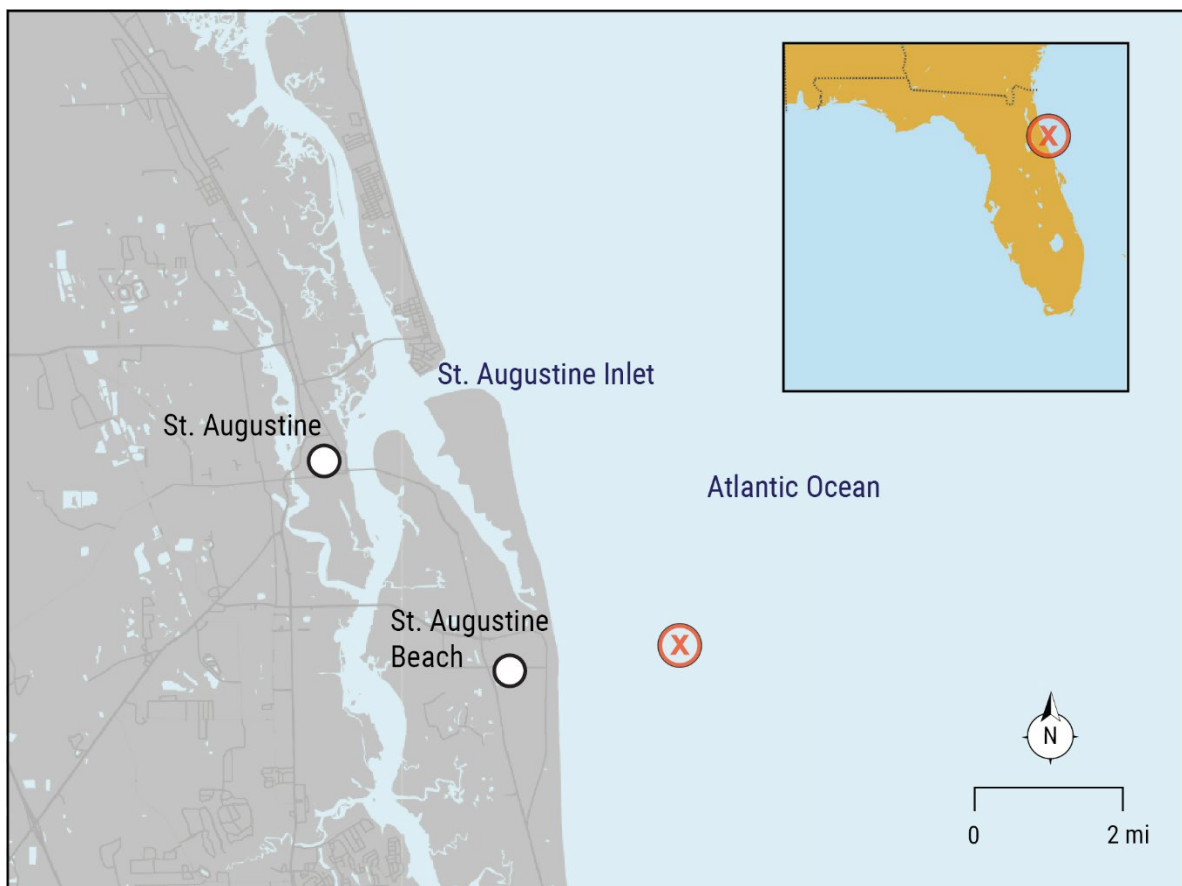
Figure 2. Area where the *Atlantis* struck the dredge pipe pump-out cube, as indicated by a circled X. (Background source: Google Maps)

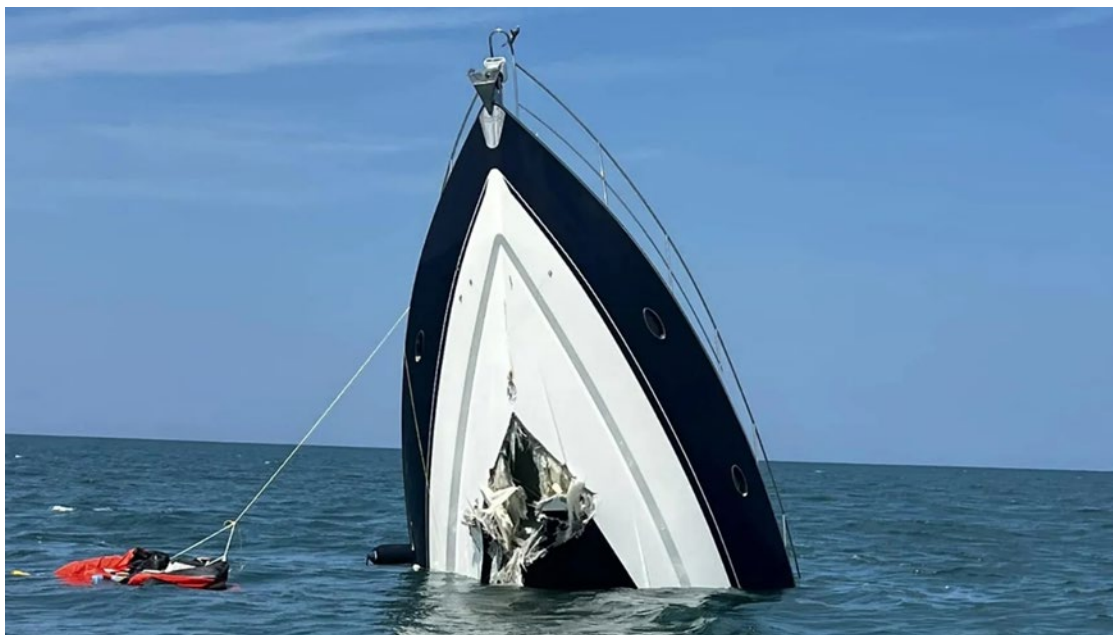
water “just pouring in” through a hole in the hull. Realizing the rate of water coming in could not be controlled, the operator determined the vessel would sink.

After the operator and spouse were rescued, the *Atlantis* drifted and eventually sank (see bow damage in figure 4). The vessel was removed from the water and transported to a marina in Jacksonville, Florida, on May 29. The owner’s insurance company declared the *Atlantis* a total loss.

Figure 4. Hull damage to the *Atlantis*. (Source: St. Johns County Fire Rescue)

The *Atlantis* was transiting north along the coast in the Atlantic Ocean when the vessel struck a floating dredge pump-out cube associated with a beach renourishment project, compromising the hull and causing the yacht to flood and eventually sink.

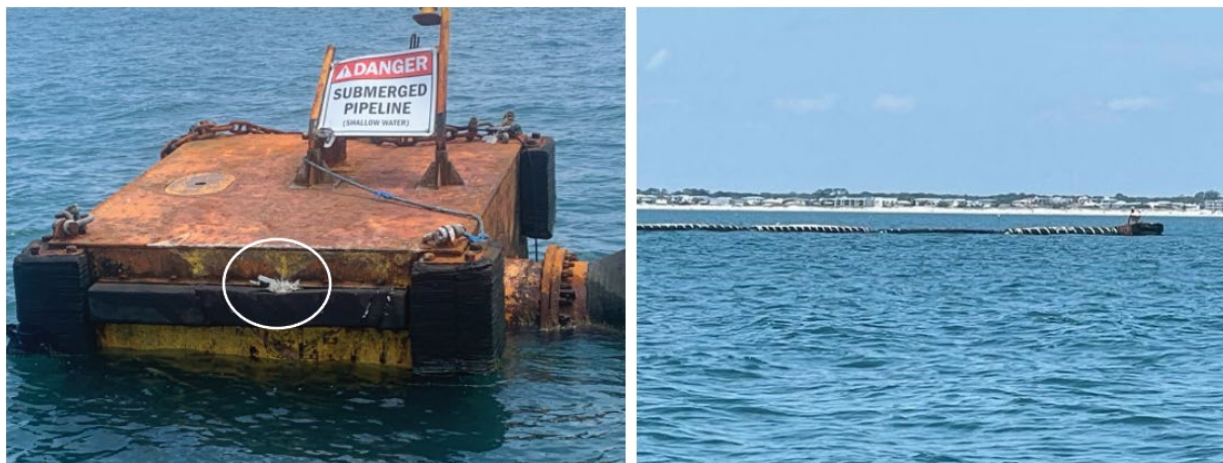
Figure 6. Left to right: The pump-out cube with damaged sign and the area where the *Atlantis* made contact circled; the dredge pipeline pump-out cube and floating hose from a distance, after the casualty. (Source: Florida Fish and Wildlife Conservation Commission)

The Coast Guard had approved the installation of the pump-out cube, floating hose, and dredge pipeline, and they had been in place for several months before the contact. Six buoys marked the underwater dredge pipe, three flashing lights were on the floating hose, and a radar-reflective warning sign and two red lights marked the pump-out cube. In addition, investigators confirmed that the location of dredging operations for the St. Augustine Beach renourishment project had been listed in all weekly editions of the District Seven Local Notice to Mariners leading up to the casualty. Therefore, the required markings and notifications were in place to warn mariners of the dredging associated with the beach renourishment project.
