MIR-24-24

Contact of *Danny Terral* Tow with Port of Lake Charles Pier

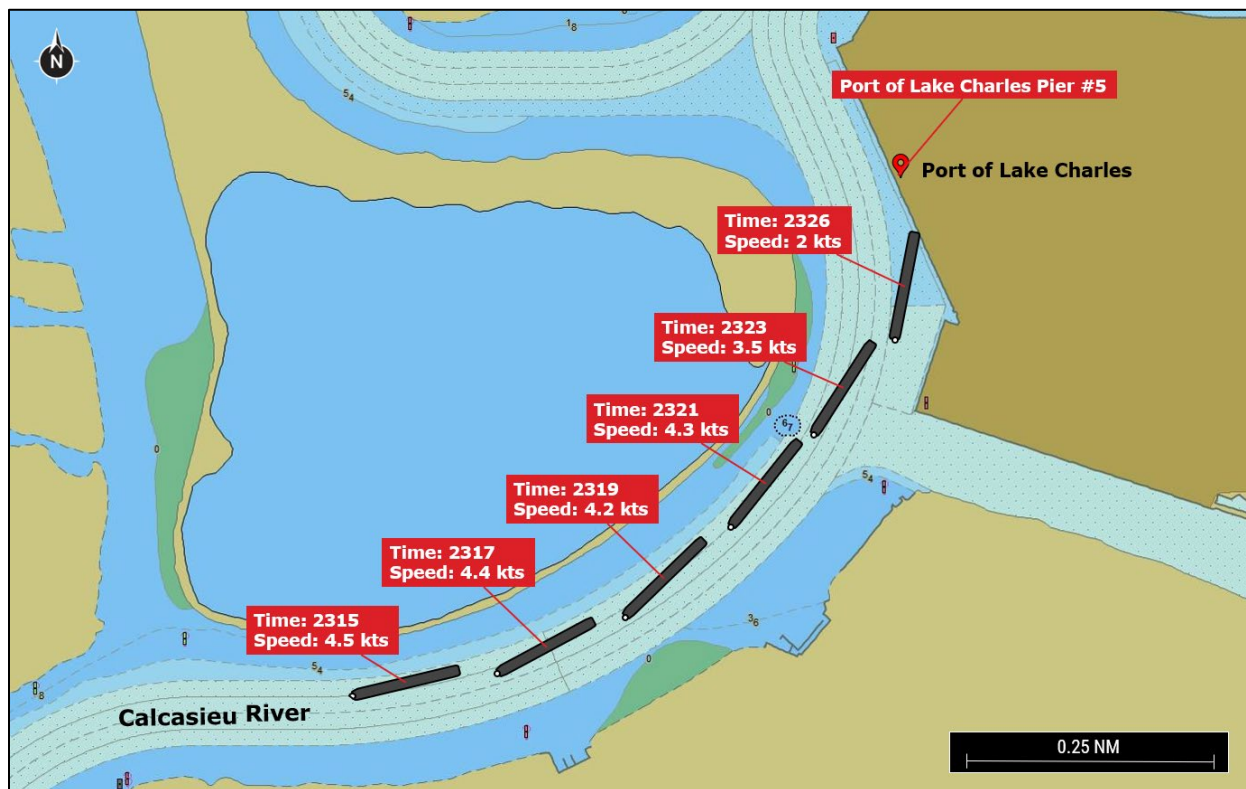
pier. The tow continued towards the pier and, about 2326, the lead starboard barge contacted the pier at 2 knots (see figure 3).

Figure 3. Trackline of the *Danny Terral* as the tow approached pier no. 5 at the Port of Lake Charles. (Background source: National Oceanic and Atmospheric Administration Electronic Navigation Chart US5LCHMB as viewed on Made Smart)

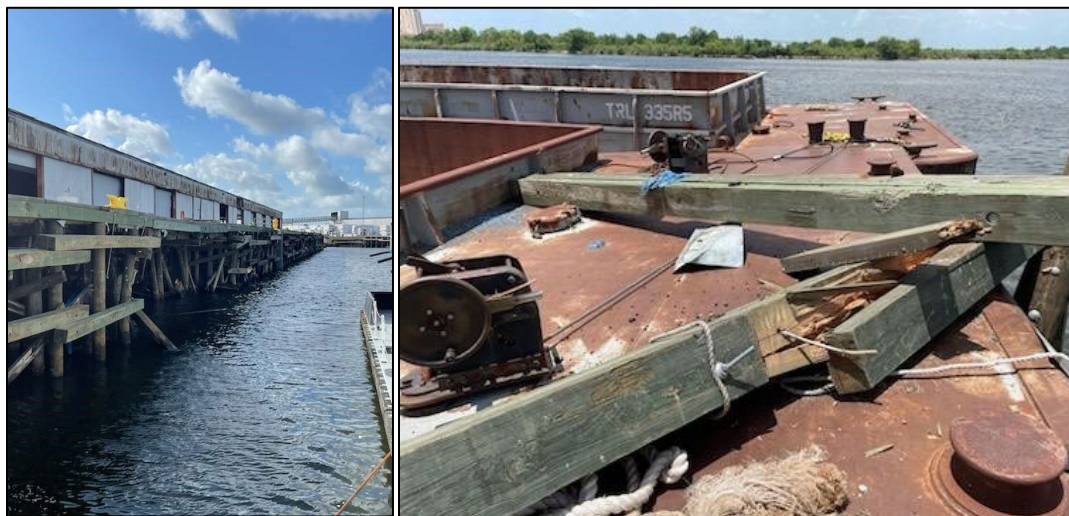
The tow remained intact following the contact. The deckhand observed damage to the pier spanning 30–40 feet and noted timber on the starboard lead barge. He did not see damage to the barges or the vessel. The Coast Guard inspected the pier the following day and noted damage to the pier support pylons

and undergirding, spanning about 40 feet in length (see figure 4). The cost to repair the pier was estimated to be about \$1 million.

Figure 4. Left to right: Damage to the Port of Lake Charles pier, and timber from the pier found on the starboard lead barge of the *Danny Terral*. (Source: Coast Guard)
