Railroad Investigation Report: RIR-24-04

1 Port Authority Transit Corporation Train 2 Strikes Two Subcontractor Employees

Camden, New Jersey
October 14, 2022

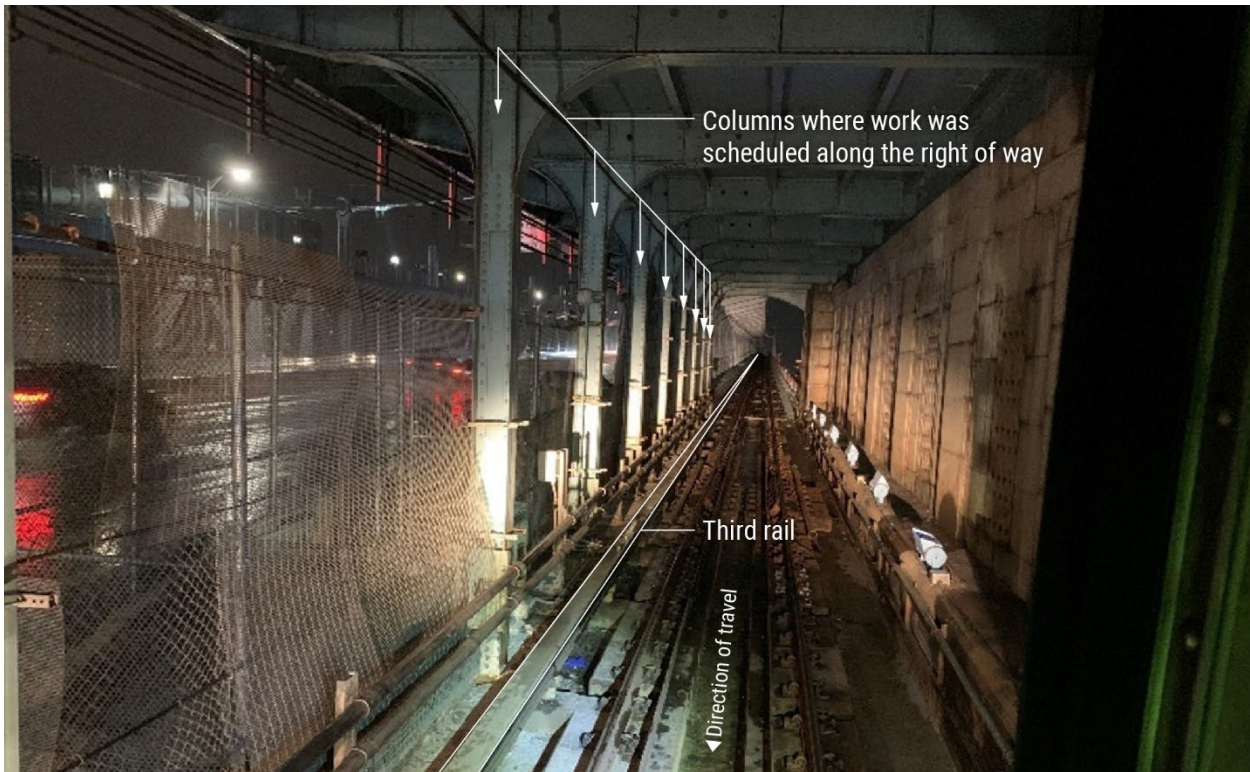
Figure 2. Photograph of Main Track 2, facing west, where the subcontractor employees were struck by PATCO train Westbound #1.

On the night of the accident, the subcontractor JPC Group employees met for a preshift meeting, including a job briefing, at 8:30 p.m. There were five employees in attendance, including the JPC Group supervisor. A Skanska Koch superintendent conducted a job hazard analysis with JPC Group employees. According to interviews the NTSB conducted with surviving attendees of the preshift meeting, the job briefing included work tasks and other safety points; however, it did not include ROW information, despite it being required as part of PATCO's ROW Safety Plan.⁸ According to interviews, JPC Group subcontractor employees and a supervisor went to their work staging yard following the job briefing to get materials. The group departed in two vehicles to the bridge work areas. One vehicle had two JPC Group subcontractor employees that would be working in the ROW where the accident occurred, and the other vehicle had the JPC Group supervisor and the remaining employees that were working in a different work area—a pedestrian sidewalk not on the ROW. The two subcontractor employees that were assigned to work the site near the ROW were tasked with putting new caulking on 11 columns that were located next to the tracks. (See figure 2.) This was their third night working in this work area.
