Aviation Investigation Report: AIR-24-05

Define the Meaning and Operational Use of Instantaneous Wind Reports

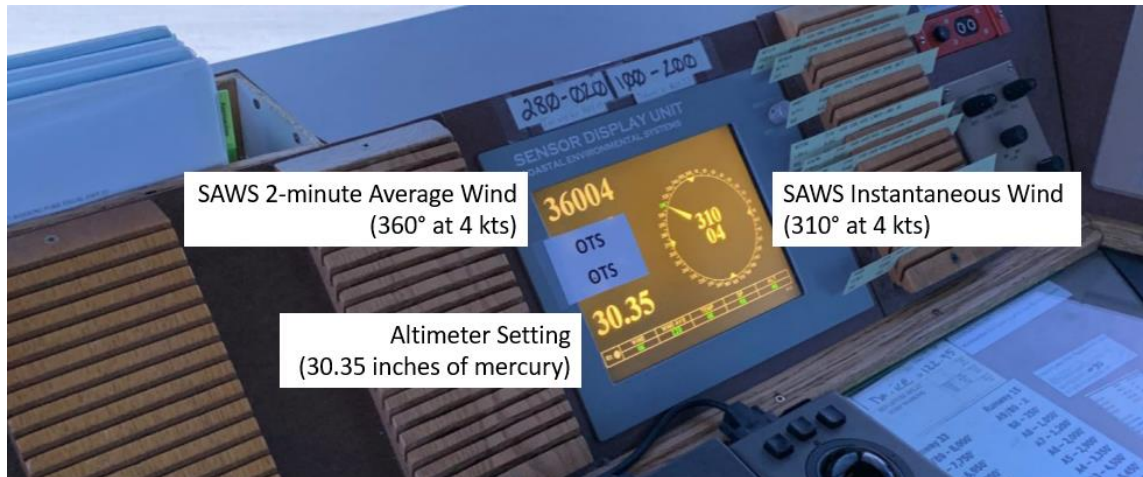
Following a fatal 2014 accident at ASE in which the wind report provided to the flight crew was near or exceeded the airplane's performance capabilities, the ASE tower updated its SOPs to require controllers to provide the 2-minute average SAWS wind measurement (see the ASE ATC tower controller wind display in the figure below),

Figure. SAWS 2-minute average wind and instantaneous wind displays in the ASE ATC tower.
