November 7, 2024

MIR-24-35

Contact of Cruise Ship *Ruby Princess* with Port of San Francisco Pier 27

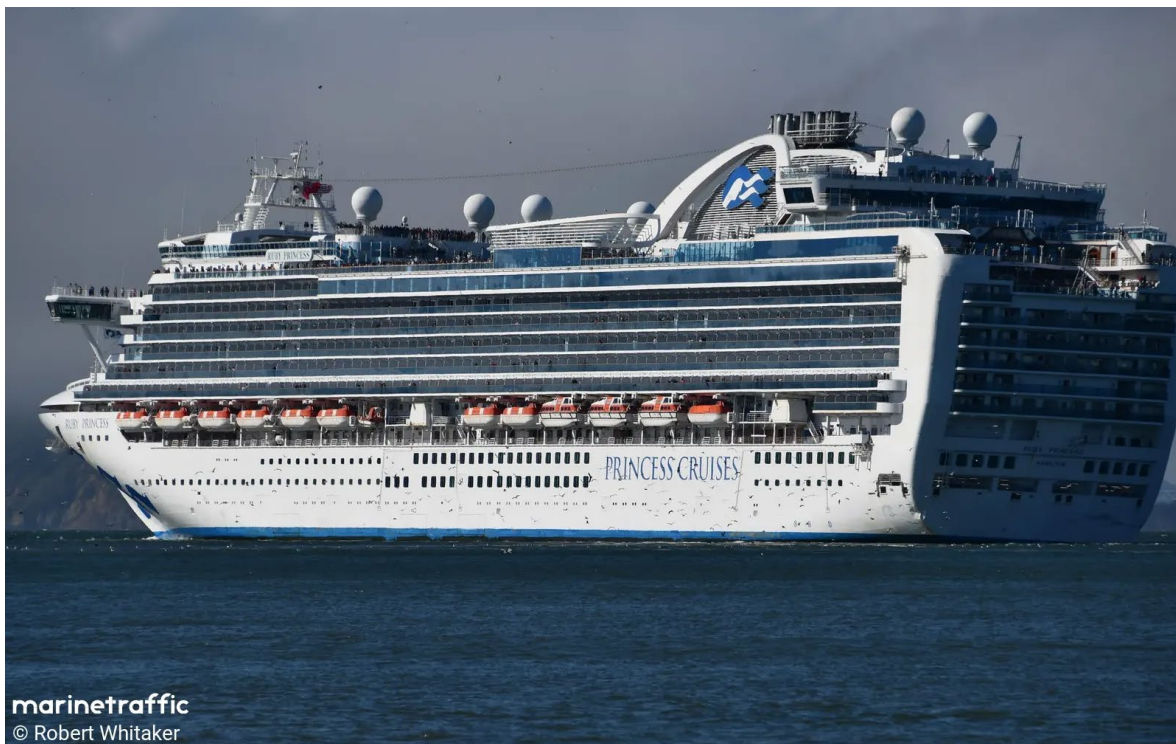
Figure 1. *Ruby Princess* underway in San Francisco Bay on September 4, 2023, after the contact. (Source: Robert Whitaker)

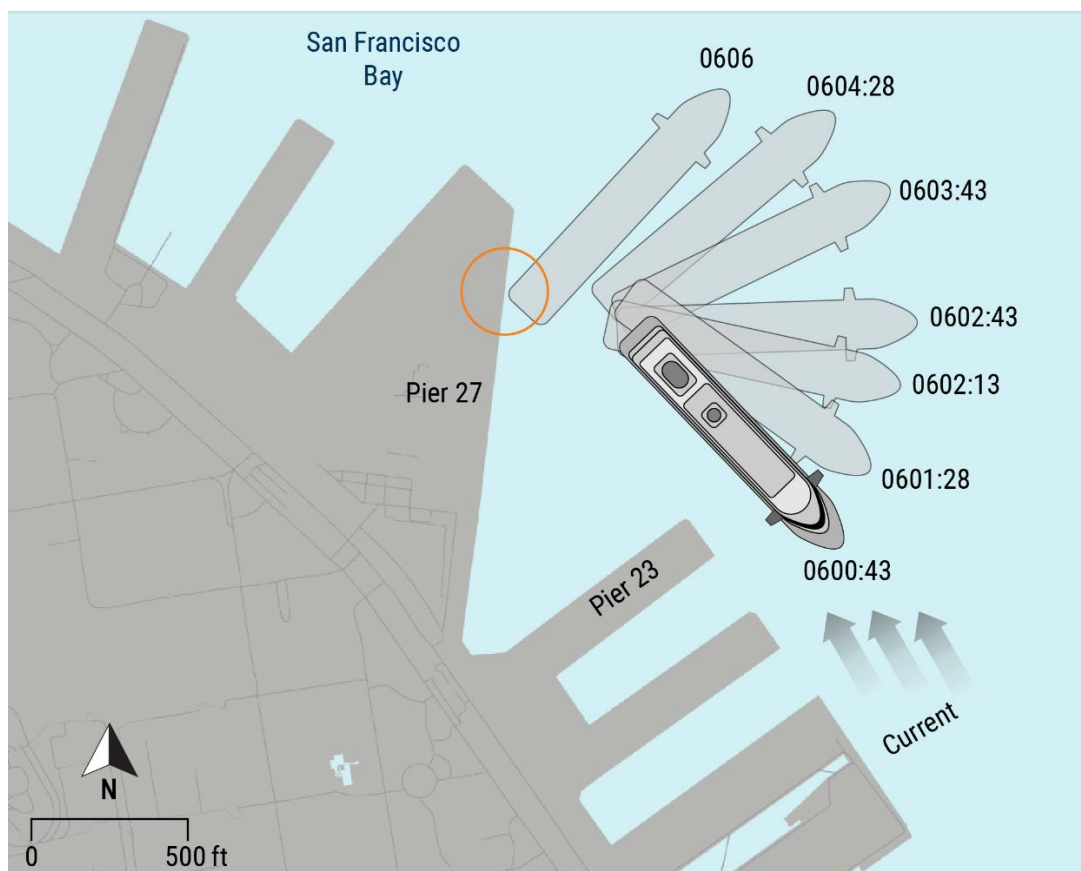
Contrary to the master and pilot's intentions, at 0604:28, the *Ruby Princess* was broadside to the ebb current, and, according to the master, outside of the shadow of Pier 23. At 0604:42, according to voyage data recorder (VDR) data, the vessel's heading was 047°, its port quarter was 165 yards from Pier 27, and its lateral movement toward the pier was 2.7 knots. The master attempted to use the main propulsion and stern thrusters to slow the vessel, and the vessel's lateral movement toward the pier slowed to 1.7 knots during the next 78 seconds. However, the vessel's lateral movement from the current could not be overcome, and the *Valor*, which had been positioned off the *Ruby Princess*'s port quarter, moved away from the vessel to avoid being caught between the vessel and dock. At 0606, the *Ruby Princess*'s port quarter contacted Pier 27 about 60 yards down from the head of the pier on its southeast side (see figure 3 and figure 4).

Figure 3. *Ruby Princess* positions as the master attempted to rotate the vessel counterclockwise to dock at Pier 27. Scale approximate; two assist tugs not shown. (Background source: Google Maps; vessel position source: *Ruby Princess* voyage data recorder)

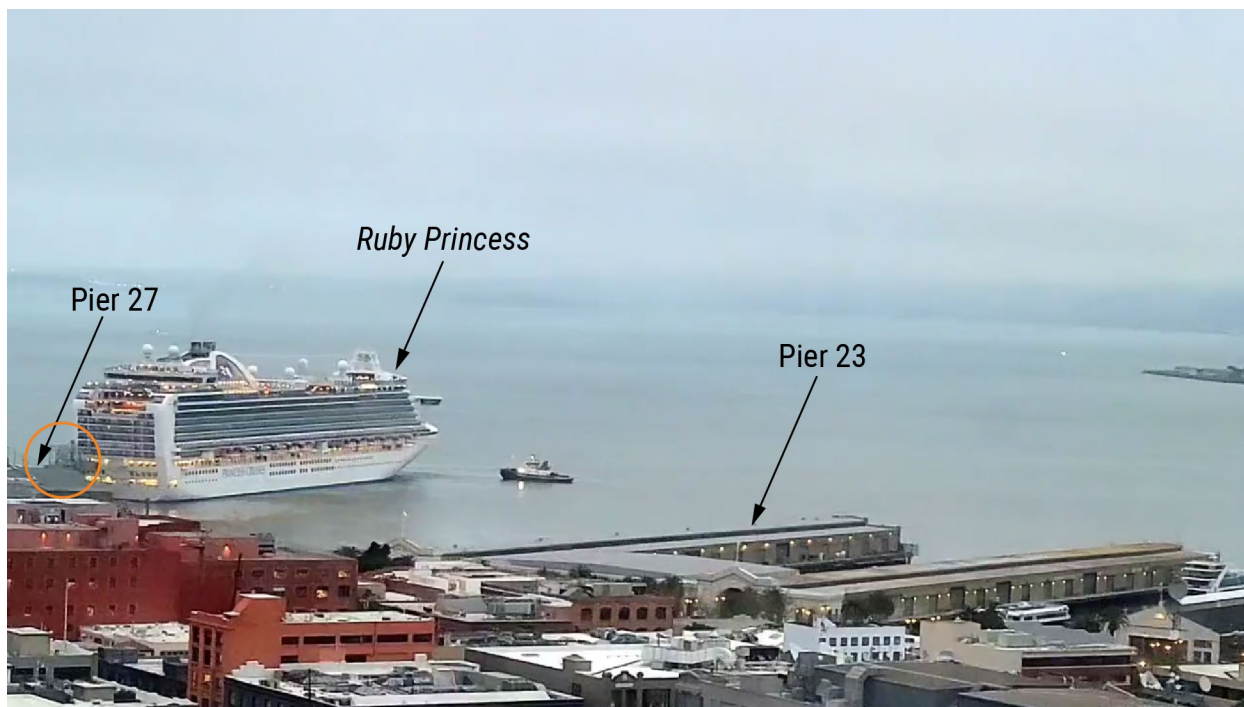
Figure 4. *Ruby Princess* at time of contact (circled) with Pier 27. (Background source: CMPTL Family on X)

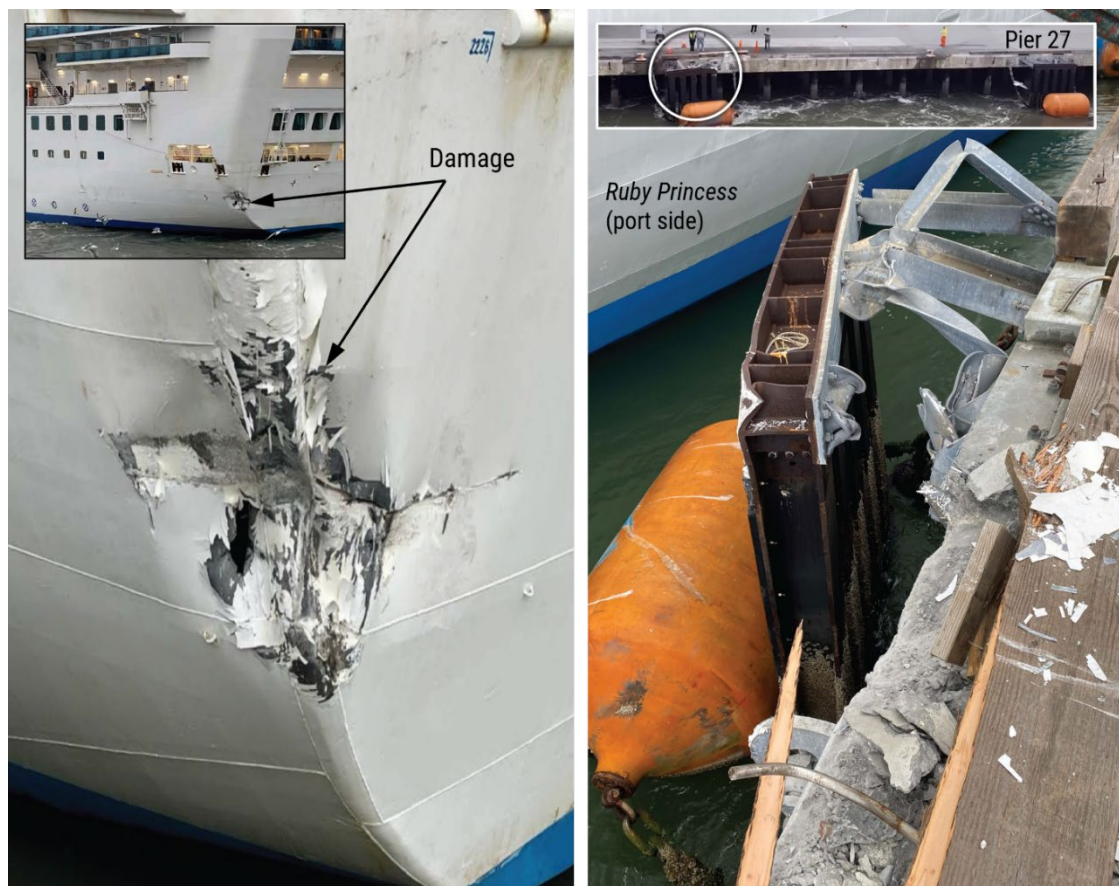
The contact resulted in the penetration of the *Ruby Princess*'s hull, and the vessel sustained internal structural damage in a heeling tank about 33 feet above the waterline. On Pier 27, a metal fender and the face of the pier in the immediate area of the fender were damaged (see figure 5). Repairs to the ship were estimated to cost \$200,000, and repairs to the pier were estimated to cost up to \$1 million.

Figure 5. Left to right: *Ruby Princess* damage and Pier 27 damage (circled in inset) on July 6, 2023. (Source: US Coast Guard (left); Coast Guard and KRON4 (inset) (right))
