MIR-24-34

Fire aboard Fishing Vessel *Whiskey Business*

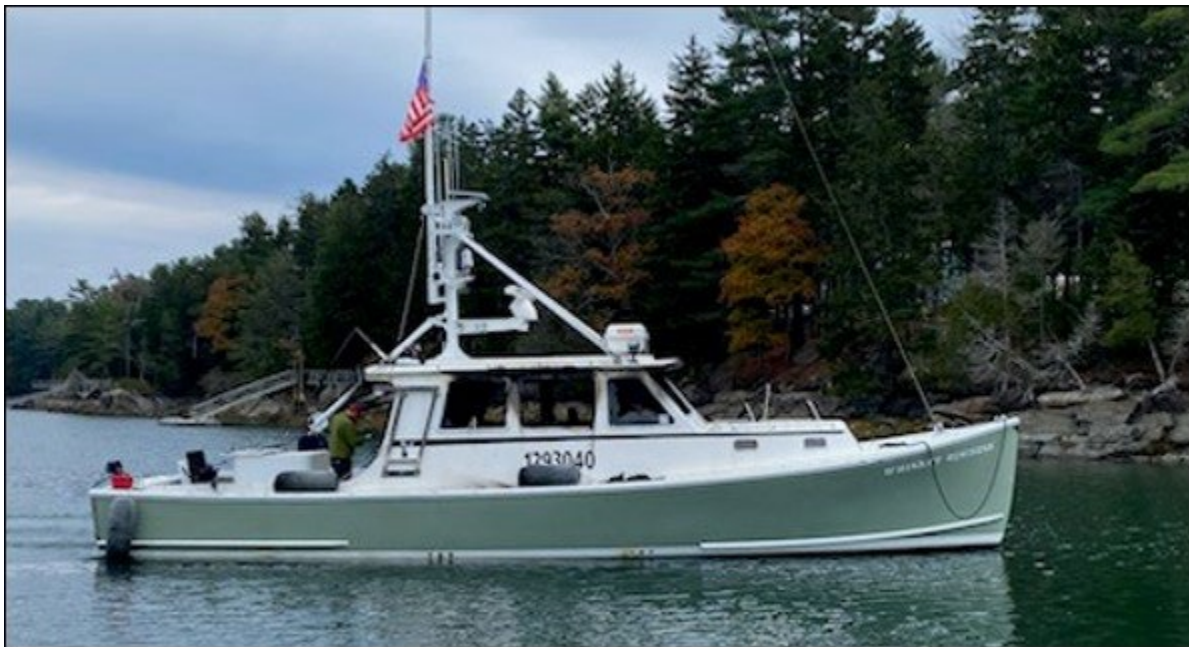
On November 5, 2023, about 0900, a fire broke out aboard the fishing vessel *Whiskey Business* while it was moored at the Safe Harbor Marina in Orrs Cove in Harpswell, Maine (see figure 1 and figure 2).¹ No one was on board at the time of the fire, and local fire departments extinguished the fire. There were no injuries, and no pollution was reported. Damage to the vessel was estimated at \$1 million.

Figure 1. *Whiskey Business* on November 5, 2023, after the fire. (Source: *Whiskey Business* captain)

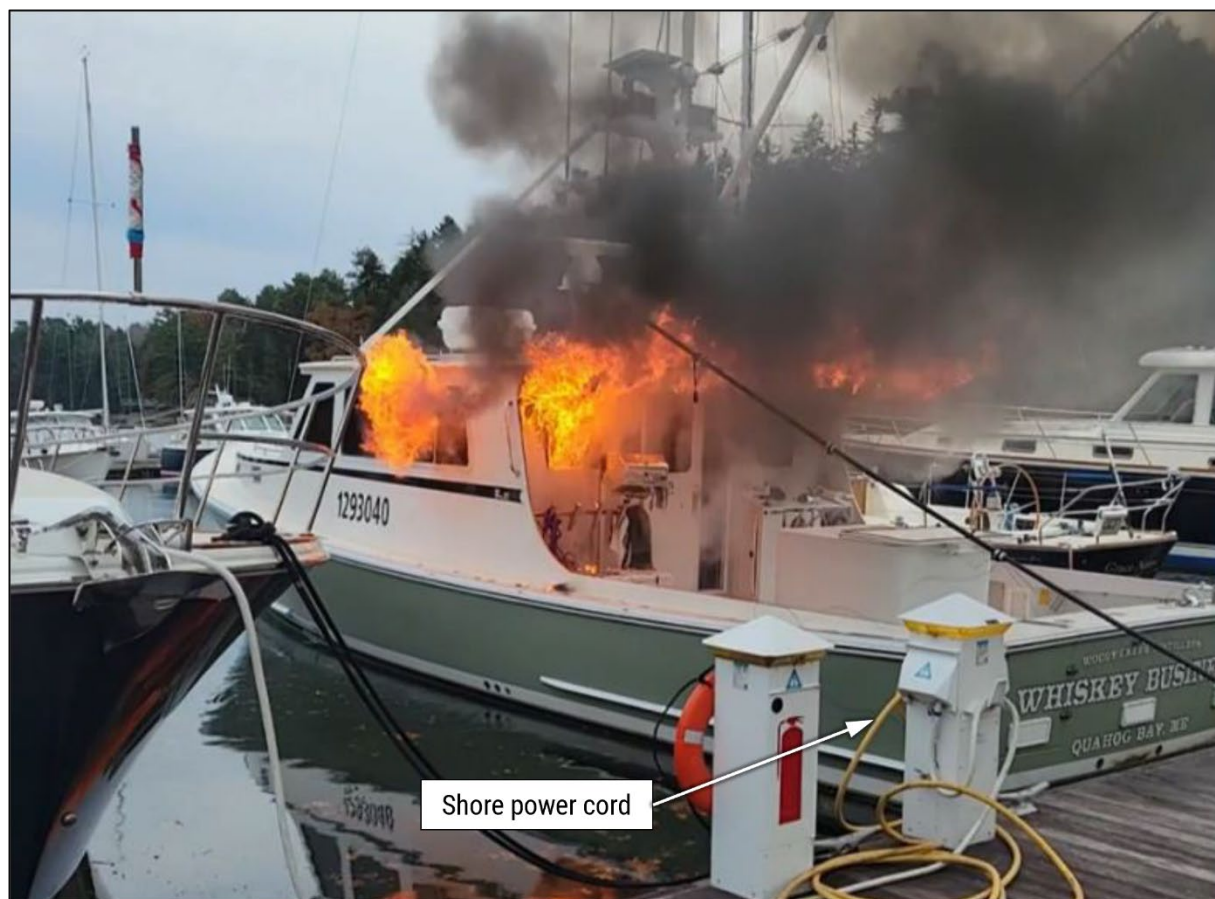
Figure 3. Fire aboard the *Whiskey Business*, about 0918 on November 5, 2024. Shore power cord had been connected from shore power pedestal to boat. (Background source: Mark Lenzi)

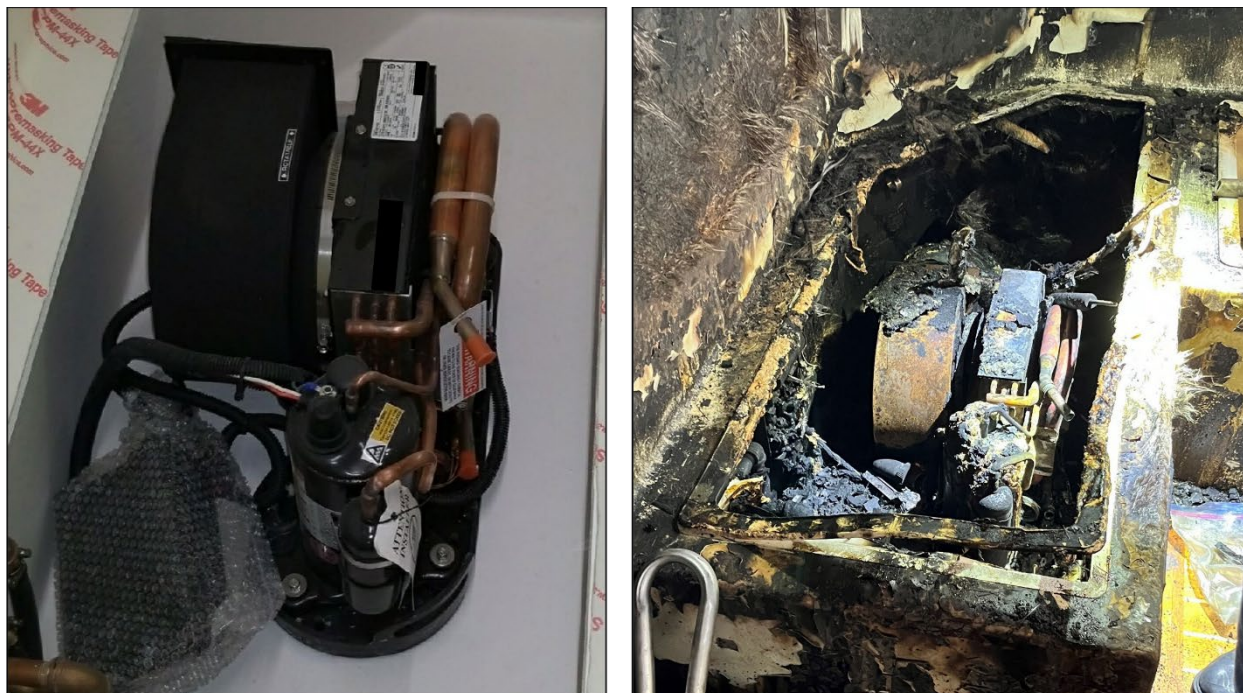
About 0943, the fire was extinguished. No injuries were reported, nor was there any damage to the marina infrastructure; one vessel near the *Whiskey Business* sustained superficial damage. The interior of the *Whiskey Business*'s cabin was damaged by the fire. All wooden structures, consoles, furniture, and galley equipment were consumed by the fire. Electrical panels and cables were damaged, the wheelhouse navigation systems destroyed, and all windows were blown out. The most extensive fire and heat damage was found on the port side of the cabin aft, near the air conditioning unit, located under a bench (see figure 4). Damage to the *Whiskey Business* was estimated at \$1 million.

Figure 4. Left to right: Air conditioning unit aboard *Whiskey Business* in 2019 after vessel construction, and same unit after fire. (Source [left]: *Whiskey Business* captain)

The fire aboard the *Whiskey Business* occurred while the vessel was docked and unattended. The vessel was on shore power, and only a refrigerator, a freezer, and two climate control units (one located in the forward stateroom and the other in the port aft corner of the cabin) were energized at the time. According to a witness (nearby boat owner), and photos and videos taken at the time of fire, the first signs of smoke and flames originated in the port aft corner of the cabin. The fire grew in intensity in this area and was seen breaking through the port aft windows of the cabin. A post-fire examination of the cabin interior space identified the greatest extent of fire and heat damage in the area near the aft air conditioning unit. The examination also found diminishing damage to the starboard side of the cabin and in the forward stateroom, and no fire damage in the engine room. Therefore, the origin of the fire was likely the air conditioning unit in the port aft area of the cabin.

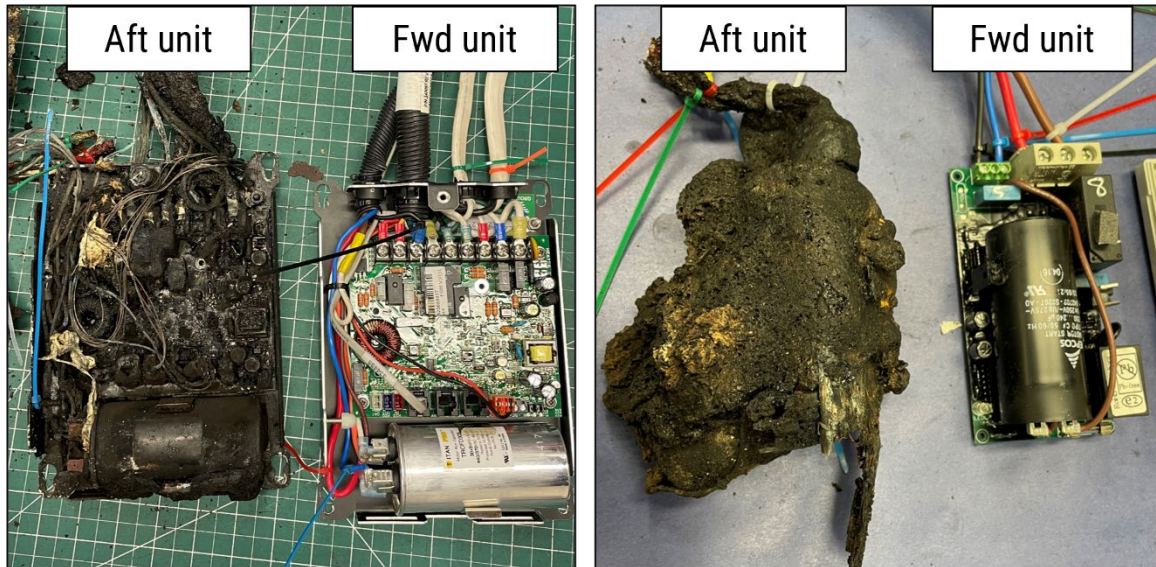
Each air conditioning unit had two external soft start control devices (connected to the unit by wires) that comprised the unit's soft start system.⁴ Both soft start control devices for the damaged air conditioning unit were X-rayed and examined. The larger device was partially consumed, and the smaller device was completely consumed. According to the vessel's captain, who managed and maintained the vessel, he had replaced the smaller soft start control device in the aft unit during the winter work period in 2021; he stated he believed that he mounted it on the floor of the compartment under the bench "as [he] found it."

Figure 5. Left to right: Larger soft start control device from damaged air conditioning unit alongside identical forward unit (shown as an exemplar). Smaller soft start control device from damaged air conditioning unit alongside forward unit after fire.

The most heavily damaged component of the air conditioning unit was a soft start control device for the air conditioning unit. According to the captain, he had replaced the device in the aft unit in 2021. Based on the captain's recollection, he believed the device was mounted on the floor without a waterproof enclosure, contrary to the manufacturer's instructions. The air conditioning unit was cooled by pressurized seawater via hoses, so it is possible that a seawater leak from a hose could have sprayed or pooled on the floor and entered the unit's soft start control device, causing an electrical fault. This water intrusion could have resulted in an electrical short circuit in the soft start control device that generated enough heat to start the fire.

The National Transportation Safety Board determines that the probable cause of the fire on board the fishing vessel *Whiskey Business* was a fault within an electrical soft start control device, possibly due to exposure to saltwater, for an air conditioning unit located under a bench in the vessel's cabin.

due to improper installation, the device can be exposed to saltwater intrusion. This can cause a catastrophic failure, which can result in the device shorting and possibly causing a fire. To avoid this issue the [soft start device] needs to be located in a dry location on a vertical surface

with the electrical connectors on the bottom... [or replaced] with our optional device that is built in a waterproof enclosure.
