September 17, 2024

MIR-24-28

# Flooding and Sinking of Fishing Vessel *Christian G*

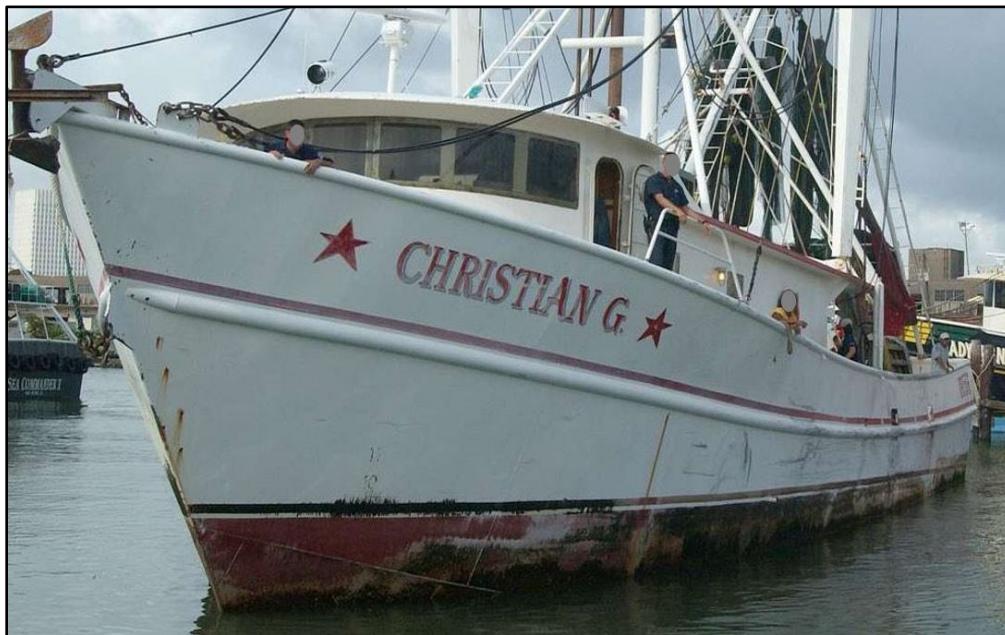
**Figure 1.** *Christian G* in July 2003. (Source: US Coast Guard)

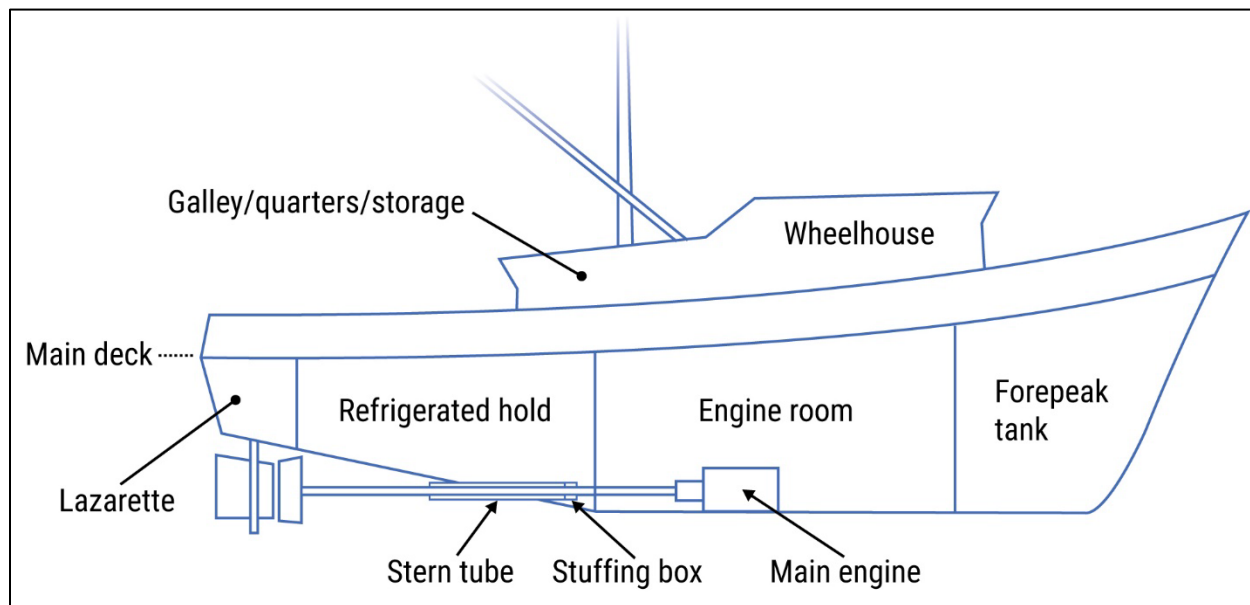
**Figure 3.** Simple profile of *Christian G* (not to scale).

By the time the captain got to the engine room after the bilge alarm sounded, water was already about 1 foot deep in the engine room bilge, which hampered him from locating a potential hull leak in that area. Because the flooding was initially found in the engine room and the captain could not locate the source of the leak elsewhere in the vessel, it is likely that the leak originated in the hull steel plate beneath the engine room.

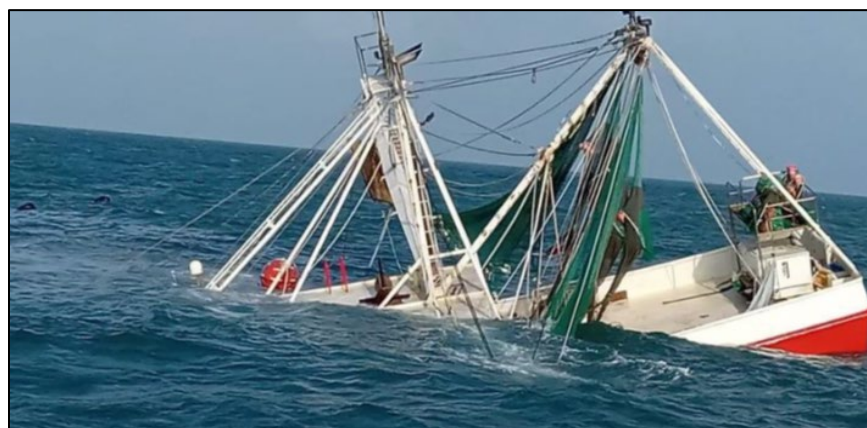
On October 4, at 0826, the vessel's emergency position indicating radio beacon activated. About 0950, 52 hours after it first began flooding, the *Christian G* sank in 78 feet of water about 69 miles southeast from Port Arthur, Texas (see figure 4). The vessel was not salvaged.

**Figure 4.** *Christian G* sinking in the Gulf of Mexico on October 4, 2023. (Source: Crew of the *Christian G*)

The National Transportation Safety Board determines that the probable cause of the sinking of the *Christian G* was flooding into the engine room—possibly caused by steel hull plating deterioration.
