Railroad Investigation Report: RIR-24-09

Norfolk Southern Railway Train Derailment

Anniston, Alabama

March 9, 2023

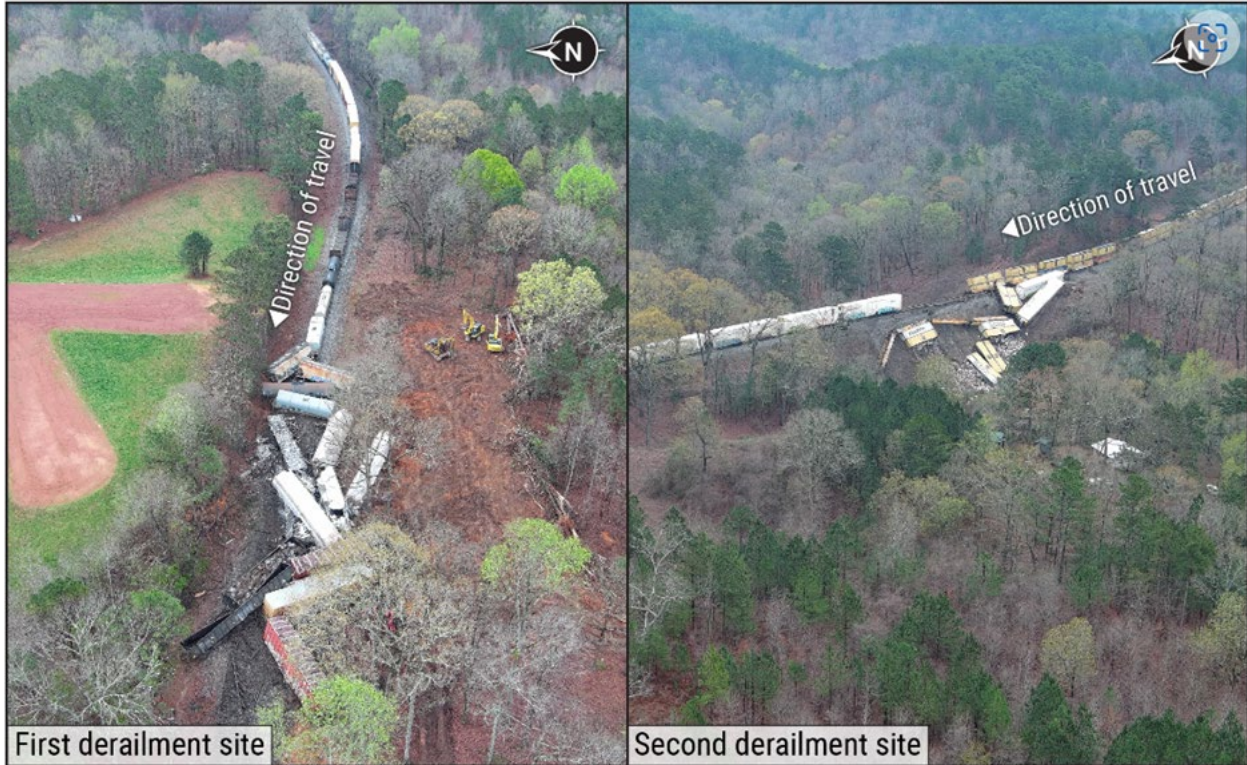
On March 9, 2023, about 6:19 a.m. local time, westbound Norfolk Southern Railway (NS) freight train 245A109 derailed 2 locomotives and 37 railcars on the Alabama East End District of its Gulf Division near Anniston, Alabama.¹ The derailment involved two sections of the train, resulting in two derailment sites. The first derailment site was located at the front of the train and where 2 locomotives and 29 railcars derailed. At the second site, located near the rear of the train, eight railcars derailed. Three of the cars that derailed were tank cars carrying hazardous materials. These tank cars remained intact and did not release hazardous materials. There were no reported fatalities or injuries. NS estimated damages to equipment, track, and signal infrastructure to be about \$2.9 million. At the time of the accident, visibility conditions were clear with early morning daylight; the weather was 57°F with no precipitation. Figure 1 shows the accident scenes.

Figure 1. Aerial view of the first derailment site (left) and the second derailment site (right). (Courtesy of NS.)

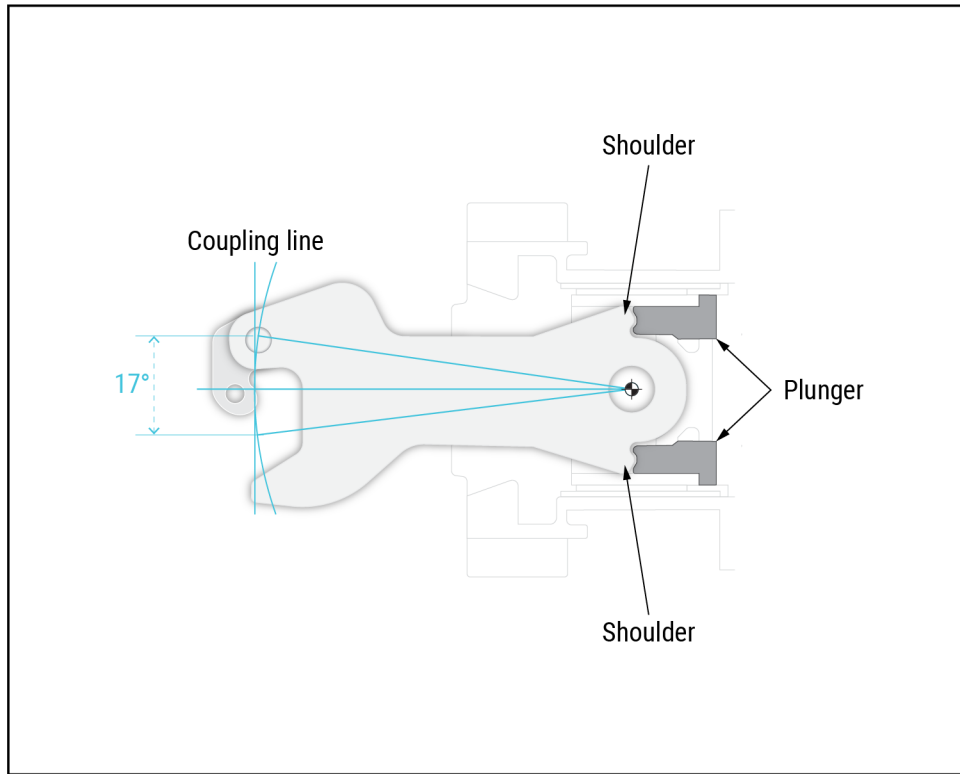
forces activate the draft gear and the plungers provide a centering torque to the coupler, limiting drawbar angles and centering the coupler in the coupler pocket. (See figure 2.)⁶

Figure 2. Alignment control coupler with plungers.

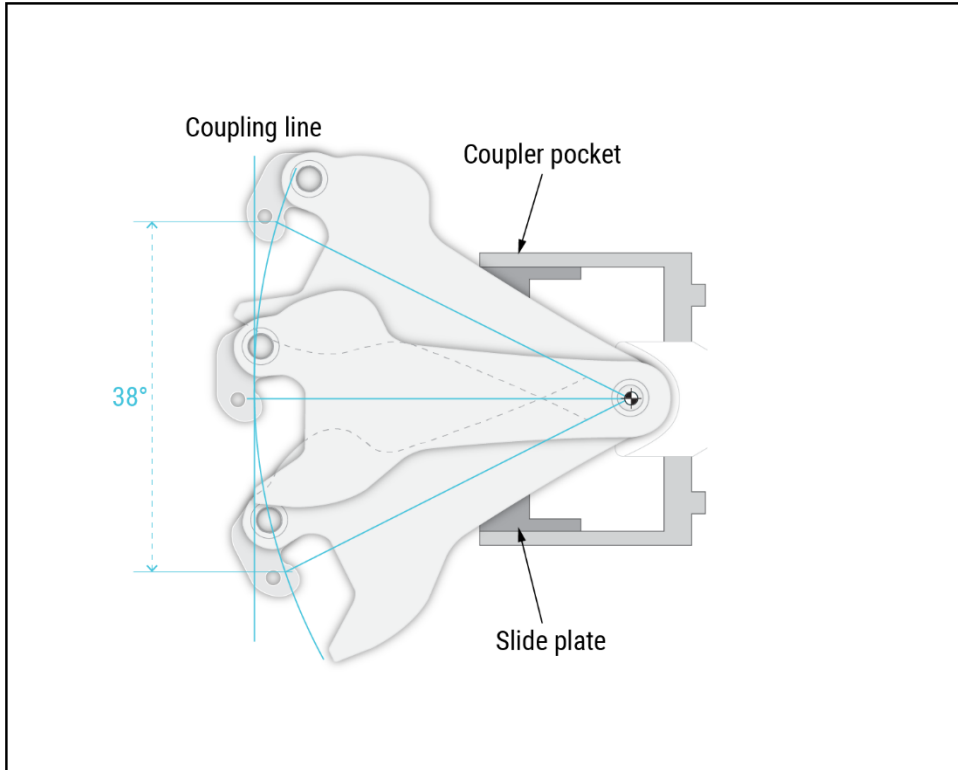
Locomotives used extensively to switch railcars, like the RMEX 08 and RMEX 06, may be equipped with nonalignment control couplers. (See figure 3.) These couplers lack the shoulders and are not equipped with the draft gear-engaging plungers. The coupler head is free to pivot to a larger degree without resistance, even when the train is in a compressed slack state.⁷ These nonalignment control coupler-equipped

Figure 3. Coupler without alignment control.

Railroads sometimes place a block in nonalignment control couplers between the coupler pocket and the side of the coupler to limit drawbar angles. These blocks, often known as stop blocks, can be either made of rubber and removable, or welded in steel. The application of stop blocks does not serve the same effect as an alignment control coupler. The stop blocks resist the rotation of the coupler, but without the shoulders and plungers found in alignment control draft gears, the coupler is not centered when compressive forces are applied, resulting in higher drawbar angles. The RMEX locomotives were equipped with these stop blocks.

The RMEX 08 had welded-in-steel stop blocks that showed signs of heavy lateral forces having been applied to them. The coupler pocket was bulged out on the left rear side with rust, wear, and moss found inside the broken welds of the coupler pocket consistent with a preexisting break.⁸ This bulging of the coupler pocket reduced the effectiveness of the stop blocks allowing higher drawbar angles to be produced.

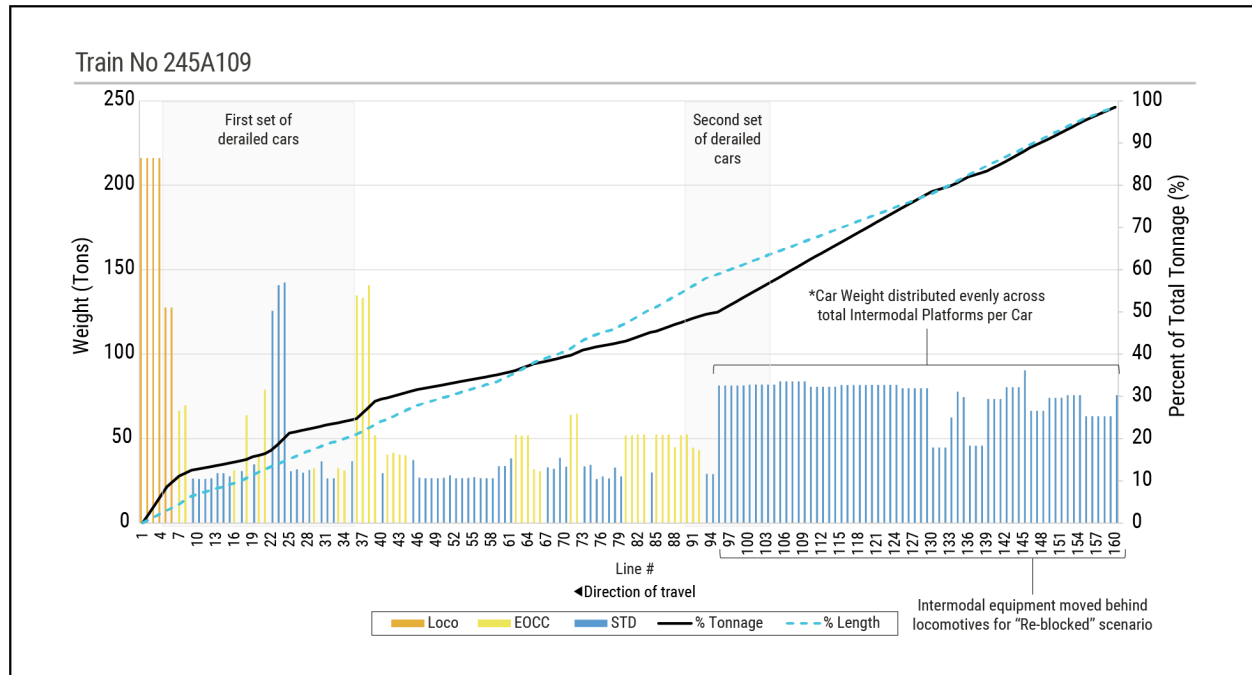
Train 245A109 consisted of 108 railcars behind the locomotive consist, weighed 9,175 tons, and was 9,769 feet long. The train consist had two distinct parts, a manifest portion, and an intermodal portion. (See figure 4.)

Figure 4. Graphical depiction of the train consist. Note the 20 intermodal cars on the rear of the train have been broken down into their individual segments.

With the placement of a block of 32 empty railcars in the head portion of the train and the loaded intermodal equipment that contained 5 well intermodal railcars on the rear, train 245A109 was not in compliance with NS's equipment restriction rules. However, the inclusion of the phrase "when practicable" in these equipment restriction rules allowed NS the ability to prioritize railcar placement in the train for destination blocking and in a manner that did not comply with equipment restriction rules.¹⁵

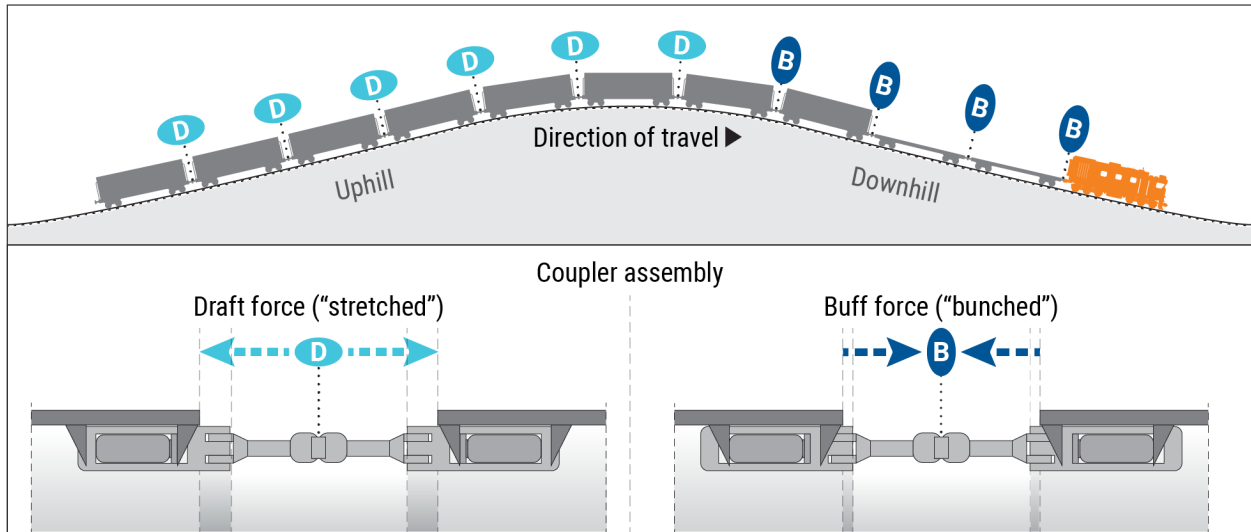
the train crests a grade and begins traveling downhill, the heavy rear railcars begin descending more quickly than the front of the train and compress the spring. (See figure 5.)

Figure 5. Train dynamics over the crest of a hill.

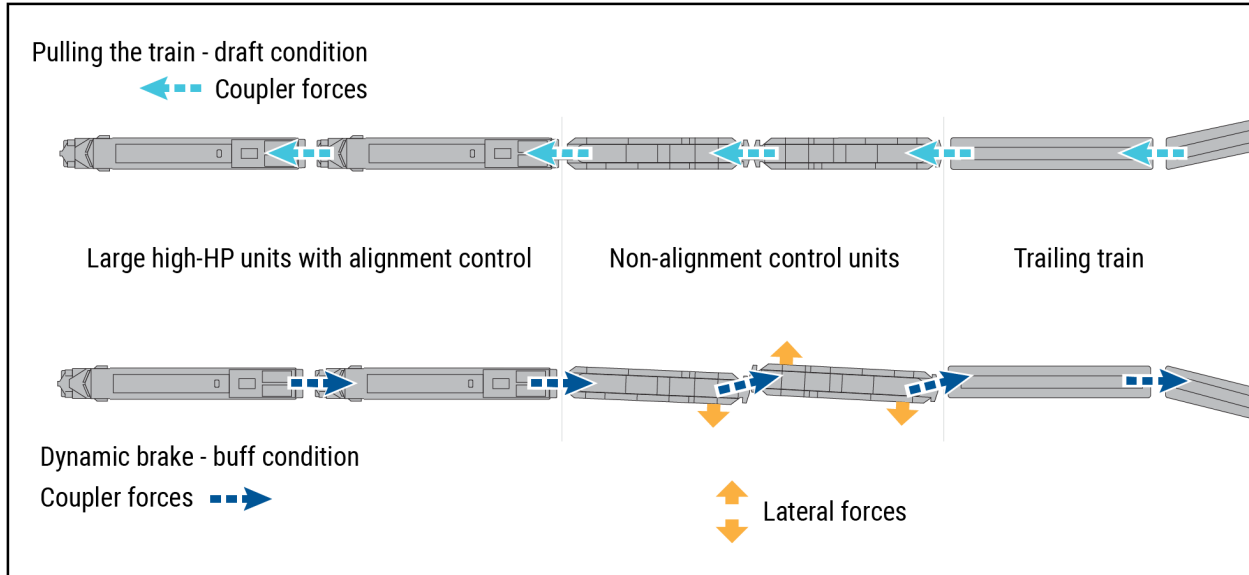
When a train is operating through curved track, or a railcar or locomotive is not steering properly, in-train forces tend to be exerted laterally (perpendicular to the direction of travel) and apply pressure against the rails below the train. These lateral forces increase when drawbars jackknife, long and short railcars are coupled together, or when dynamic braking is used. When lateral forces exerted on the rail exceed the vertical forces on the rail from the weight of the railcar, there is an increased risk for the rail to roll over beneath the train or for light railcars to climb up the rail. Figure 6 illustrates the transition to lateral forces and jackknifing couplers.

Figure 6. NTSB depiction of a *Railway Age* graphic showing the differences in how a train is pulled in draft condition as compared with buff condition.

by NS rules. Therefore, the two locomotives coupled together could still be at risk to jackknife, leading to a rail-rollover event. (See figure 6.)
