NTSB

Illustrated Digest

Norfolk Southern Railway Derailment and Subsequent Hazardous Materials Release

East Palestine, Ohio • February 3, 2023

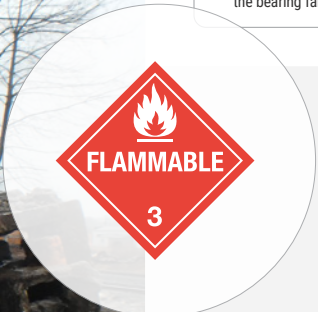
Punctured DOT-111 tank car that released butyl acrylates, a flammable liquid, likely starting the postderailment fires.

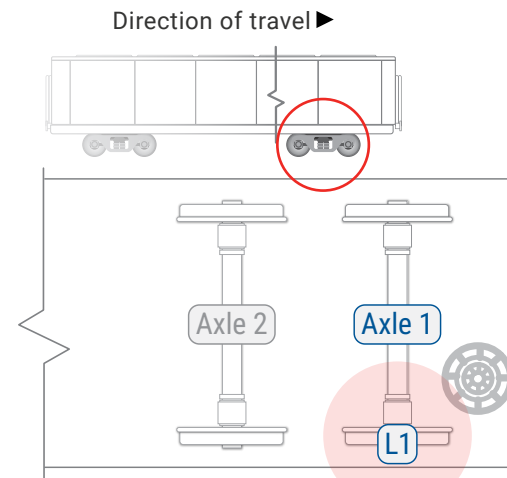
The L1 bearing

The bearing that caused the accident hopper car to derail was its L1 bearing, which is on the right side of the car, facing the direction of travel.

Railcar axles are numbered starting from the end of the railcar with the brake wheel (the "B end"). When the B end is in the front of the car (when it faces the direction of travel) the "left-side" wheels and bearings are on the right.

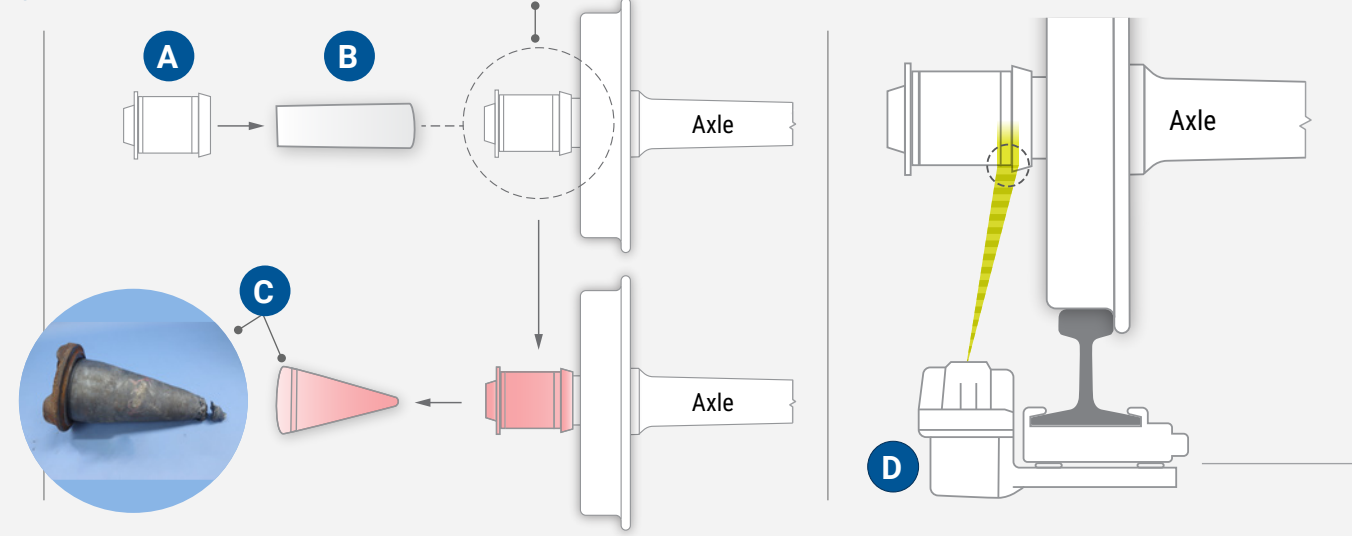
The undetected hot bearing burns off

1. HBDs (D) measure the temperature on the outside of the bearing cup. When a bearing heats up inside, it may take 30-60 minutes for the HBD to sense it from the outside. The HBD in Salem measured a temperature of only 103° above ambient, despite the fact that the bearing was on fire. So, it generated an alert to the Wayside Help Desk, not an alarm to the train crew.

2. By the time the alarm sounded at the East Palestine HBD, the journal was worn down to a cone, and it was too late. The hopper car and 37 others derailed as the train's emergency braking system activated.

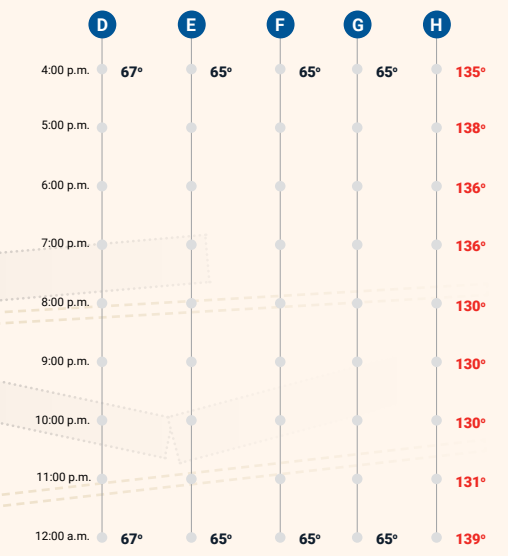
Tank car temperatures, February 5

The temperatures of the five cars, measured on February 5 and 6, do not approach the 185 °F that caused the initial PRD actuations, and temperature trend was even declining (see charts at right).

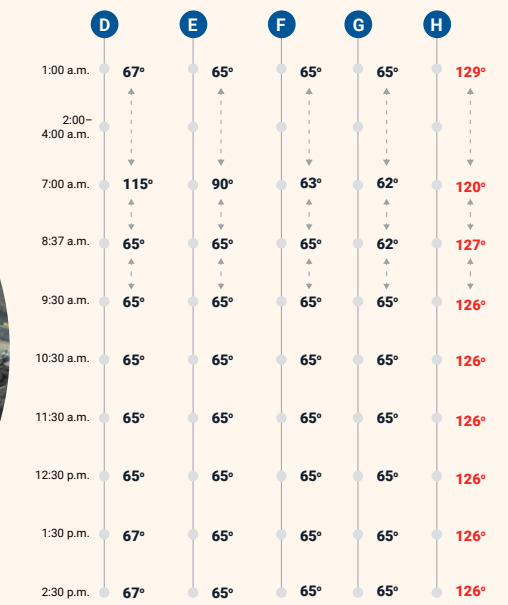
Tank car temperatures, February 6

Consistently above 100°, but never exceeding 138°

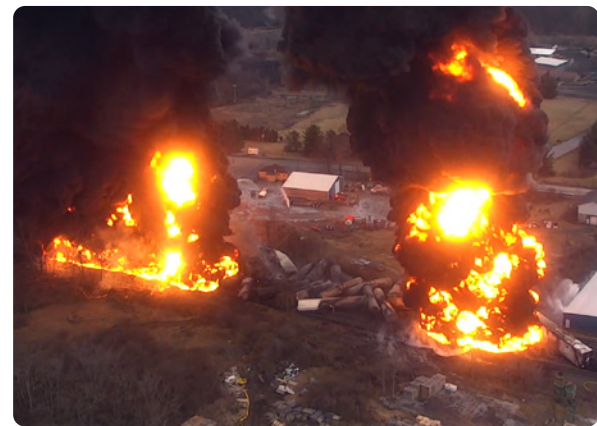
Contractors breached the five tank cars at 4:47 p.m. Contractors positioned flares near each tank car to ignite vapor as it was expelled. Burning VCM resulted in a column of black smoke that grew into a persistent cloud. According to the NS system manager for hazardous materials, the cloud likely contained soot particles, carbon dioxide, carbon monoxide, hydrogen chloride, and a trace of phosgene (a toxic gas).
