October 8, 2024

MIR-24-32

Contact of Barge *San Juan-JAX Bridge* with Pier

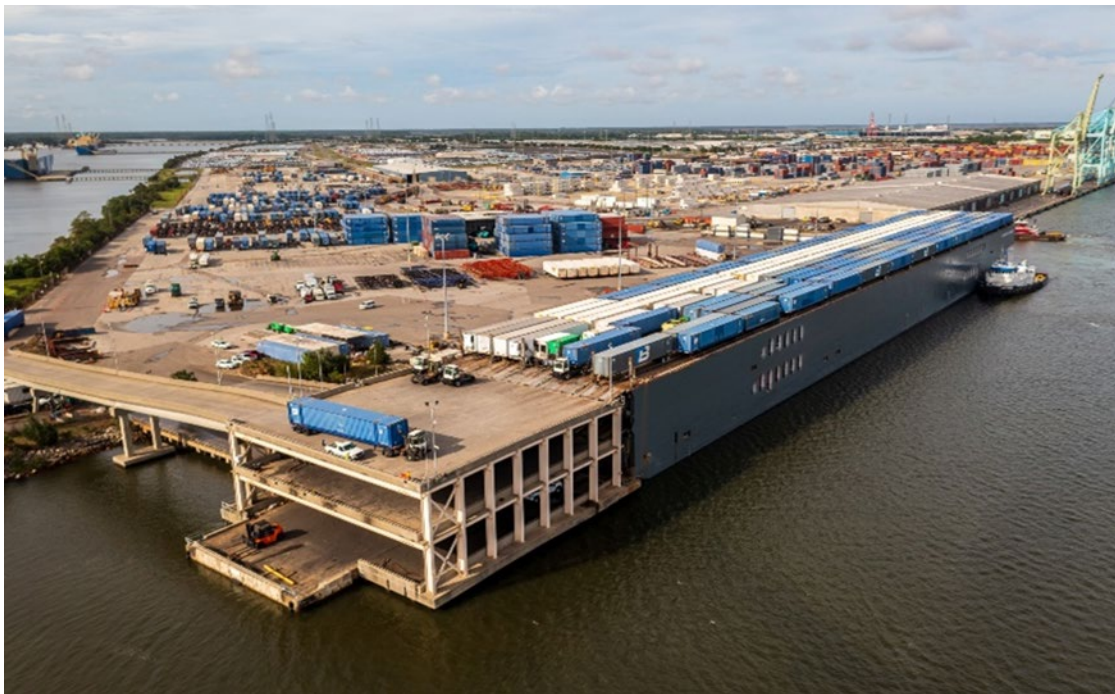
Figure 1. Barge *San Juan-JAX Bridge* moored in Jacksonville, Florida, on unknown date before the casualty. (Source: Trailer Bridge)
