September 11, 2024

MIR-24-27

Barge Breakaway from *Nell Womack* Tow and Contact with Dock

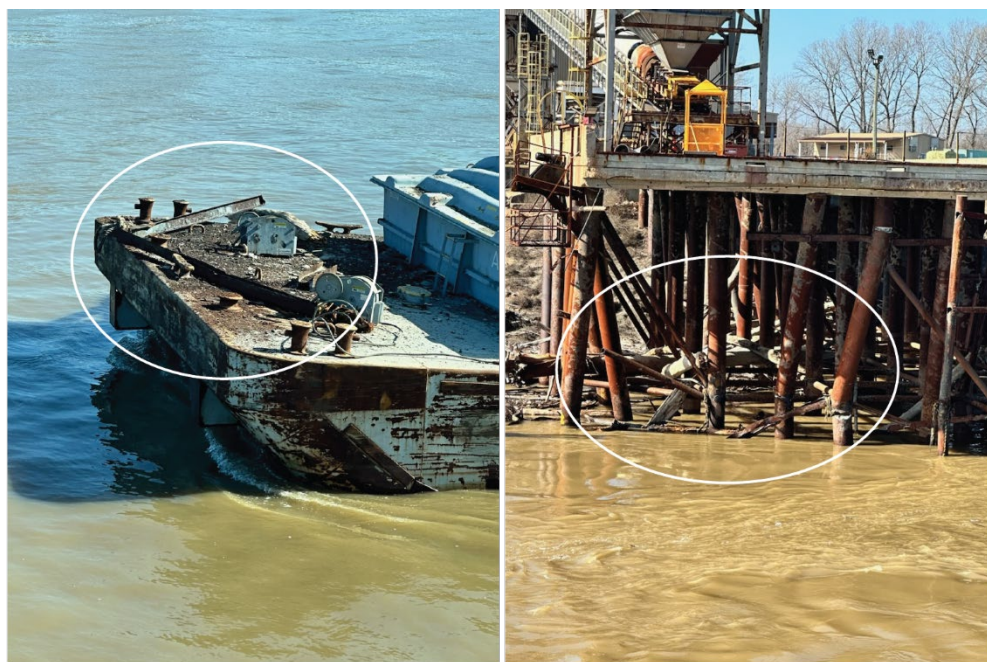
The *ACBL2549* sustained minor damage, and the *ACL23401* was not damaged. The Port of West Memphis dock sustained damage to eight structural pylons: three were severed, and five were severely damaged (see figure 4).

Figure 4. Left to right: The damage to barge *ACBL2549* after the contact (circled), and the damage to the Port of West Memphis dock (circled). (Source: US Coast Guard)
