REPORT OF INVESTIGATION

Fatal Machinery Accident
December 14, 2023

Bison No. 1
Bison Materials LLC
Bartlesville, Washington County, Oklahoma
ID No. 34-02093

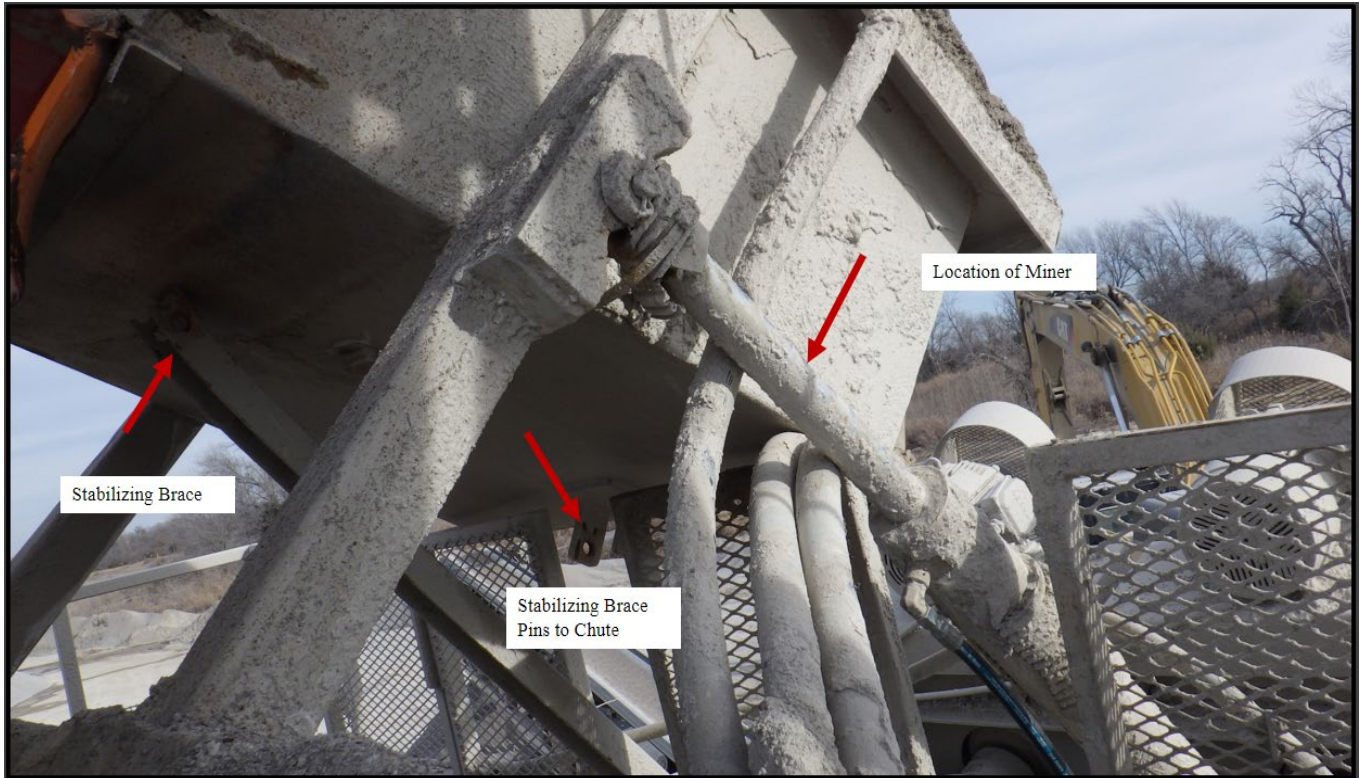
APPENDIX A – Stabilizing Brace and Mounting Point

According to information gained in interviews, it was determined Hoppock started the hydraulic pump motor in preparation to use the hydraulic system to lower the feed chute. Hoppock went to the screen platform to remove the pin from the brace that supports the feed chute using a hammer and punch (see Appendix A). Once Hoppock had knocked out the pin from the brace, the feed chute rotated backward pinning Hoppock between the feed chute and the handrail.

On December 14, 2023, a fatal accident occurred at this mine when a miner performing work on the wash plant feed chute became pinned between the feed chute and a handrail of a screen platform. Prior to removing the pin holding the feed chute's stabilizing brace in place, the mine operator did not block the wash plant feed chute against hazardous motion. The unblocked feed chute rotated backward, pinning the miner between the feed chute and the handrail, resulting in a fatal injury.

Corrective Action: The mine operator developed a new procedure addressing blocking machinery against hazardous motion and retrained all miners in the new procedure requiring blocking machinery and tools against hazardous motion during maintenance and repairs.

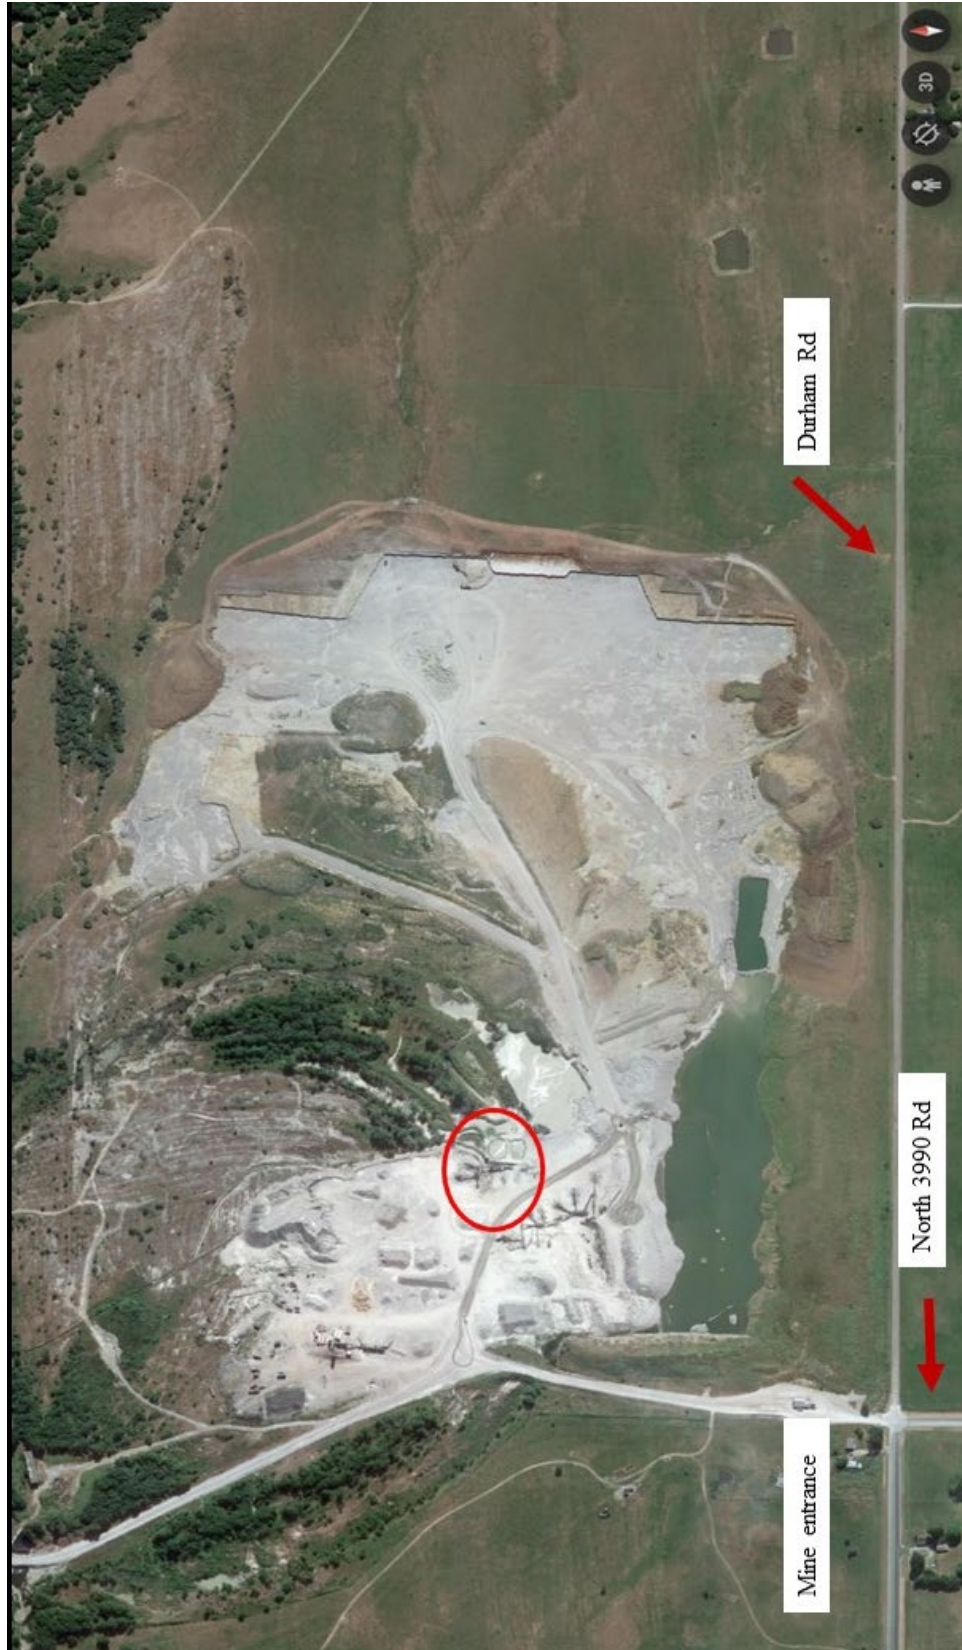
APPENDIX C – Aerial View of the Accident Location

The accident occurred on the screen platform of a Cedarapids screen on the wash plant (see Appendix C).
