REPORT OF INVESTIGATION

Fatal Machinery Accident
May 16, 2024

Cornerstone Labor Services, Inc. (B4839)
Ashland, Hanover County, Virginia

Coal Mountain No 1 Surface
CM Energy Operations LP
Coal Mountain, Wyoming County, West Virginia
ID No. 46-09062

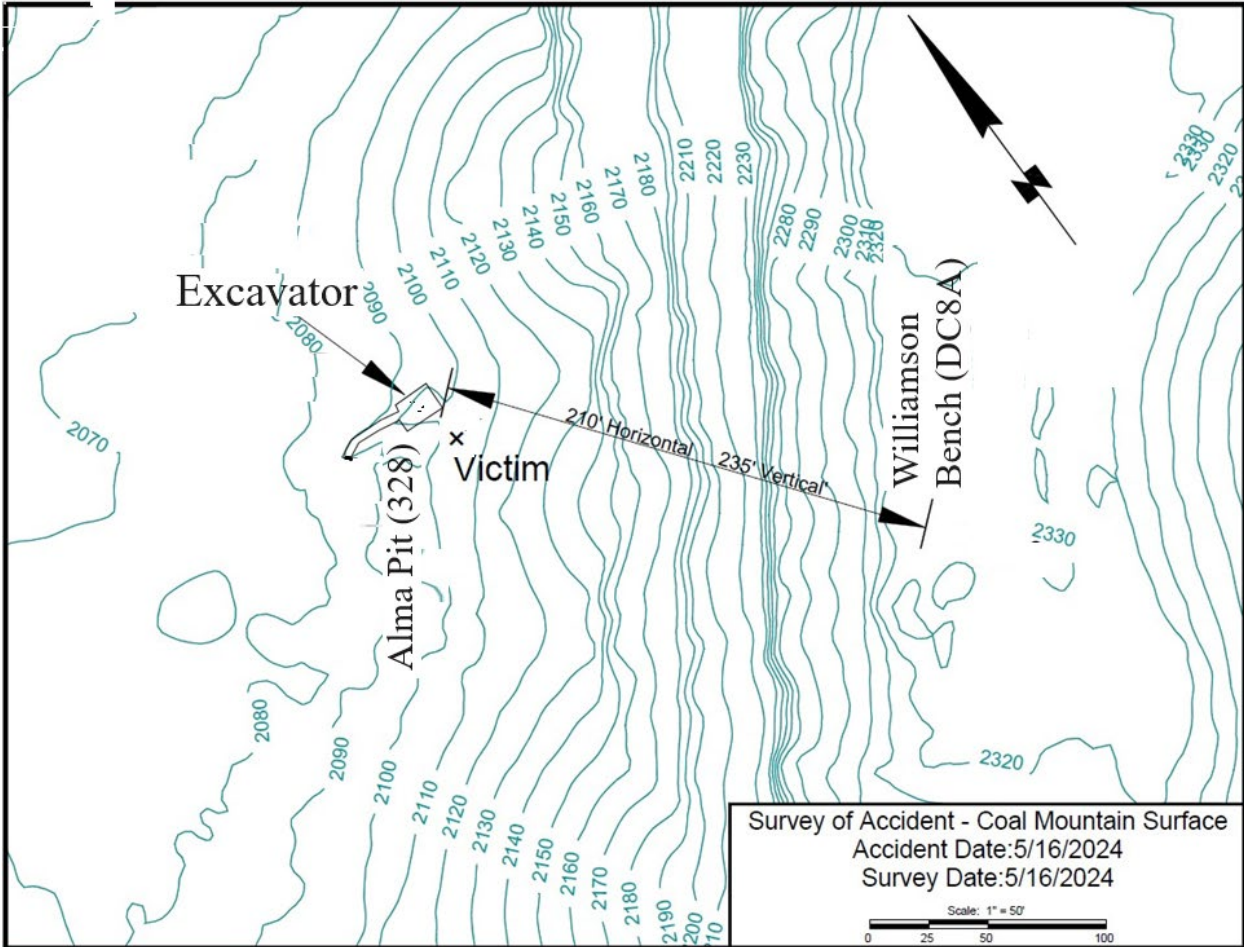
APPENDIX C – Map of Accident Area

Paynter was operating the excavator on the DC8A Williamson bench that has a steep highwall on one side and steep hillside on the other. The width of the bench where Paynter operated the excavator started at 165 feet and narrowed to 54 feet. After the fall, the excavator and Paynter were located at the 328 Alma pit approximately 235 feet below (see Appendix C).

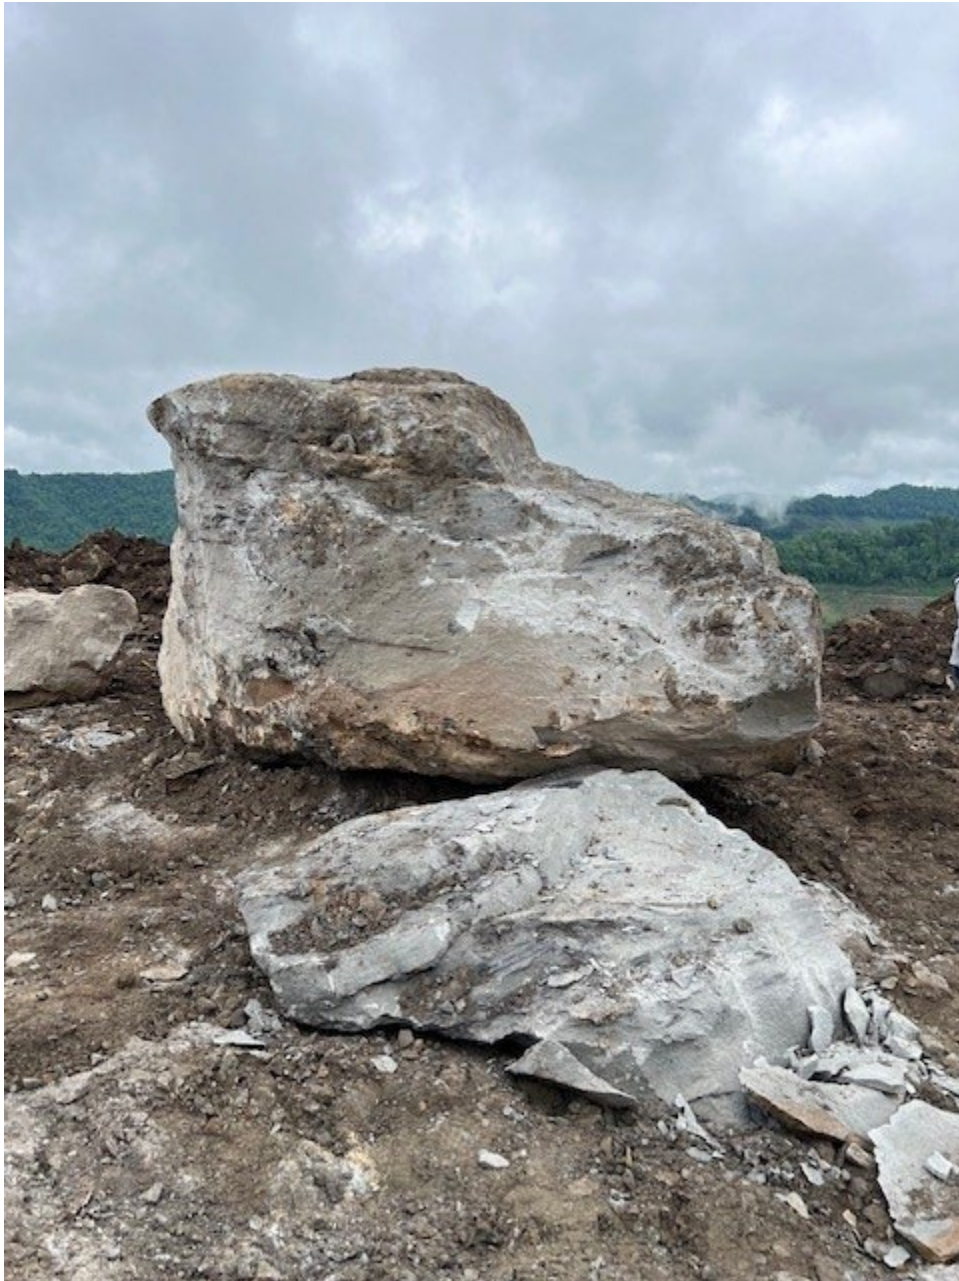
APPENDIX D – Rock with Smaller Piece Broken Off

Investigators observed the right track impression of the excavator between the rock and the edge of the highwall. Investigators measured the rock to be 15 feet from the edge of the highwall. The track of the excavator measured 19 feet in length, and therefore at least four feet of the track would have extended over the highwall edge. There was also a five-foot indentation in the face of the highwall which created a depression in the bench. Previous mining had filled the depression with loose unconsolidated material that was pushed over the highwall by a bulldozer. The right track of the excavator was positioned in the center of the depression. This indicated solid rock was only supporting one-half of the excavator's right track.

Due to marks from the excavator's bucket observed on the rock and a four-foot by four-foot by one-foot piece of the rock found next to it (see Appendix D), investigators determined that as Paynter attempted to move the rock closer to the edge of the highwall, the smaller piece of the rock broke off, releasing the stored energy of the excavator's hydraulic system. This would have caused the balance of the excavator to shift and travel over the highwall.

Corrective Action: The mine operator revised its Ground Control Plan to include procedures to prevent a reoccurrence. The procedures include:

- 4) An excavator may be used to preliminarily move the rock to the approximate middle of the bench or no closer than 30 feet from the edge of the outside wall to make room for a bulldozer to get behind the rock and push it over the inside edge.
