REPORT OF INVESTIGATION

Fatal Electrical Accident
May 8, 2024

Belt Tech Industrial Inc (VIT)
Washington, Indiana

US Aggregates-Flat Rock Plant
US Aggregates Inc
Flat Rock, Shelby County, Indiana
ID No. 12-00016

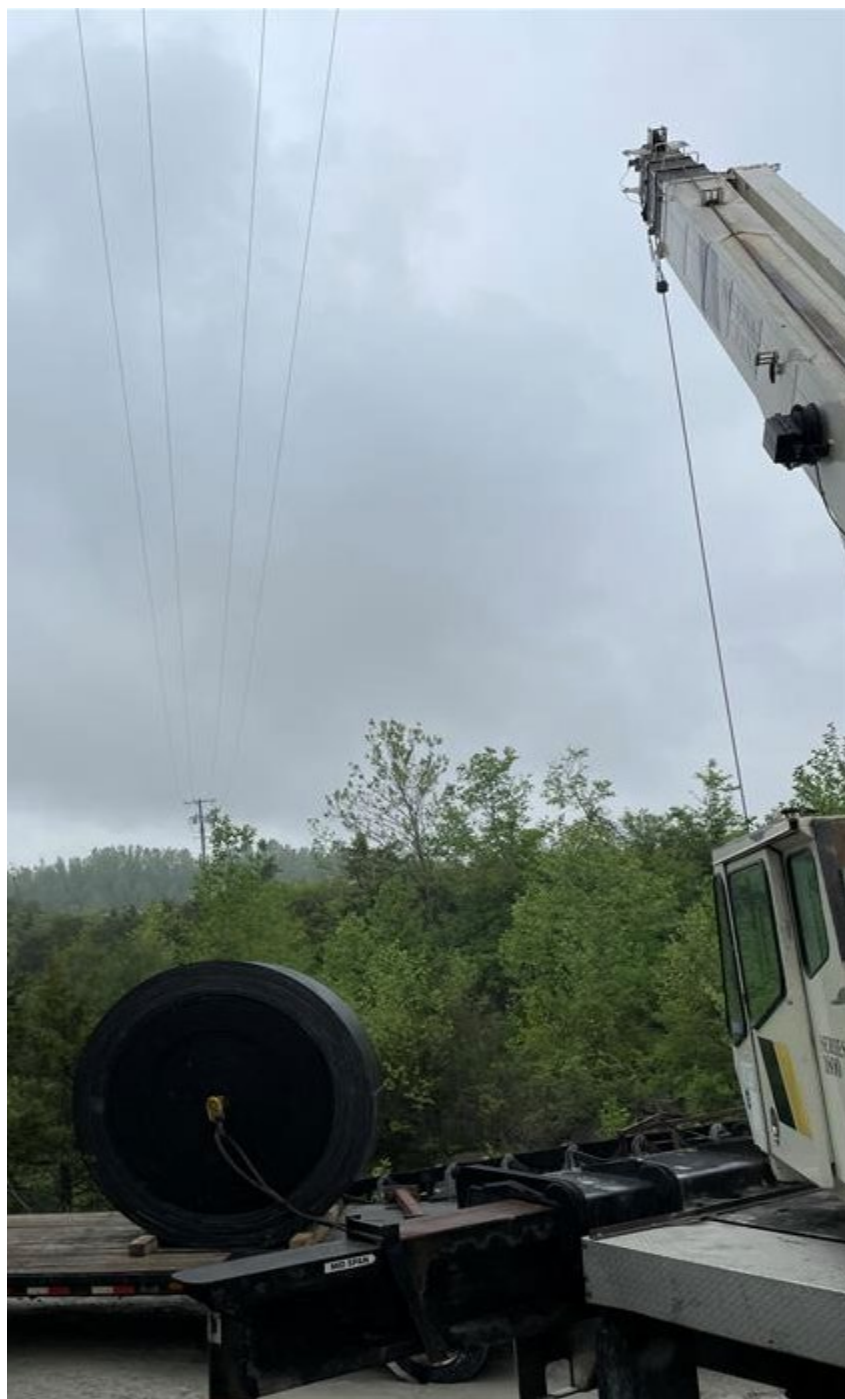
APPENDIX C – Photo of Roll of Belt Positioned under High-Voltage Powerlines

According to interviews, Graber backed the truck and trailer with the roll of belt into position. He remained in the truck so he could pull it out of the way once the crane lifted the roll of belt off of the trailer. Shake began removing the bolts from the top belt rollers on the PB9 belt conveyor to make room to splice the belt. Marek climbed onto the trailer and attached the rigging for the roll of belt to the crane hook. Decker stood between the PB9 belt conveyor and the trailer to help either Marek or Shake if needed. Muck began winching the rigging off the floor of the trailer with Marek holding onto the rigging to prevent it from binding up. At this point, Muck began to move the crane boom to center it over the roll of belt and realized he needed to telescope the boom out. While vertically telescoping the boom out, the crane boom contacted the 12,470-volt overhead powerlines.

The accident occurred just inside the entrance to the PB9 Belt Conveyor Take-Up area. There are three separate powerlines in the area, ranging in height from 12 feet, six inches to 46 feet, three inches above the ground. The ground was wet due to overnight precipitation. Shake, Graber, and Decker stated in interviews that they were aware of the overhead high-voltage powerlines. Shake and members of the Belt Tech Crew positioned the roll of belt directly under the energized high-voltage powerlines (see Appendix C). Shake instructed Muck where to set up the crane to lift the roll of belt. Muck positioned the crane, as instructed by Shake which resulted in the crane operating within ten feet of high-voltage powerlines. Investigators determined that these conditions contributed to the accident.

There were no warning devices to conspicuously mark the restricted clearance in advance of the

PB9 Belt Conveyor Take-Up area. Investigators determined that this contributed to the accident.

Corrective Action: US Aggregates Inc placed two warning signs at the entrance to the PB9 Belt Conveyor Take-Up area as well as a visual indicator on the powerlines.
