REPORT OF INVESTIGATION

Surface
(Phosphate Rock)

Fatal Machinery Accident
March 1, 2024

Swift Creek Mine
White Springs Ag Chems Inc dba Nutrien
White Springs, Hamilton County, Florida
ID No. 08-00798

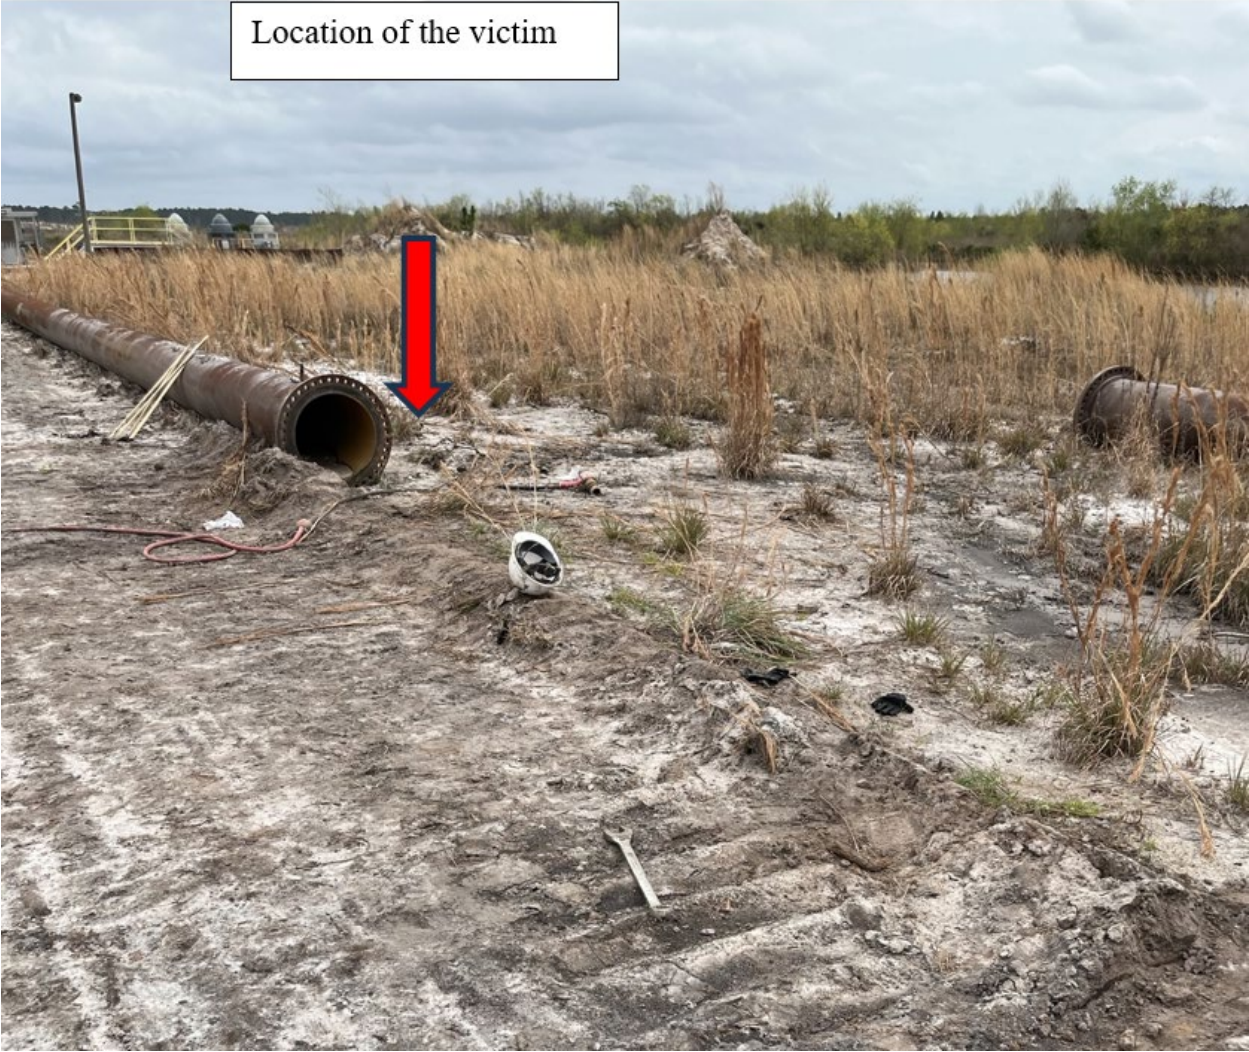
APPENDIX A – Accident Site

According to interviews, Daniels and his work crew received daily work assignments from Chris Payton, Area Supervisor, then gathered work supplies, and traveled to the #5-line at the #8 lift area to begin the process of breaking down the slurry pipeline for a new pump station installation (see Appendix A).

The accident occurred along the mine's 5-line at the #8 lift area. At the time of the accident, miners were working to remove a section of the slurry pipeline to install a new pump station.

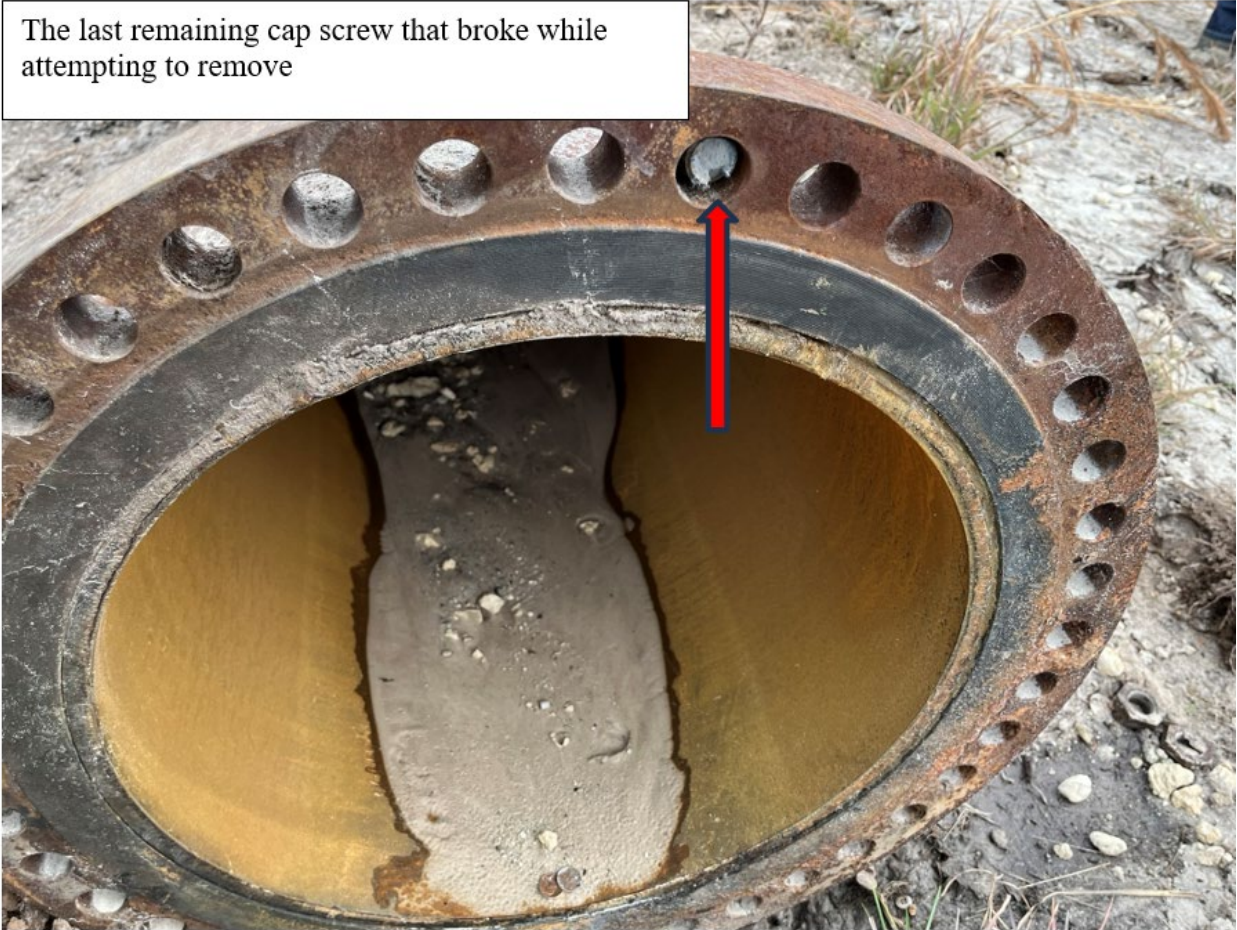
APPENDIX B – Last Cap Screw Location

Root Cause: The mine operator did not ensure the slurry pipe was blocked against hazardous motion.

A fatal accident occurred at this operation on March 1, 2024, when a 20-inch steel slurry pipe struck a miner. The miner was removing the last top cap screw from the slurry pipe's flange when the cap screw sheared off causing the 20-inch steel pipe to break loose and strike him. The mine operator did not block the pipe against hazardous motion.

The last remaining cap screw that broke while attempting to remove

Corrective Action: The mine operator developed and implemented written procedures for pipe installation and removal and workplace examinations, regarding proper examinations for hazardous conditions, when to conduct them, what to look for, and actions to take when examiners identify hazards. The mine operator trained all designated miners in the new procedures.

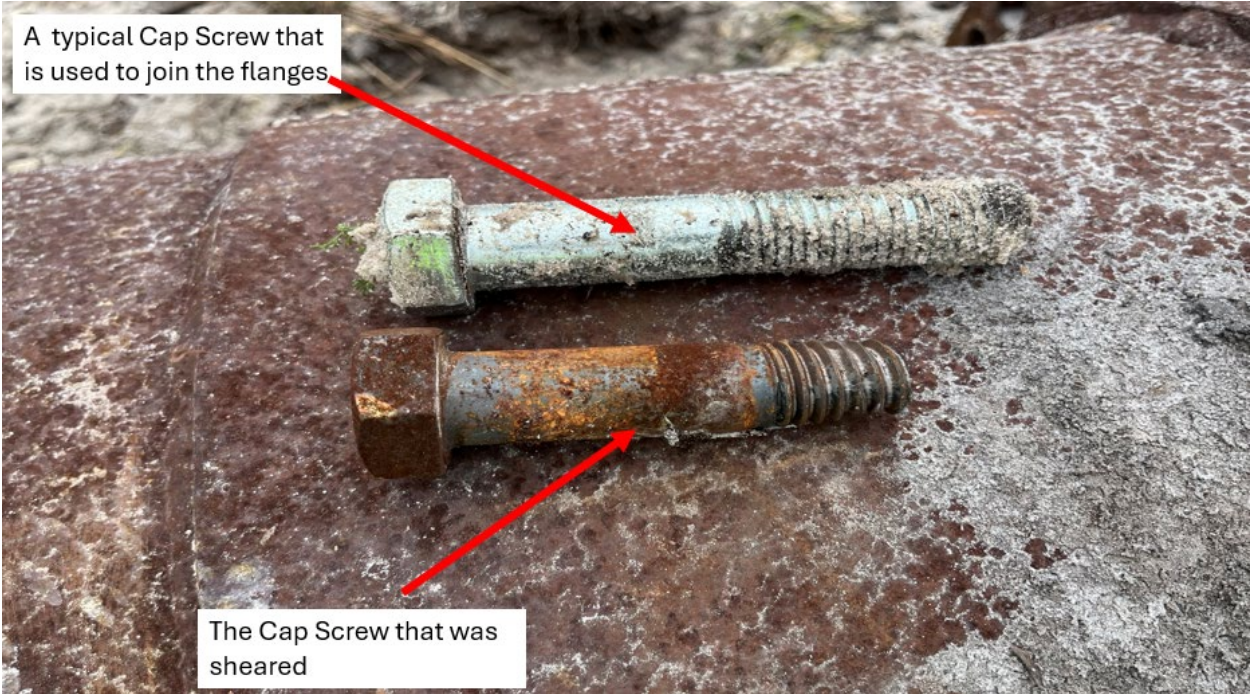
APPENDIX D – Cap Screws

The cap screws used to couple the slurry pipe's flanges were one inch in diameter, five inches in length, and classified as Grade 5 by manufacturer by Nucor Fastener. The specified tensile load limit for this type of cap screw is 72,700 pounds.

Technical Support's examination revealed the cap screw involved in the accident was exposed to loads that exceeded the yield strength of the steel which resulted in a tensile failure (see Appendix D).
