REPORT OF INVESTIGATION

Fatal Powered Haulage Accident
January 2, 2024

Mobile Crusher #3 Frontera Materials
Frontera Materials Inc
La Joya, Hidalgo County, Texas
ID No. 41-04292

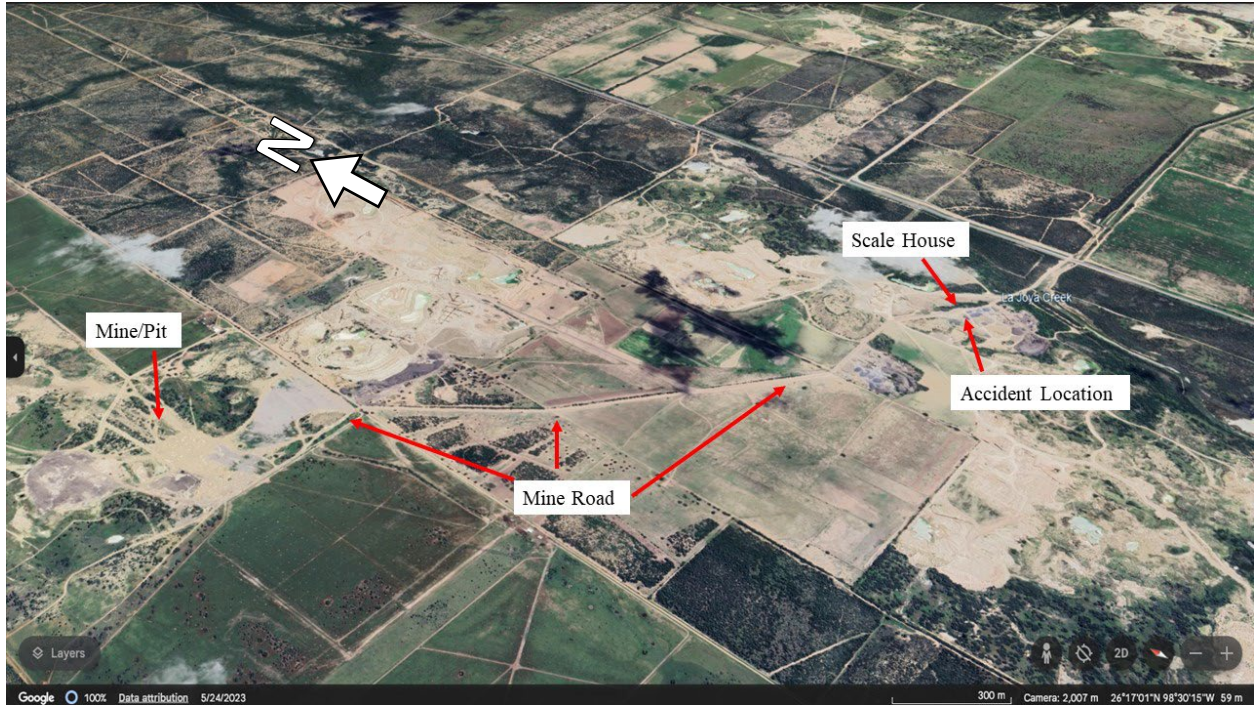
APPENDIX A – Location of the Accident

The accident occurred at the designated customer dump-off area near the scale house (see Appendix A).

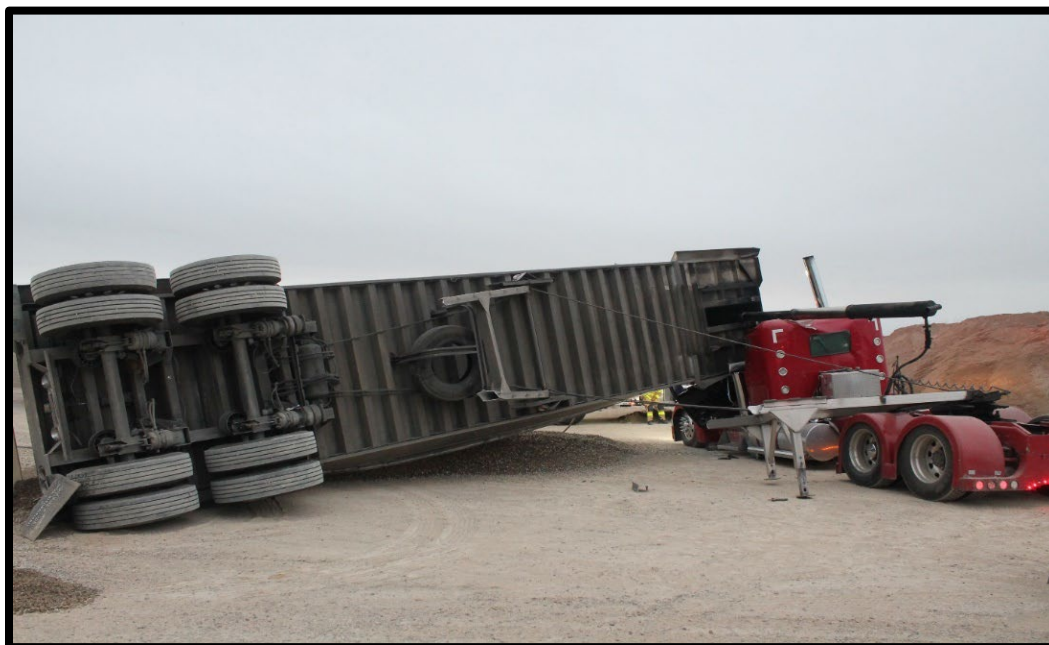
APPENDIX C – Kenworth W900 Semi Truck and Travis Aluminum Rear Dump Trailer

The over-the-road truck involved in the accident was a 2009 Kenworth W900 truck and a 2007 model T90 Travis aluminum frame 39-foot rear dump trailer (see Appendix C). Investigators examined the truck and trailer and performed a functionality test on the air system. Investigators did not identify any defects that contributed to the accident.

Investigators obtained the Travis Body & Trailer, Inc. Universal Truck Trailer Owner's Manual Rev 2/2015. This document contains precautions to be followed when dumping a load out of the trailer. The following dump trailer operating procedures listed in the manual were not followed and contributed to the cause of the accident:

1. Tractor and trailer must be in a straight line on firm-level ground with sufficient overhead clearance.
2. Make sure the tailgate is in the OPEN (unlatched) position when dumping.
3. Failure to observe these precautions could result in a tip-over or damage.

Root Cause: Rivera did not properly align the truck and trailer prior to raising the trailer to unload the excess material.

Corrective Action: The mine operator developed and implemented a new requirement for the site-specific hazard awareness training that states that over-the-road trucks pulling rear dump trailers must stay in a straight line while offloading excess material. The mine operator added this requirement to the site-specific hazard awareness training signs and paper given to all truck drivers who come onsite.
