UNITED STATES  
DEPARTMENT OF LABOR  
MINE SAFETY AND HEALTH ADMINISTRATION

REPORT OF INVESTIGATION

Fatal Falling, Rolling, or Sliding Rock or Material of Any Kind Accident  
May 16, 2023

San Miguel Lignite Mine  
NACG Texas, Inc.  
Christine, Atascosa County, Texas  
ID No. 41-02840

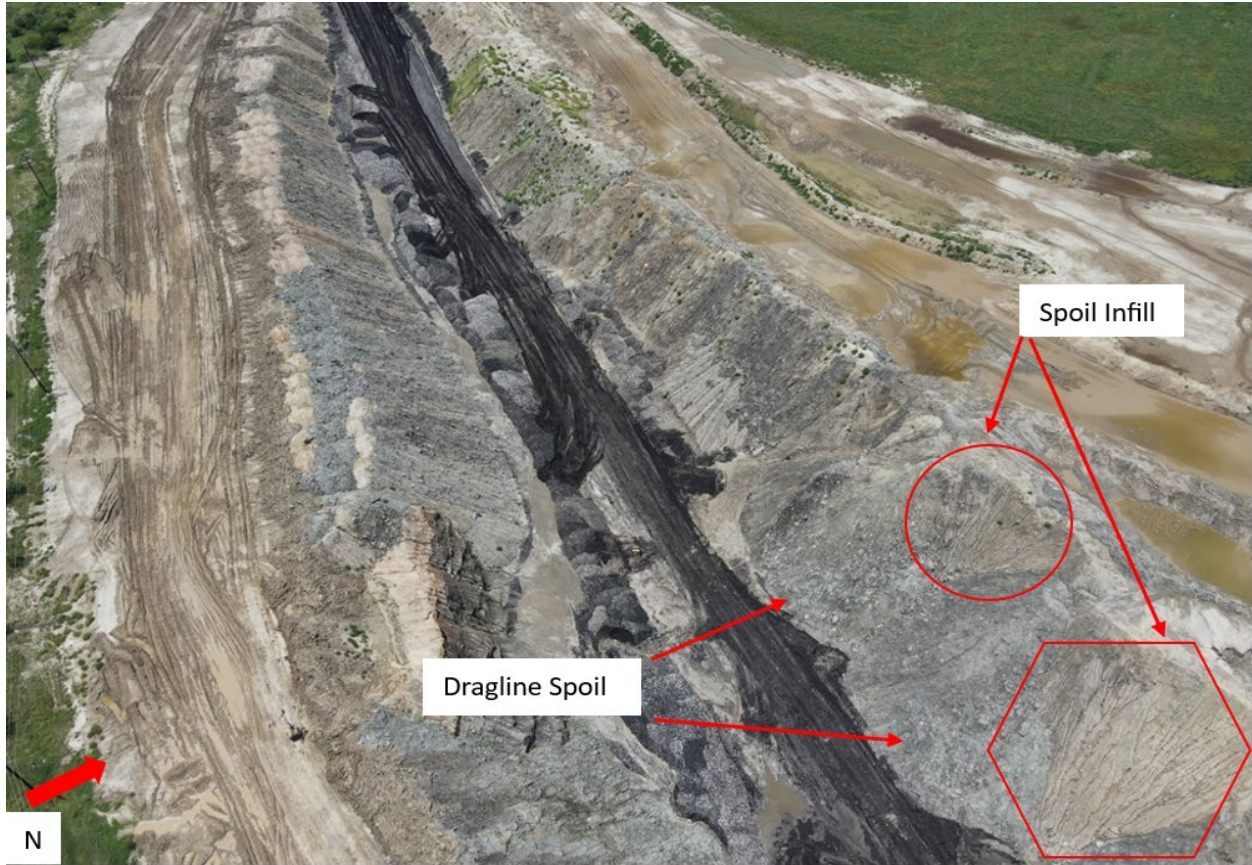
APPENDIX B – View along the South Slope of Spoil Bank

The mine operator's drone images captured on May 1, 2023, revealed a large volume of water impounded between the haul-back and pre-strip berms on the top of the spoil bank. This same pond of water impounded up against the edge berm, which is directly above the slope of the spoil bank, west of where the pre-strip berm intersects with the edge berm. A drone photo (see Appendix C photo two) taken on May 16, 2023, just hours prior to the accident, revealed a large volume of water ponded directly above where the large slope failure occurred. Other drone photographs show similar concerns (see Appendices B and C).

The 1B ramp spans from the top of the pit (top of photo) down to the pit floor (bottom of photo)

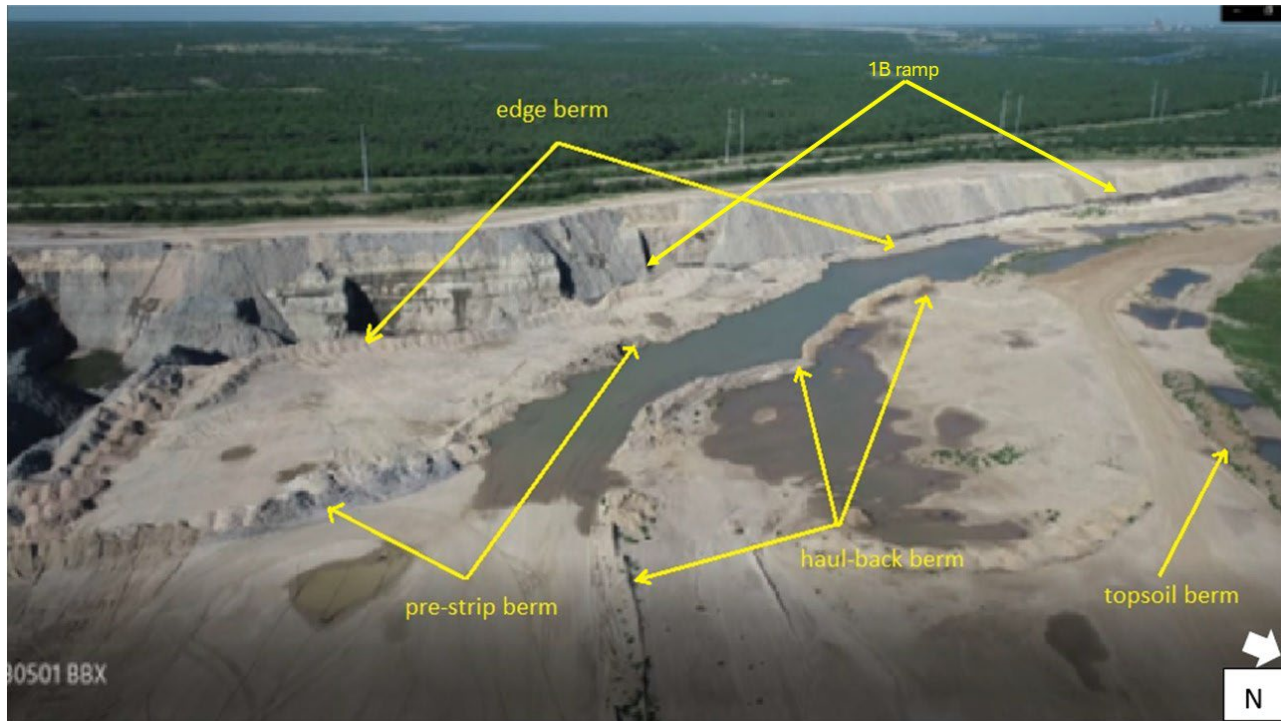
APPENDIX D – Top of the Spoil Bank with Impounded Water

The slope failure appeared to occur in two phases. The first phase of the failure consisted of a large slide of the spoil slope face material that ran out onto the 1B ramp and completely covered the bulldozer. Due to the saturation of the slope material and the potential energy due to the slope geometry, the failed mass flowed like a fluid. The second phase of the failure, consisting of the erosion and retreat of the material at the top of the spoil bank, then occurred. The shape of the wedge behind the initial slope failure is consistent with this progression. The observance of erosion from the sediment-laden water extending from the failed area down to the active area of the pit is further evidence of the secondary mudflow caused by the significant volume of water impounded at the top of the slope at the time of the failure. A photo taken hours prior to the failure shows the pre-failure conditions of the slope. There is a large volume of water ponded inside (east side) of the pre-strip berm at the left edge of the photo (see Appendix D).

The 1B ramp is located between the spoil bank and highwall (south of the spoil bank).
