REPORT OF INVESTIGATION

Fatal Fall of Face, Rib, Side or Highwall Accident
November 13, 2023

Piedmont Mining, LLC (B2884)
McIntyre, Wilkinson County, Georgia

Wrens Plant
KaMin LLC
Wrens, Jefferson County, Georgia
ID No. 09-00143

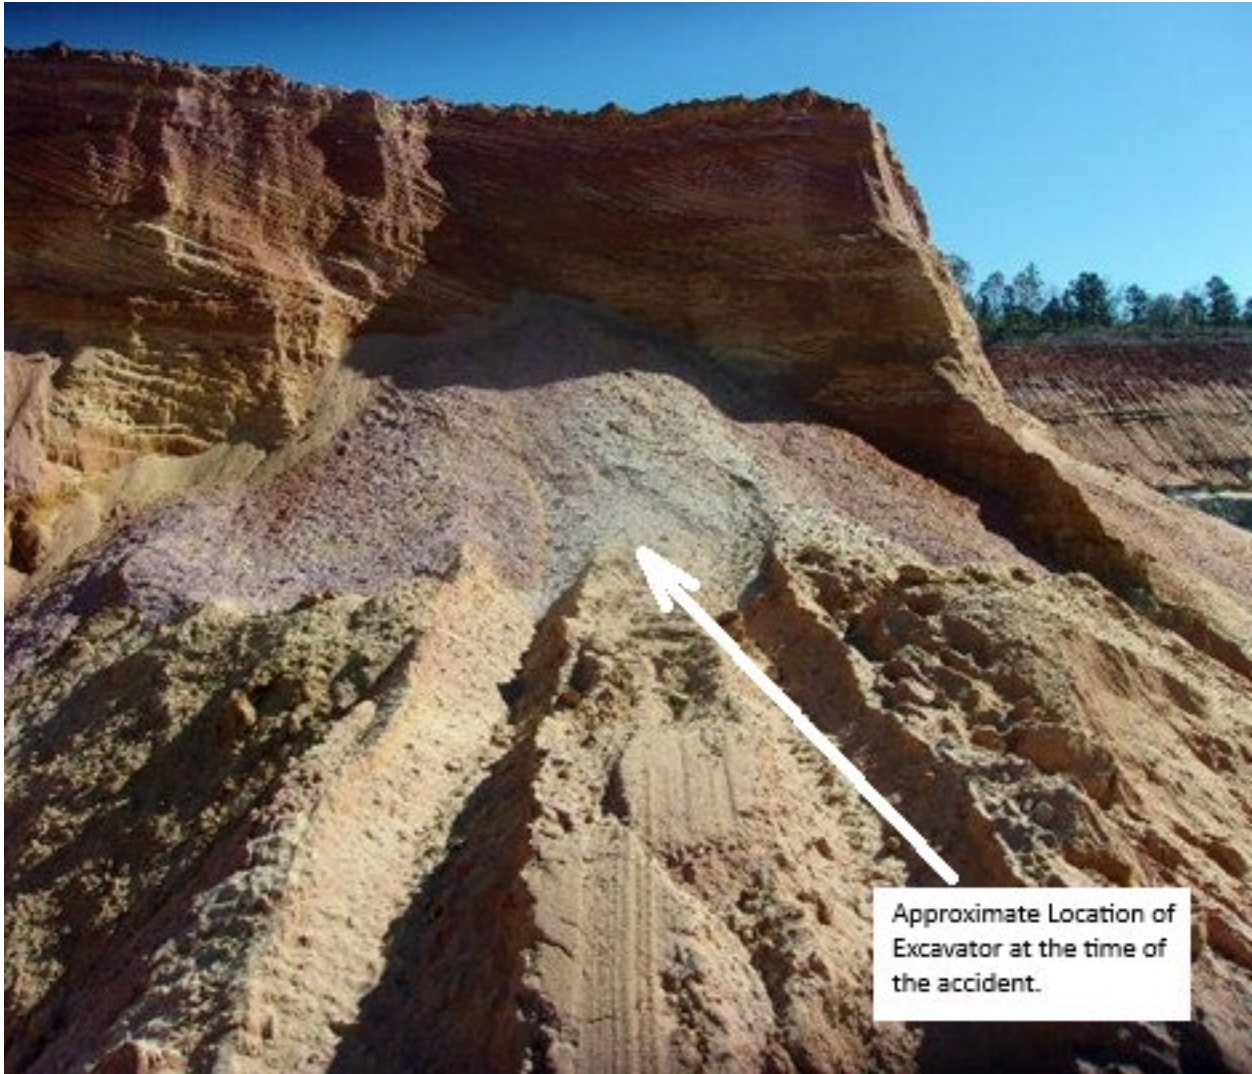
APPENDIX B – Accident Scene

At 12:00 p.m., Hightower chose to remain in his excavator as the crew left the pit for lunch. The crew returned to the pit at 12:30 p.m. Denton drove his fuel truck into the pit to service the equipment, starting with Jordan's excavator. While lubricating the bucket of Jordan's excavator, Denton and Jordan noticed Hightower's excavator sitting idle. After Denton completed servicing Jordan's excavator, Jordan returned to his excavator and used his excavator's horn to get Hightower's attention. Not receiving a response from Hightower, Jordan moved the bucket of his excavator and bumped the bucket on Hightower's excavator, but he still received no response from Hightower. Denton walked up onto the mound of material where Hightower's excavator was located adjacent to the pit highwall, throwing clay balls at Hightower's machine to get his attention. Receiving no response, Denton continued to the cab of Hightower's excavator. Once there, Denton saw Hightower was not in the cab of his excavator. Denton saw that material from the pit highwall had sloughed down and piled up onto the steel tracks and up to the door of the excavator. The sloughed material had filled in the trench between the excavator and the highwall.

The accident occurred in the Number 23 area of the Lewis Pit. The area had a 44-foot highwall being accessed by a Caterpillar 349 Excavator (see Appendix B).

Piedmont did not prevent miners from working or traveling between equipment and the highwall where equipment may hinder escape from falls or slides of highwalls, which contributed to the accident.

Corrective Action: The contractor developed and implemented a new written procedure that includes training of contractors' activities to ensure contractors are complying with MSHA regulations. The procedure requires that equipment operators remove equipment from the area of the highwall before exiting the machine.
