REPORT OF INVESTIGATION

Fatal Powered Haulage Accident
January 29, 2024

Ellangowan Bank #45
Reading Anthracite Company
Mahanoy City, Schuylkill County, Pennsylvania
ID No. 36-02234

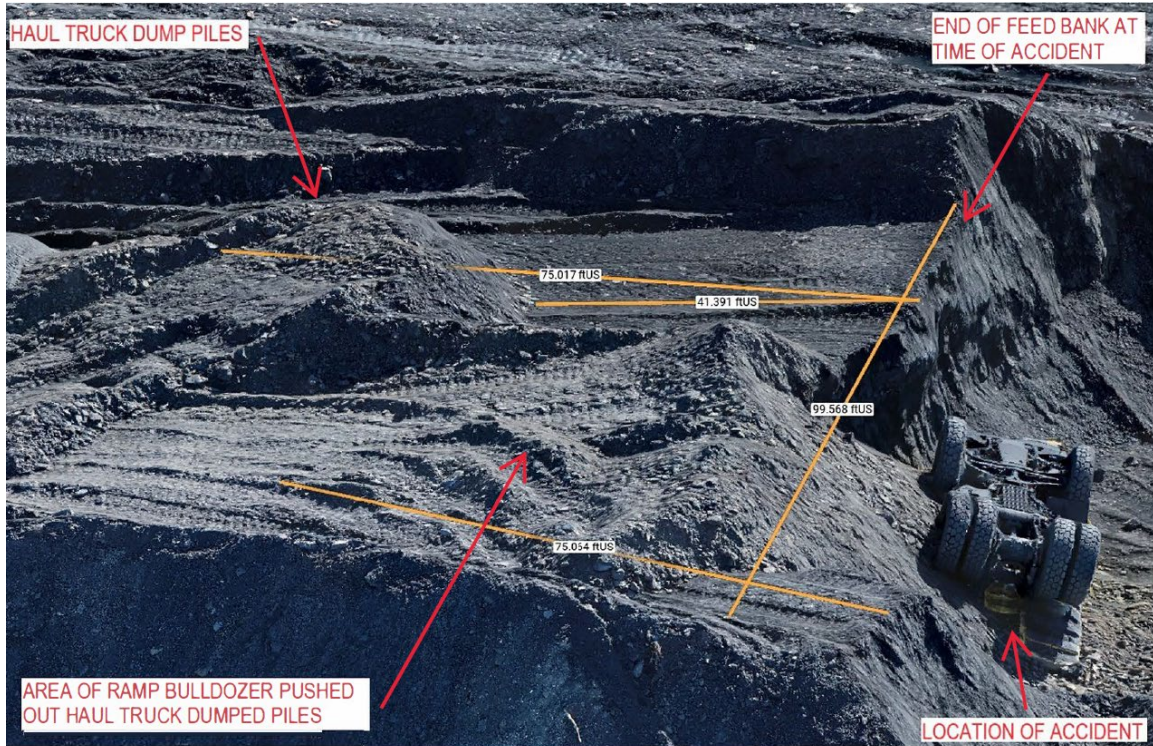
APPENDIX A – Drone Photo of the End of the Feed Bank

According to interviews, between 4:17 a.m. and 7:39 a.m., three other haul trucks continued to haul material and dump it on the feed bank. At approximately 6:20 a.m., Joseph Nadja, Bulldozer Operator, began pushing the piles the haul trucks had dumped on top of the feed bank over the end of the feed bank (see Appendix A). At 6:26 a.m., Bowers sent a text to Moyer's cell phone to see where he was and received no response. At 7:07 a.m., Bowers called Moyer's cell phone and received no answer.

A front-end loader, over the course of two shifts on January 27 and 28, 2024, had removed material from the toe of the feed bank leaving a 24-foot drop-off. Investigators determined that no berms were present at the end of the ramp of the feed bank at the time of the accident. The investigation team determined the mine operator not maintaining a berm or similar means to prevent overtravel or overturning at the dumping location contributed to the accident.

Corrective Action: The mine operator developed and implemented through their new ground control plan the requirement to maintain a berm on the feed bank to prevent over travel and overturning. The mine operator retrained the miners on their new ground control plan.

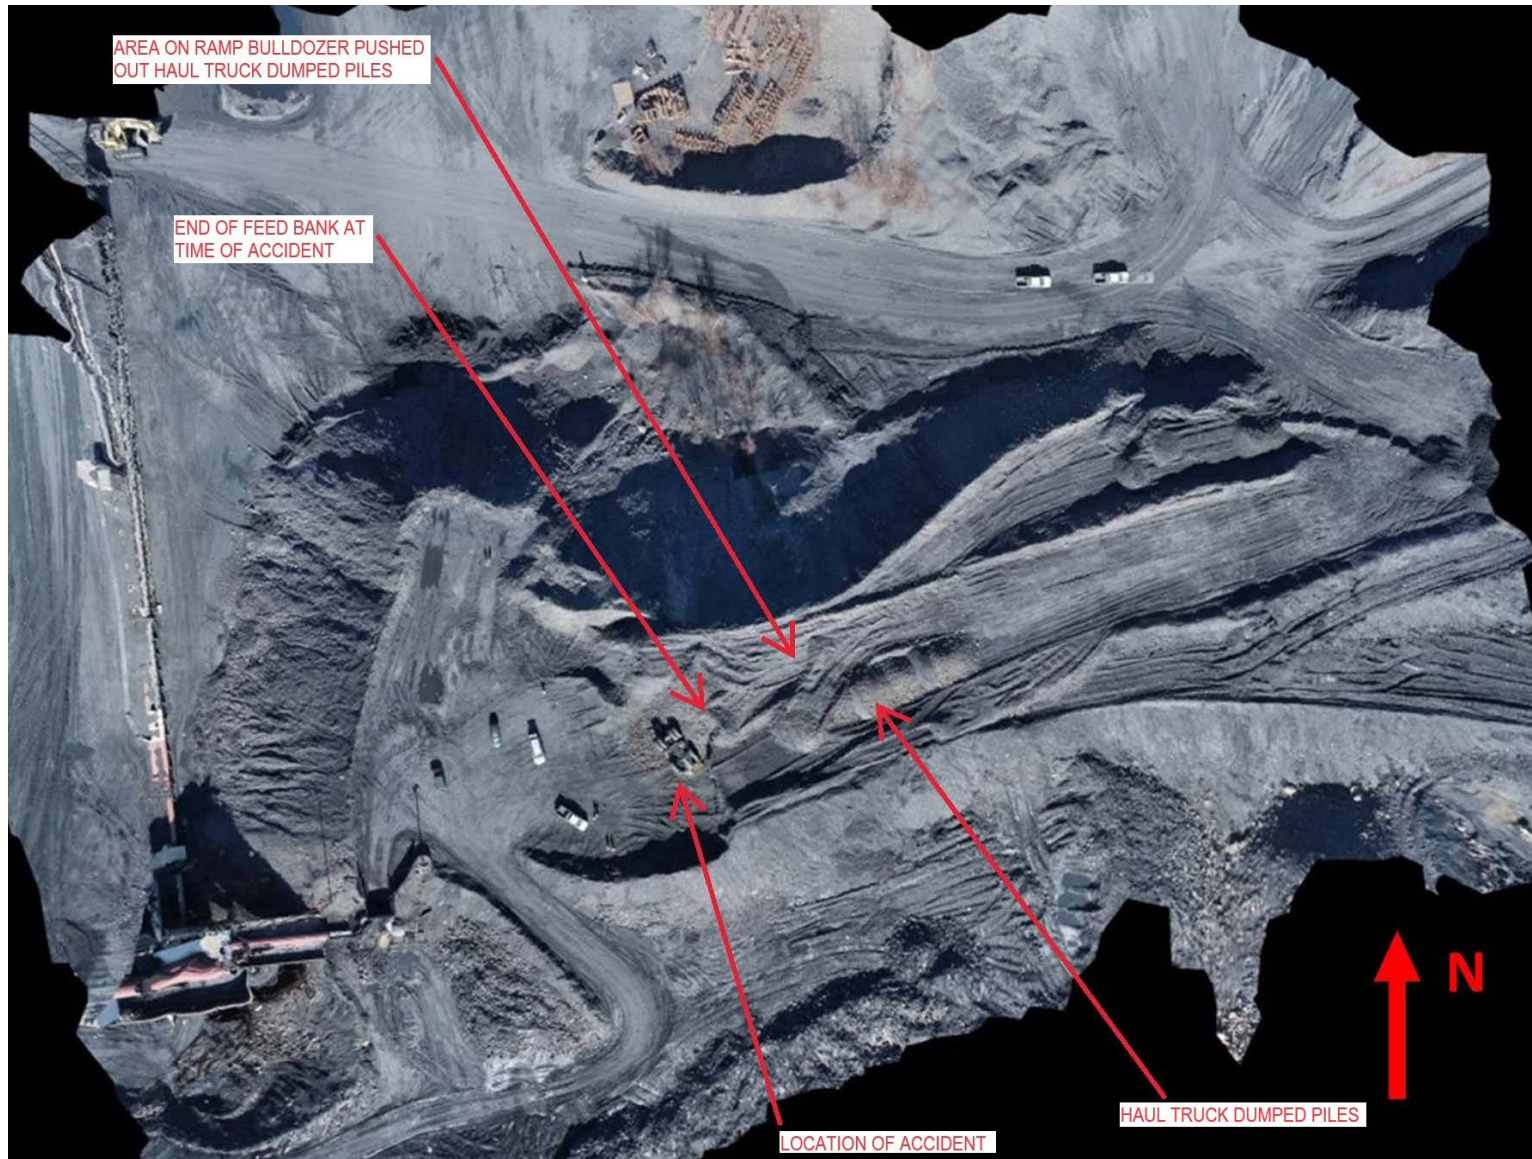
APPENDIX C – Aerial View of Feed Bank

The accident occurred at the end of the feed bank. The feed bank was 500 feet long, 24 feet in height, and with a nine percent grade elevating/rising towards the end of the bank at the time of the accident (see Appendix C).
