Safety Alert

Highwall Failure Accident

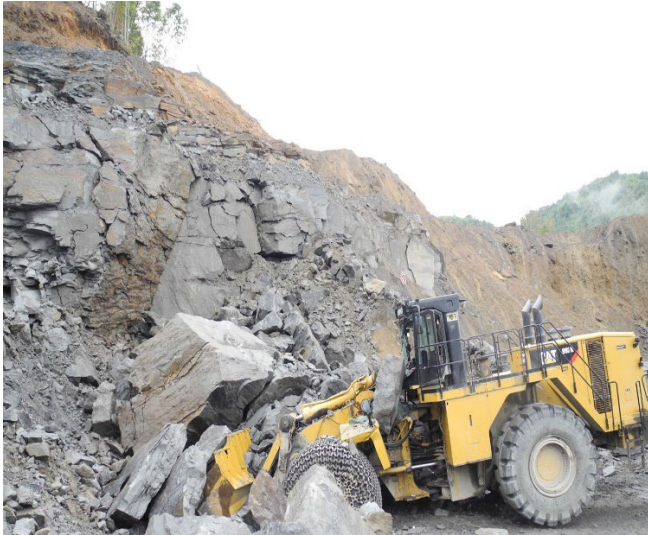
A FEL operator was seriously injured when a section of highwall fell onto the CAT 992K FEL while operating next to a highwall.

- **Develop and follow procedures** for the safe control of all highwalls where miners work and travel in close proximity to the highwall.
- **Train miners to recognize highwall hazards.**
- **Conduct highwall examinations** and eliminate hazards (loose rocks, overhangs, trees, etc.) prior to working or traveling near the highwall. Examine highwalls from multiple perspectives (bottom, sides and top/crest). Examine highwalls more frequently after rain events and periods of freezing and thawing.
- **Use auxiliary lighting** during low light conditions to conduct highwall examinations and illuminate active work areas.
- **Never park equipment, perform maintenance or store materials beneath the highwall.**

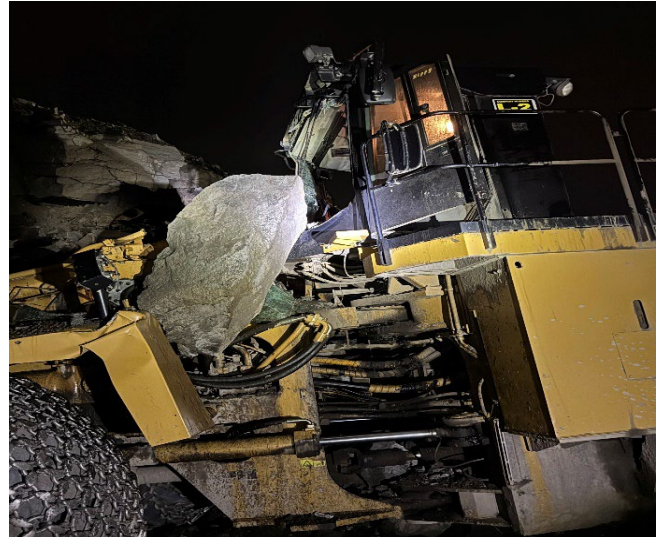
A large rock from the collapsed highwall crushing the FEL front cab pinning the miner's legs under the dash.
