REPORT OF INVESTIGATION

Fatal Fall of Roof or Back Accident
May 31, 2024

Buchanan Mine #1
Buchanan Minerals, LLC
Raven, Buchanan County, Virginia
ID No. 44-04856

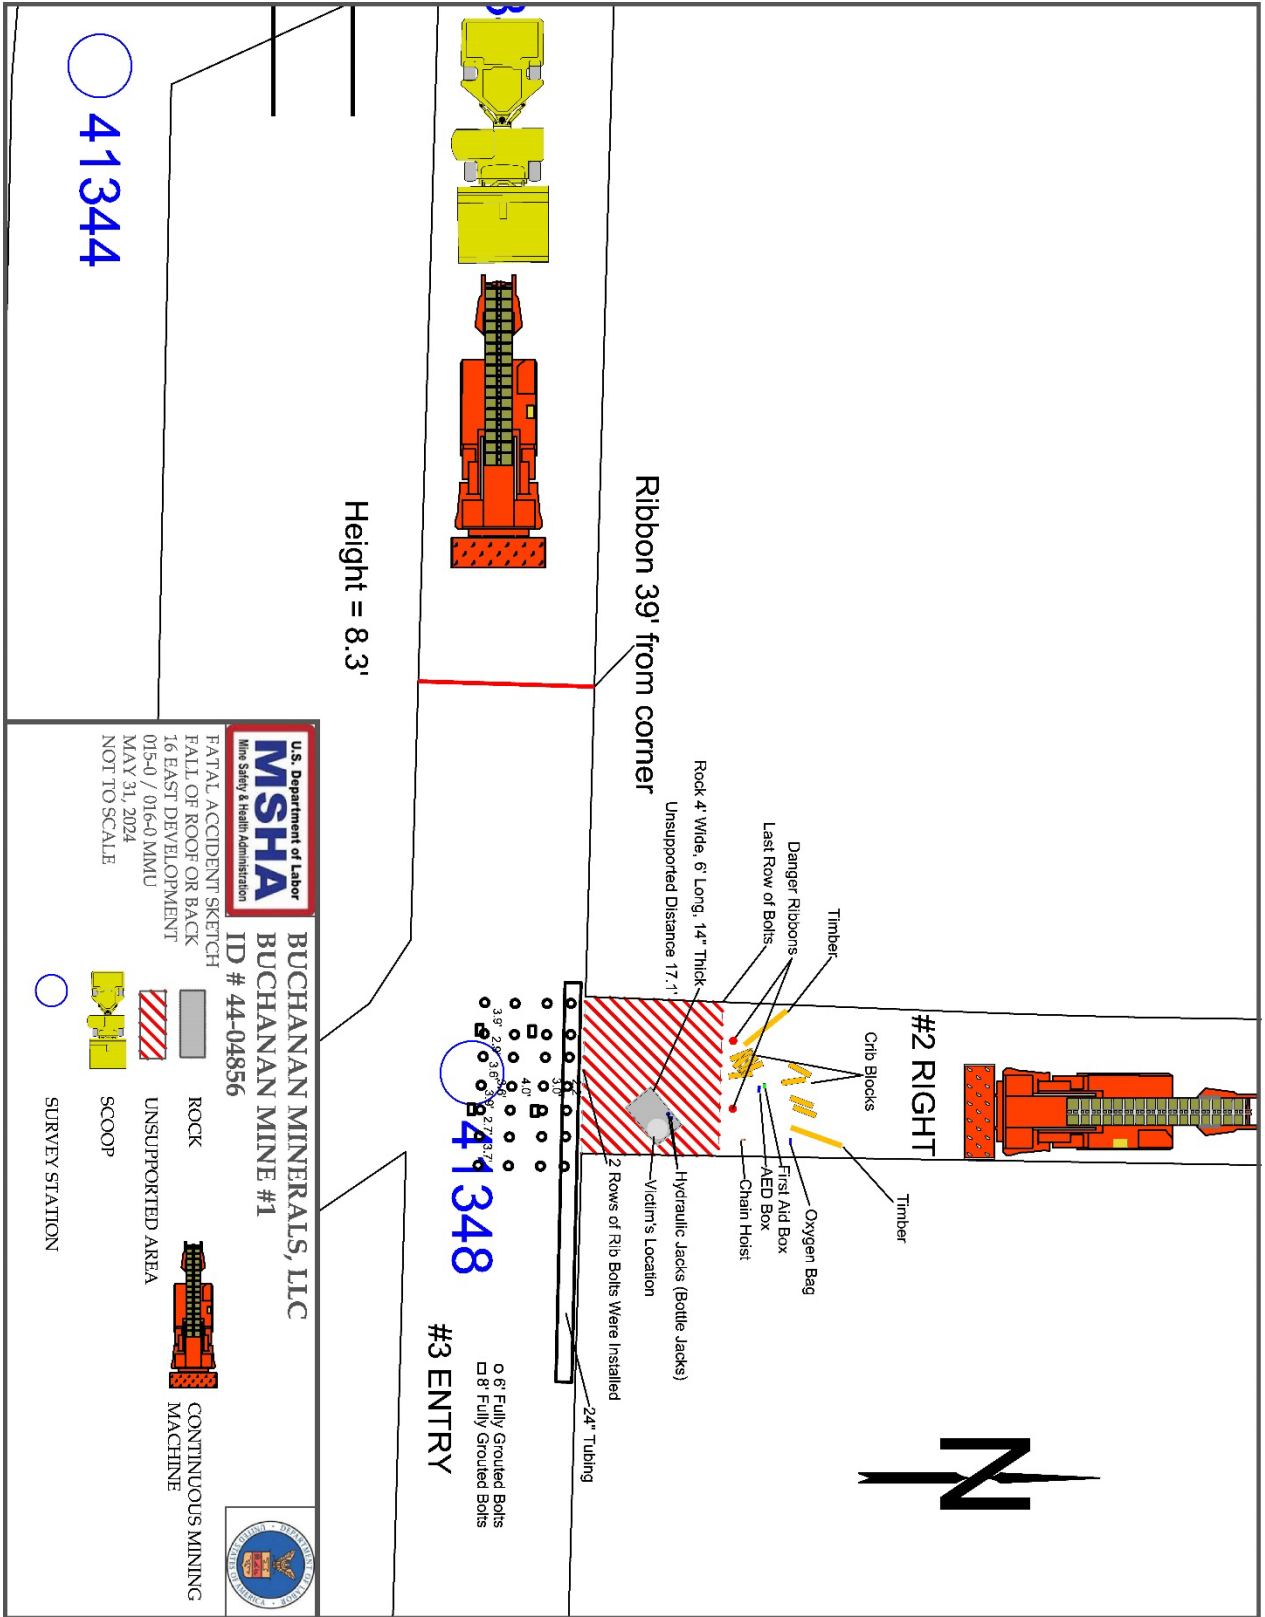
APPENDIX B – Location of Accident and Accident Scene

According to interviews, Jackson saw Gibson and Shortridge and asked if they had any cable bolts, but they told him they did not. Jackson then left the No. 4 Entry and traveled the same route to the No. 2 Right crosscut. Lester and Dotson warned Jackson not to travel back through the unsupported area. While traveling back through the area of unsupported roof in No. 2 Right crosscut, Jackson was struck by a section of mine roof. The investigator measured the fallen section of mine roof that struck Jackson to be approximately six feet long, by four feet wide, and an average of fourteen inches thick.

The accident occurred in the 16 East Section of the mine, near Survey Station 41348, in an area of unsupported roof in the No. 2 Right crosscut (see Appendices B and C).

A fatal accident occurred on May 31, 2024, when a miner traveled through an area of unsupported mine roof in the No. 2 Right crosscut, near Survey Station 41348. The miner traveled from the supported area in the No. 2 Right crosscut, through the unsupported area, and into the No. 3 entry. The accident occurred when the miner traveled from the No. 3 entry back through the unsupported area. A section of unsupported mine roof approximately six feet, by four feet, and 14 inches thick fell, struck, and covered up the miner.

Corrective Action: The mine operator has developed and implemented a revision to the approved roof control plan. This revision includes more visible warning devices and physical barriers to all approaches leading to unsupported areas. All miners have been trained on the revision to the approved roof control plan which included a reemphasis that miners are not to travel under unsupported roof.
