UNITED STATES  
DEPARTMENT OF LABOR  
MINE SAFETY AND HEALTH ADMINISTRATION

REPORT OF INVESTIGATION

Fatal Powered Haulage Accident  
July 26, 2023

Lexington Quarry Company  
Lexington Quarry Company  
Nicholasville, Jessamine County, Kentucky  
ID No. 15-06264

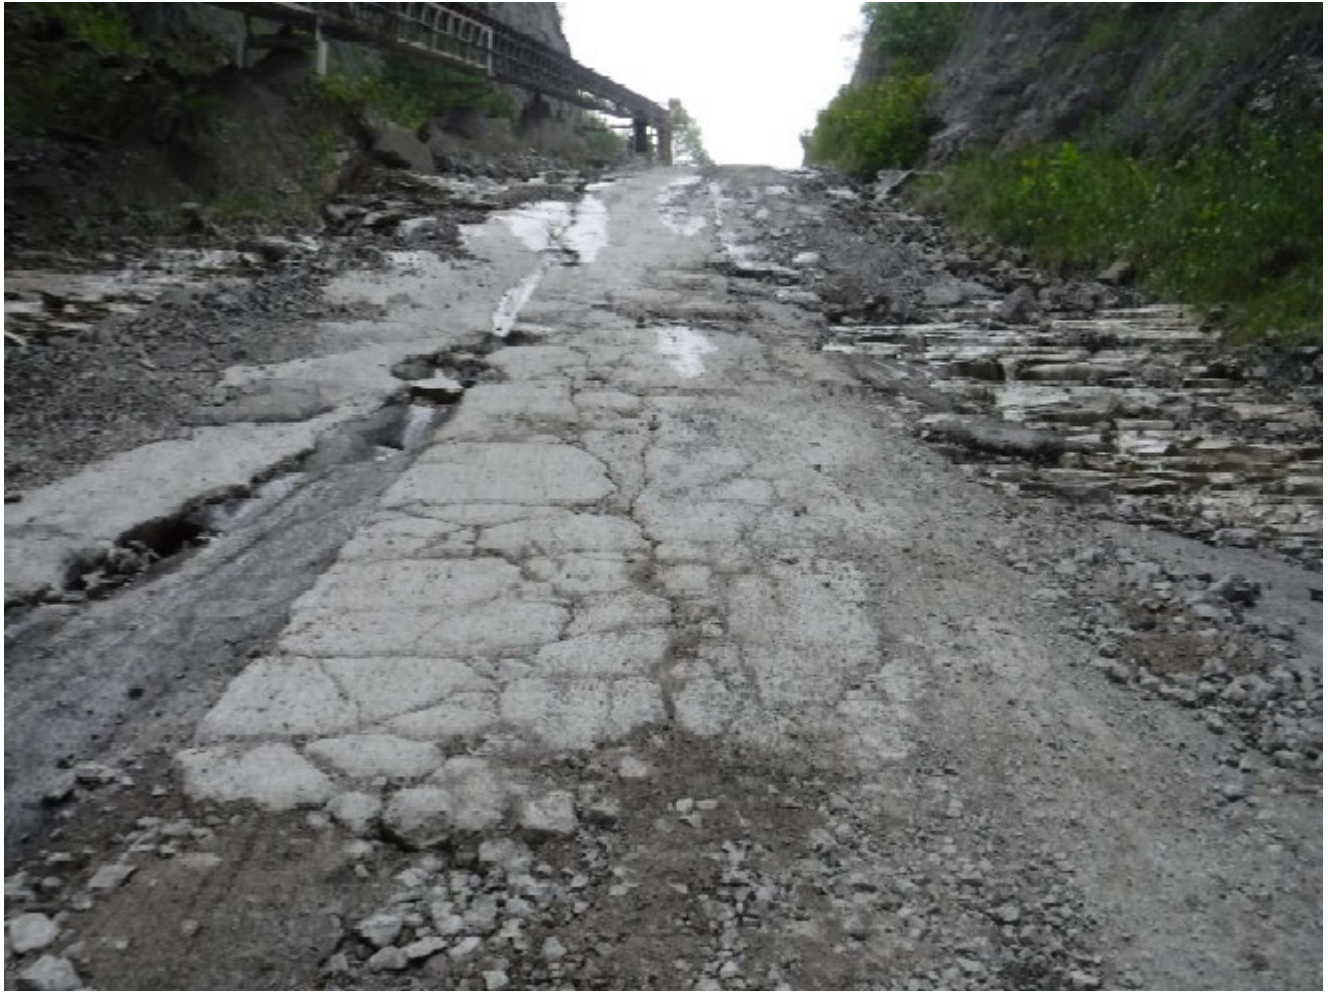
APPENDIX B – Top of the Slope

According to interviews, at approximately 2:45 p.m., Conrad returned to the East 2/Second Level area, but Pennington and the pickup truck were no longer there. Conrad continued out of the mine to look for Pennington and found the pickup truck crashed against the gob pile at the mine entrance. Pennington was lying approximately 50 feet up the slope with obvious injuries. There were no eyewitnesses to the accident. Based on Conrad’s statement of interaction with Pennington and an examination of the accident scene, Pennington indicated that the truck lost traction and began traveling backward down the slope. Pennington exited the vehicle and received significant head injuries from striking the ground and/or being struck by the truck. The truck continued backward down the ramp, coming to rest at the mine portal.

The accident occurred on the surface slope at the entrance to the mine (see Appendix B). The grade of the slope is 14 degrees. The truck came to rest at the bottom of the slope (see Appendix C).
