U.S. Department  
of Transportation  
Federal Railroad  
Administration

## Full-scale Grade Crossing Impact of a Single-frame Highway Truck into an LNG Tender: Pre- and Post-Test Analyses

1. REPORT DATE (DD-MM-YYYY) 03-21-2024		2. REPORT TYPE Technical Report		3. DATES COVERED (From - To) August 2018 – March 2022	
4. TITLE AND SUBTITLE Full-scale Grade Crossing Impact of a Single-frame Highway Truck into an LNG Tender: Pre- and Post-Test Analyses				5a. CONTRACT NUMBER DTFR5317F00767	
				5b. GRANT NUMBER	
				5c. PROGRAM ELEMENT NUMBER

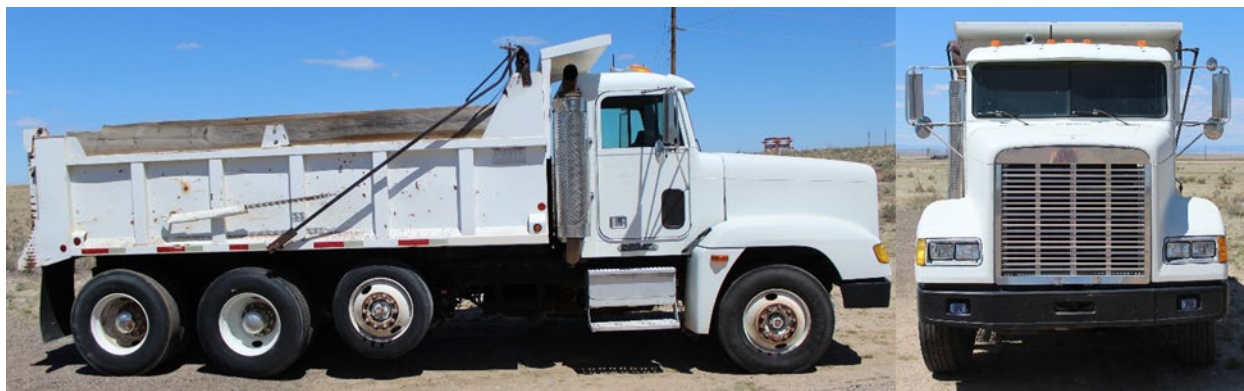
**Figure 2. Side and Front View of the 1994 FLD 120 Dump Truck**

M-1004 specifications require a single-frame vehicle to impact the fuel tender. A 1994 FLD 120 dump truck was selected as the single-frame vehicle for testing (Figure 2). The test conditions would result in a severe impact, necessitating a vehicle trajectory that would have to be controlled externally. In a modeling environment, the trajectory of the vehicle can easily be controlled, but during the test, control of the vehicle's trajectory is much more difficult and complex. Additionally, the M-1004 specifications provided a target test speed of 40 mph for the impact so the velocity of the dump truck needed to be controlled precisely for the test.

The team instead chose to use a dump truck converted for use as a high-rail vehicle (see [Figure 2](#)). With the dump truck modified to roll on two railroad wheelsets on existing track, the dump truck's trajectory could be effectively controlled by the railroad tracks on which it traveled. The anticipated low rolling resistance between the steel wheels and the steel rail would allow the dump truck to be "shoved" up to speed by a locomotive before it coasted into the point of impact with the tender. The dump truck would run on an existing track at TTC, while the locomotives and fuel tender would be positioned stationary at a 90-degree angle to the dump truck (as shown in [Figure 3](#)).

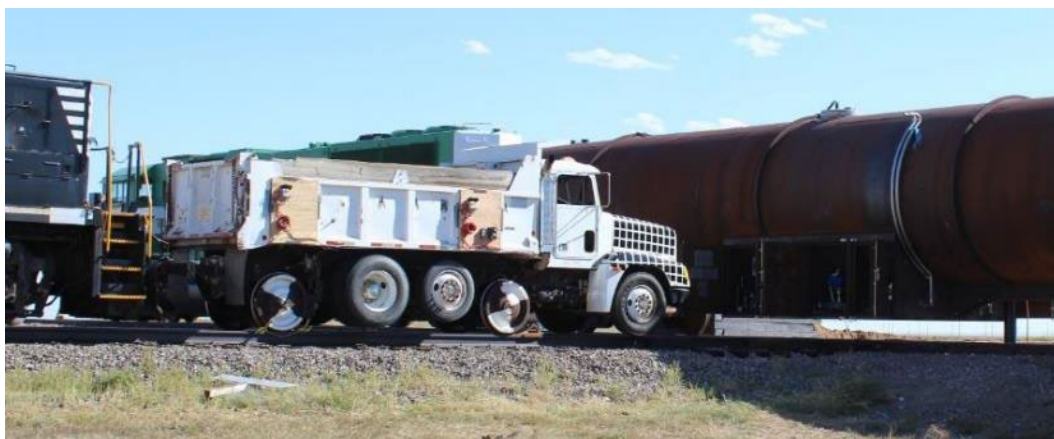
**Figure 3. Oblique View of Dump Truck Aligned at the Impact Point with the Tender**

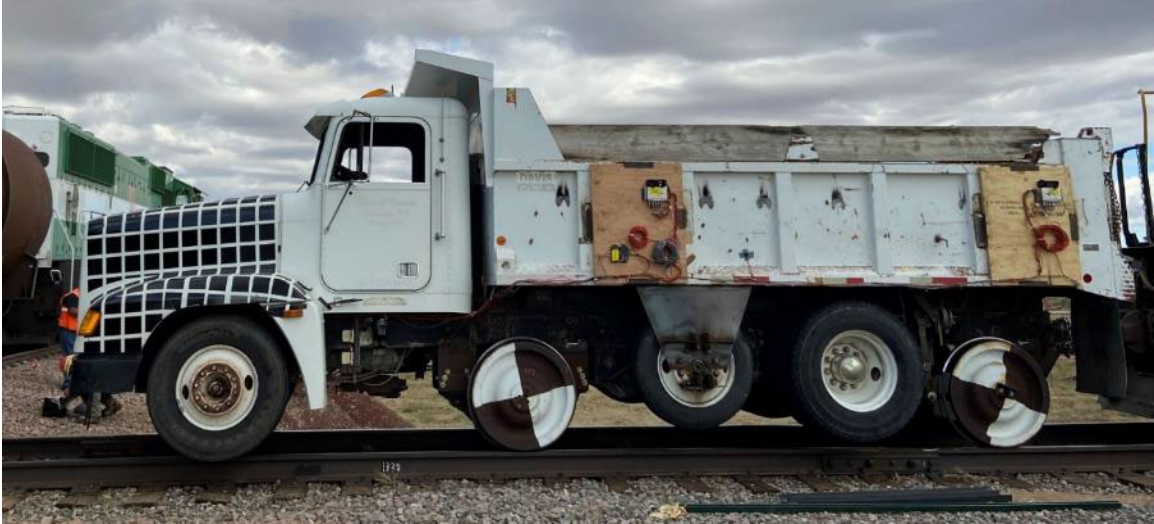
**Figure 6. Dump Truck Fitted with the Leaf Spring Suspension and Railway Wheelset**

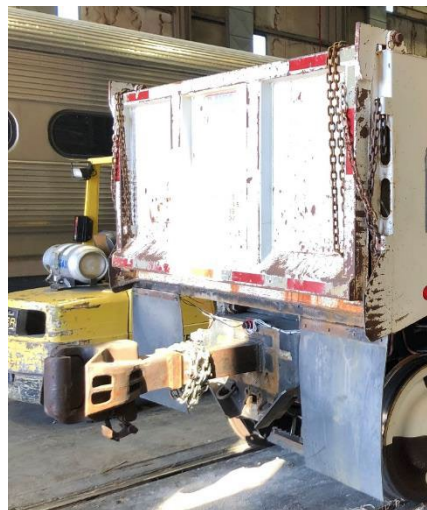
**Figure 9. Railway Coupler Fitted to Dump Truck**

Speed upgrade tests were performed to determine that the dump truck, modified to roll like a hi-rail vehicle, could negotiate the test track safely at 40 mph. A brake system was designed and installed and the rear of the dump truck was fitted with a railway coupler to allow the truck to be hauled by a locomotive ([Figure 9](#)).

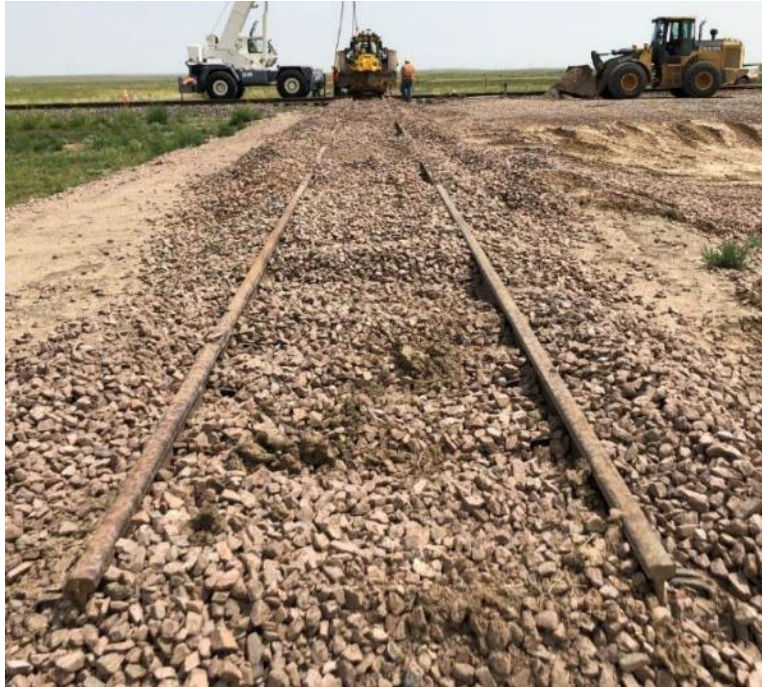
**Figure 11. Track Section Under Construction (West View)**

The test section of constructed track extended roughly 130 feet to each side of the center of the existing test track. The continuity of the track was broken and the section of track that was constructed was continuous from east to west. Class 3 American Railway Engineering and Maintenance-of-Way Association (AREMA) ballast was used for the ballast bed. Concrete ties supported the rails with a 24-inch center-to-center spacing. Secondhand 136RE rails and some 141RE rails were used in the track construction but brand new fasteners were used to clamp the rails to the ties. No measurements were taken to confirm the track Class, but the track was constructed and tamped to conform to FRA's Class 4 track specifications [8]. [Figure 11](#) shows the section of track under construction.

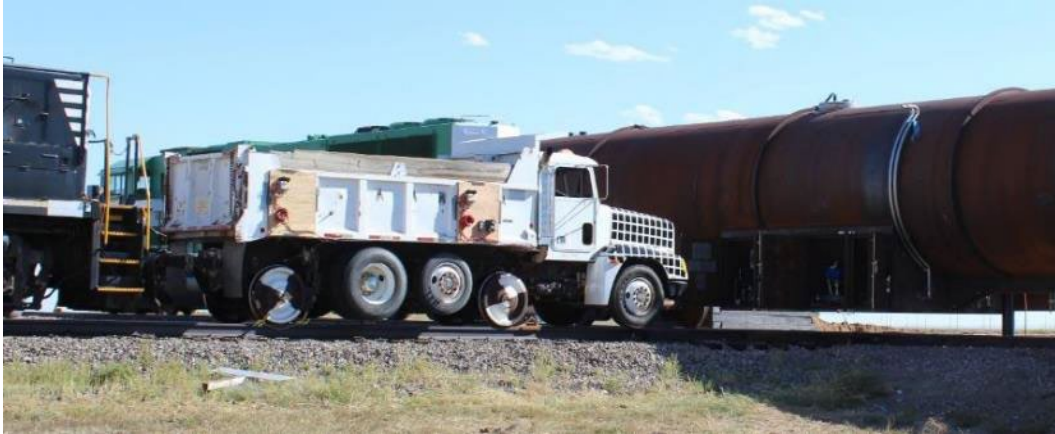
**Figure 17. Pre-test Test Setup with Dump Truck Close to the Housing of the Fuel Tender**

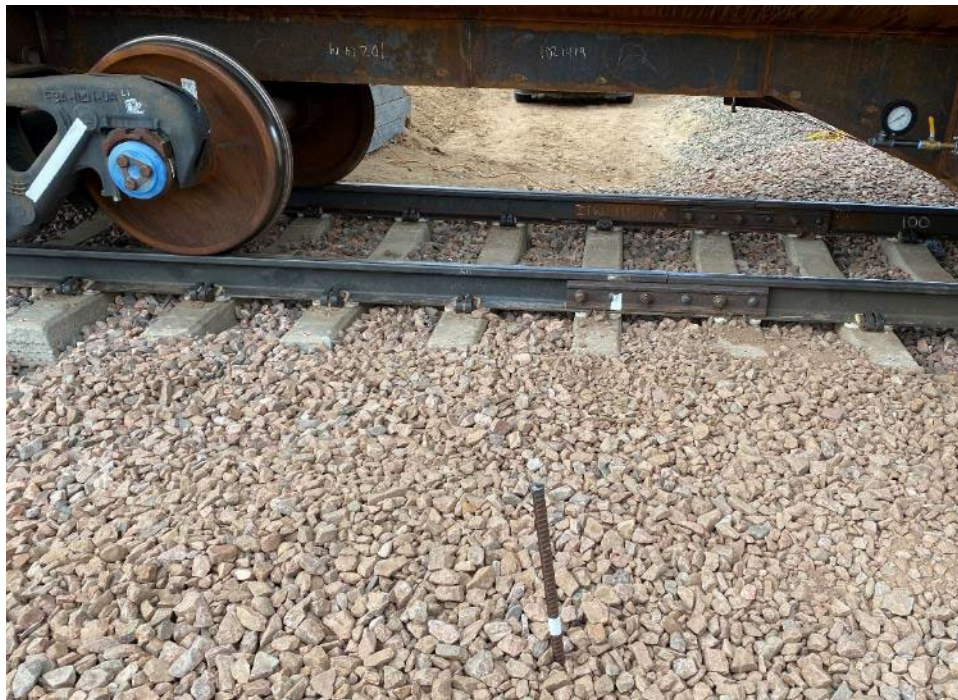
**Figure 23. Fixed Measurement Point used to Assess Track Shift After the Impact**

The connection of the rails to the ties and the ties to the ground is one of the model parameters mentioned but not well defined in M-1004. In the test, flexible rail fasteners were used to connect the rails to the ties and Class 3 AREMA ballast was used to construct the track bed. Additionally, a small marker was placed on the northern edge of each tie to assist in measuring displacement between pre-test and post-test tie positions. The movement of the ties relative to fixed ground points was measured before and after the impact to assess the track shift that occurred during the impact. Figure 23 shows one such fixed measurement point represented by rebar driven into the ground. Additionally, point clouds of the test area were produced before and after the impact using a drone-based system. The displacement of each tie marker during the test was approximated by post-processing the pre- and post-test drone scan data as described in Appendix J.

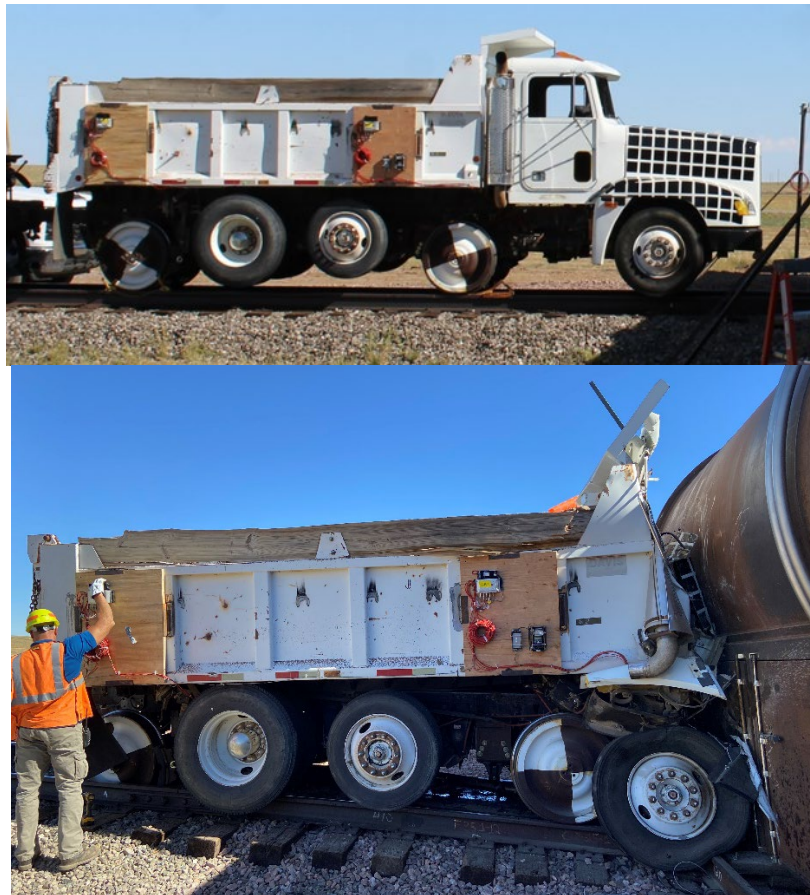
**Figure 25. Pre- and Post-Test Condition of the Dump Truck**

The kinetic energy of the dump truck was calculated to be 4.94 million foot-pounds (ft-lbf). The main components of the dump truck capable of energy absorption were the dump truck cab, underframe, and bed. The cab was constructed mainly from fiberglass with some structural steel and the underframe of the truck consisted of two C-channels interconnected by cross members. For the test, the dump bed was loaded with steel weights, increasing the structural rigidity of the truck bed. [Figure 25](#) shows the condition of the dump truck before and immediately after the impact. Most of the dump truck cab was destroyed, and some components, such as the seats, were compressed against the rear of the cab. The C-channel forming the underframe peeled back above the front tire of the dump truck. The rear railway wheel of the dump truck derailed.

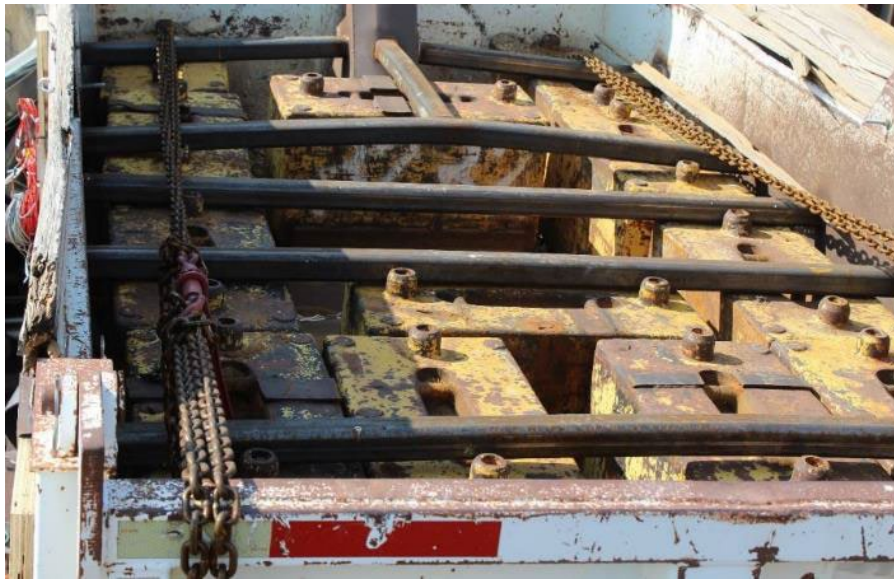
**Figure 27. Condition of the Weights and Restraining System Post-Impact**

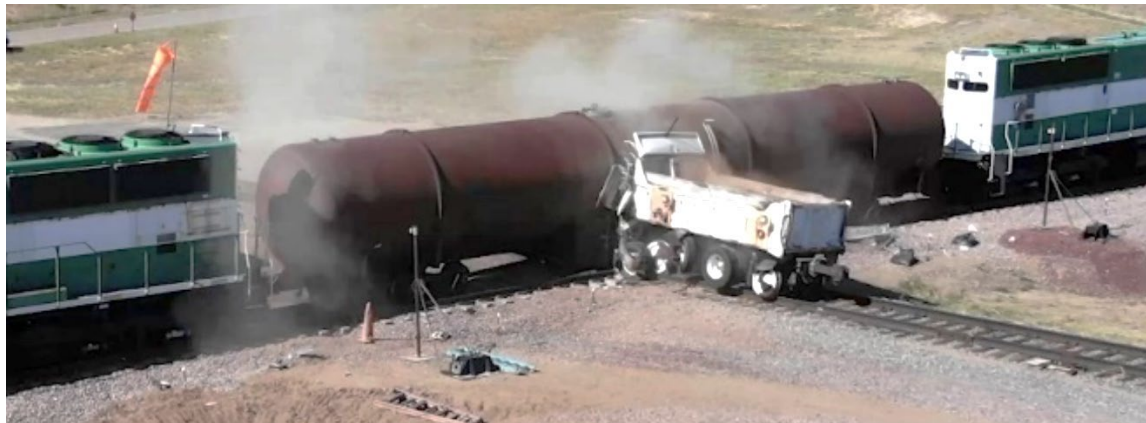
**Figure 57. Post-impact State of Test (top), Model Case E (Center), and Model Case J (Bottom)**
