Annual Compliance Report

EPBC 2021/9026 Carosue Dam TSF CELL 4 22 November 2022 – 21 November 2023

5 February 2024

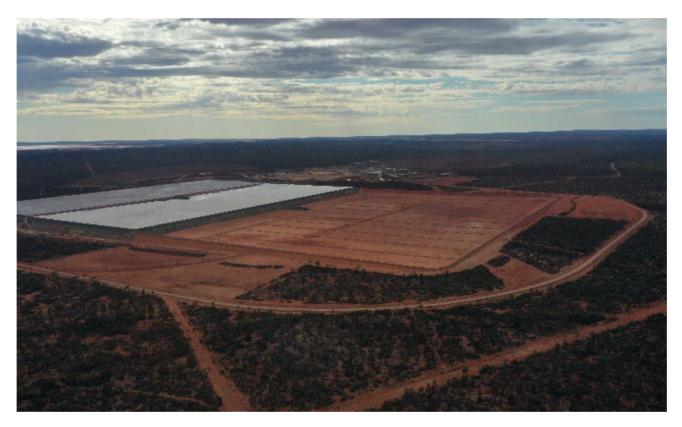
Plate 1 - TSF Cell 4 looking south south-west.

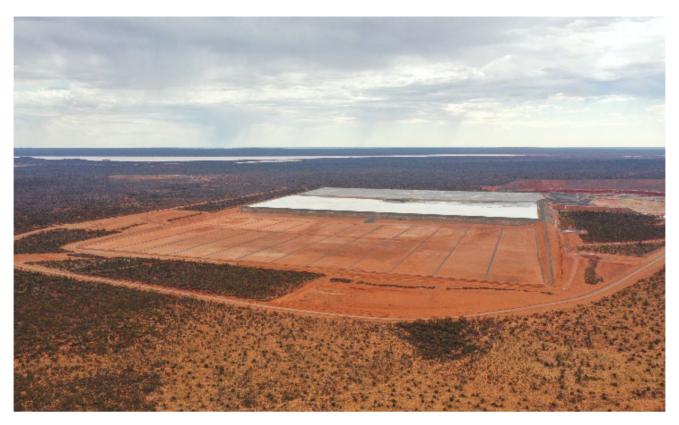
Plate 2 – TSF Cell 4 looking east.

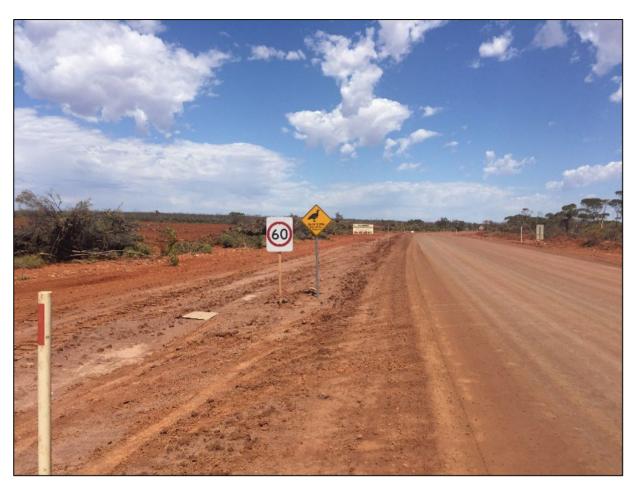
Plate 3 – Malleefowl signage and speed limits in place.

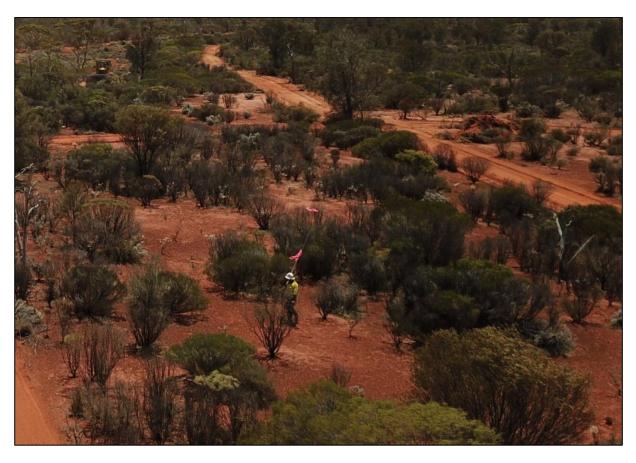
Plate 4 – Fauna spotter walking ahead of dozer during clearing activities.

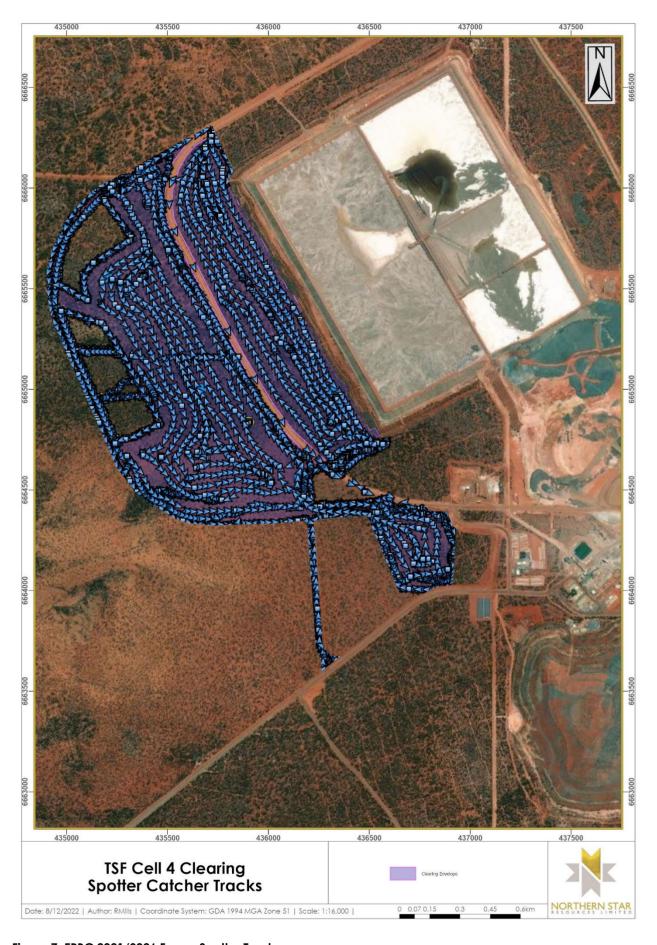
Figure 7: EPBC 2021/9026 Fauna Spotter Tracks

Objectives	Performance Criteria	Compliant (Y/N/NA)	Evidence
			Daily inspections of entire Project area (including water facilities) conducted with no fauna deaths recorded, evidence provided in the Daily Fauna Sightings Register (Appendix B). No water deposition occurred during the reporting period. Water present in Turkeys Nest due to rainfall
Minimise requirements for clearing which results in habitat loss and fragmentation.	No unauthorised clearing and/or clearing outside approved clearing areas. No unauthorised clearing of active Malleefowl mounds.	Partial	See Section 2.1 for details on Non-Compliance recorded related to minimal clearing outside of the disturbance envelope. Pre-clearance survey found no active mounds within the Controlled action Area (Holm, 2022). No active mounds were cleared.
Minimise increases to predator abundance.	No increase in predator abundance. No fauna/Malleefowl deaths due to predation.	Y	No increase in predators has been recorded. No fauna/Malleefowl death due to predation has been recorded. Fauna spotters were present at all times during clearing (Figure 7).

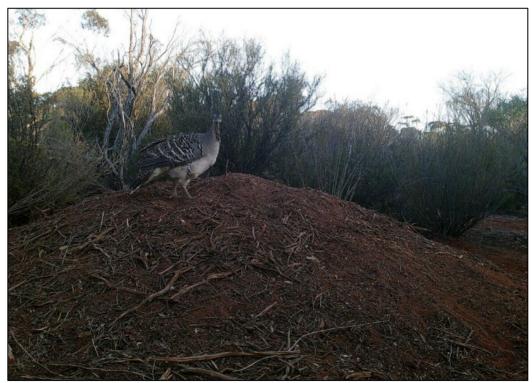
Data from the cameras were analysed confirming EEL55_007 to be an active mound (Plate 6). No Malleefowl activity was captured at EEL55_009 during this period, indicating the mound is likely to be inactive following a predation event (see Section 4.2).

Plate 6: Malleefowl working active mound at EEL55_007

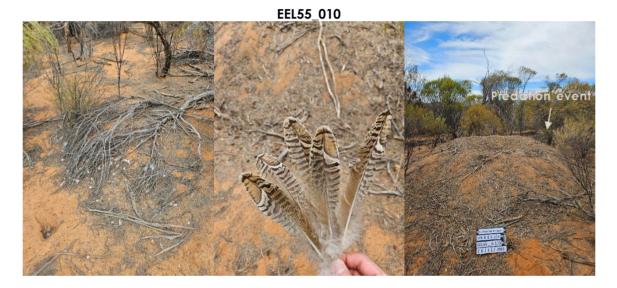
EEL55_009

During the 2023 monitoring program in November and December, potential predation events were identified at two separate breeding mounds (EEL55_009 and EEL55_010). Large tufts of Malleefowl feathers found near the mounds indicate the birds had possibly been attacked with mortality unknown. Both mounds had been recently worked by Malleefowl, likely in preparation for this breeding season. Predation is indicated in the photos below.
