BUREAU OF ALCOHOL, TOBACCO, FIREARMS AND EXPLOSIVES

Project Record

Title	Smoke/CO Alarm Activation on Lower Floor with				
	Smoldering/Flaming Combustion Occurring on Upper Floor				
Test Type	Custom				
Lab Number	22FR0016-1 Author David R. Tucholski				
Test dates	3/6/23, 3/7/23, 3/8/23, 3/9/23	No. Tests	3	4

Introduction

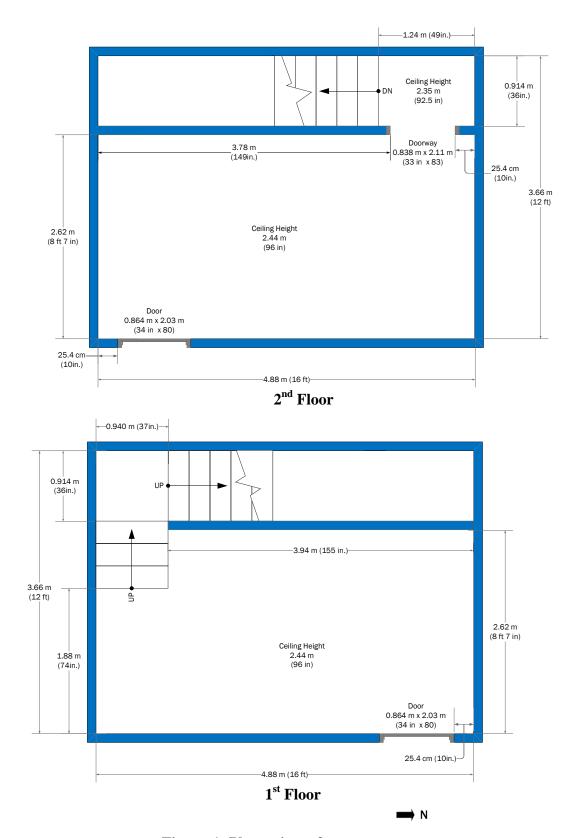
Figure 1. Plane view of test structure

Figure 1 shows a plan view of the two-story structure. The overall interior dimension of each floor was approximately 4.88 m long by 3.66 m wide (16 feet long by 12 feet wide). Each floor had a room that measured approximately 4.88 m long by 2.62 m wide by 2.44 m high (16 feet long by 8 feet 7 inch wide by 8 ft high). A stairwell was located on the west side of the structure that connected the two floors. The structure was built on top of a wood platform. An exterior door was located on each floor of the structure, although the door on the bottom floor was sealed with tape during each test. The door on the upper floor was either open or closed, depending on the test being conducted. Figure 2 shows an exterior view of the east side of the structure.

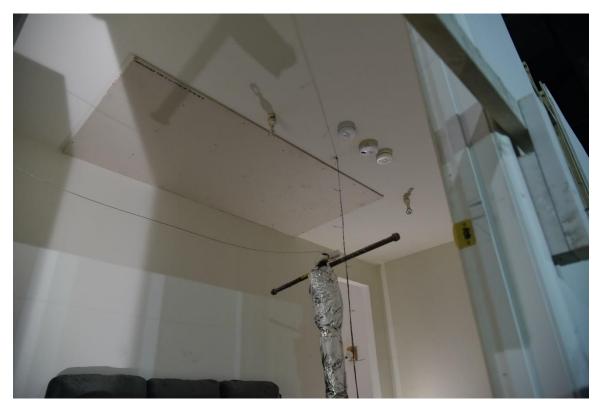
Figure 3. Extra section of gypsum wall board attached to ceiling above the sofa for the flaming fire tests (360086_1305181.jpg)

For the flaming fire tests, a section of gypsum wall board was attached to the ceiling above the sofa to limit the damage to the ceiling. Figure 3 shows the extra piece of gypsum wall board attached to the ceiling.

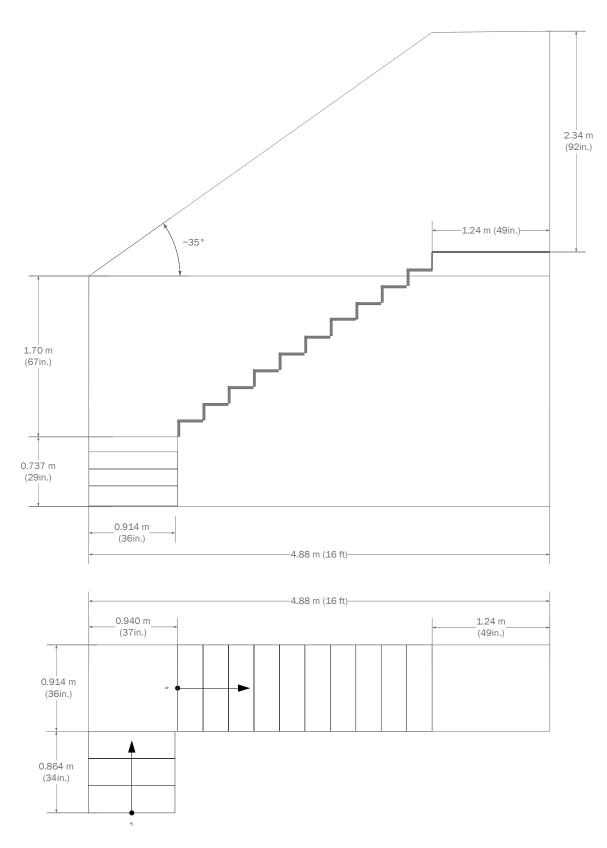
Figure 4. Stairs - elevation and plan view

An L-shaped set of stairs was located on the west side of the structure. There were three steps between the first floor and a landing. The stairs turned 90 degrees and an additional 10 steps went from the landing to the second floor. The wood steps were covered with 1.27 cm (1/2 inch) thick gypsum wallboard and had a nominal rise of 17.8 cm (7 inch)

and tread depth of 27.9 cm (11 inch). The width of the stairs was approximately 0.91 m (36 inch). A drawing of the stairs is shown in Figure 4. The ceiling above the stairs was sloped at an angle of approximately 35 degrees, similar to the slope of the stairs. The ceiling started to slope above the landing and then stopped at the second floor landing.

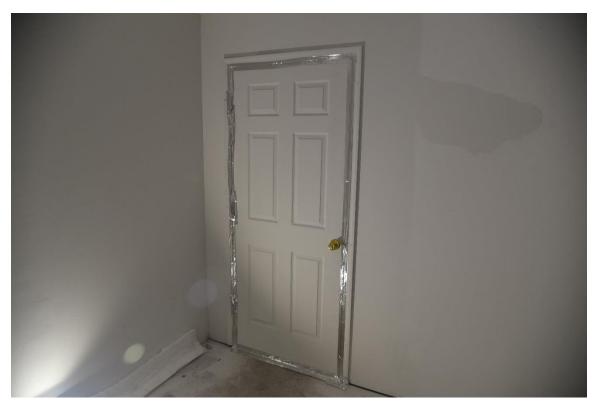
Figure 5. First floor door sealed with aluminum tape (360079_1304764.jpg)

The structure had two exterior doors, one on each level. Each door was a standard hollow core door that measured 86.4 cm (34 inch) wide by 2.03 m (80 inch) high. For each test, the door on the first floor was sealed with aluminum tape before the start of the test, as shown in Figure 5. The door on the upper level was either open or closed, depending on the test being conducted. For the flaming fire test, the door on the upper floor was removed from the structure.

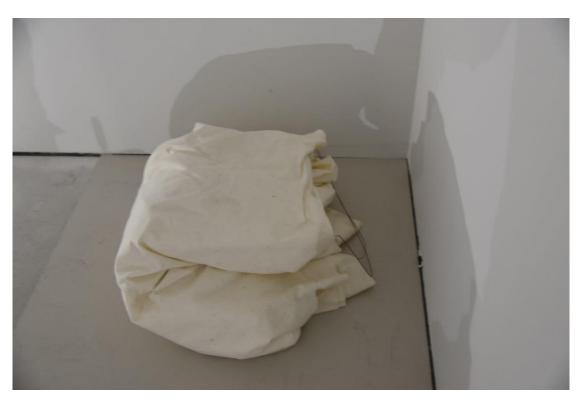
Figure 6. Cotton batting for Test 1 (360079_1304756.jpg)

Cotton batting from the Warm Company (Warm and Natural, Item 2105A) was used for the smoldering tests. The batting was made of 87.5% cotton and 12.5% polypropylene. The batting measured 1.14 m (45 inch) wide by 36.6 m (40 yards) long and weighed approximately 8.2 kg (18 lbs). The batting arrived in a roll that was approximately 30.5 cm (12 inch) in diameter by 1.14 m (45 inch) long. For each smoldering test, the cotton batting was unrolled and then folded into an approximate rectangular shape, as shown in Figure 6 and Figure 7. For Test 1, the folded shape of the cotton batting measured roughly 0.610 m wide by 0.813 m long by 0.406 m high (24 inch wide by 32 inch long by 16 inch high). For Test 2, the folded shape of the cotton batting measured roughly 1.17 m wide by 0.610 m long by 0.178 m high (46 inch wide by 24 inch long by 7 inch high).

After folding the cotton batting, it was placed on a section of gypsum wallboard, which was located in the north-east corner of the room on the 2^{nd} floor.

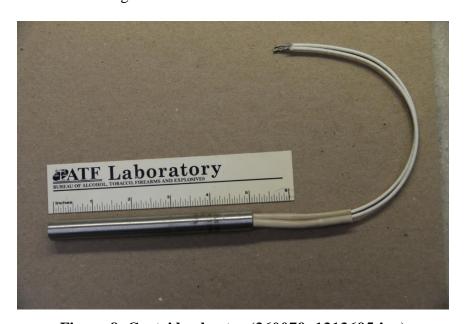
Figure 8. Cartridge heater (360079_1313695.jpg)

A cartridge heater from Vulcan (Model TB507A) was placed within the cotton batting to initiate a smoldering combustion reaction. The cartridge heater was 12.7 cm (5 inch) long and had a diameter of 1.27 cm (½ inch). The heater had an output power rating of 500 Watt at a 120 VAC input. The heater was powered using a variable transformer (Staco Energy, model 2510CT). The cartridge heater is shown in Figure 8 and the transformer is shown in Figure 9.

The cartridge heater was placed between the layers of the cotton batting as shown in Figure 10 and Figure 11.

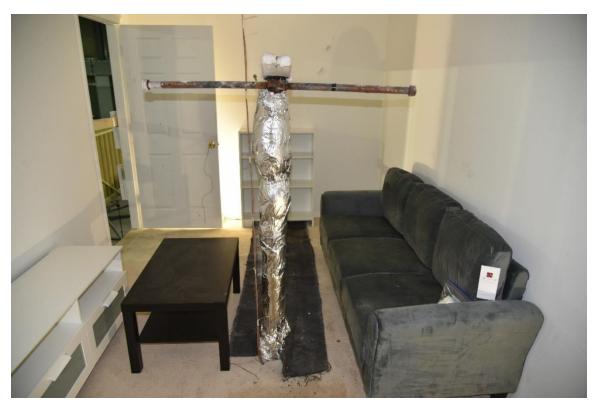
Figure 12. Upholstered sofa, coffee table, TV stand and bookcase for the flaming fire $(360086_1305161.jpg)$

The upper room was furnished with an upholstered chair and sofa, a coffee table, a TV stand, and a bookcase. Table 1 contains a summary of the items. The items are shown in Figure 12 and Figure 13. The approximate location of each item is shown in Figure 14.

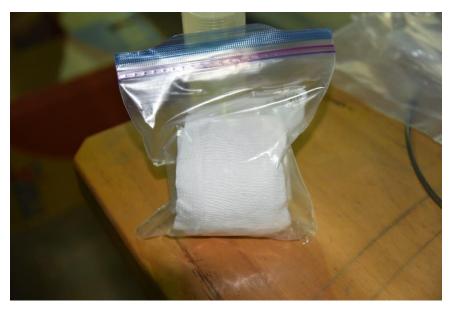
Figure 15. Ignition package (358561_1238921.jpg)

The fires were initiated on the sofa using an open flame from a butane torch to ignite an ignition package prepared by the FRL staff. The ignition package is shown in Figure 15. The ignition package consisted of a quart-size plastic bag that contained paper towels and medical gauze rolled together and soaked in gasoline. The medical gauze used was a CVS/pharmacy Sterile Premium Rolled Gauze, constructed of a Rayon-polyester blend. The gauze had a listed un-stretched length of 7.62 cm x 1.92 m (3 inches x 2.1 yard). Ten sheets from a paper towel roll were used and each sheet of paper towel measured 22.5 cm x 27.9 cm (8.875 inch x 11 inch).

Each ignition package was assembled by first unrolling the medical gauze and laying it out flat in the un-stretched position. A continuous section of ten (10) paper towel sheets

was then removed from the paper towel roll and folded width wise in a tri-fold manner such that the folded width of the continuous section of paper towels measured approximately 7.3 cm (2.875 inches). The folded continuous section of paper towels was placed on top of the un-stretched medical gauze. They were then rolled together such that the paper towels were on the inside and the medical gauze was on the outside of the roll. The roll was then placed inside the quart-sized plastic bag and approximately 250 ml (8.5 fluid ounces) of gasoline was poured into the bag.

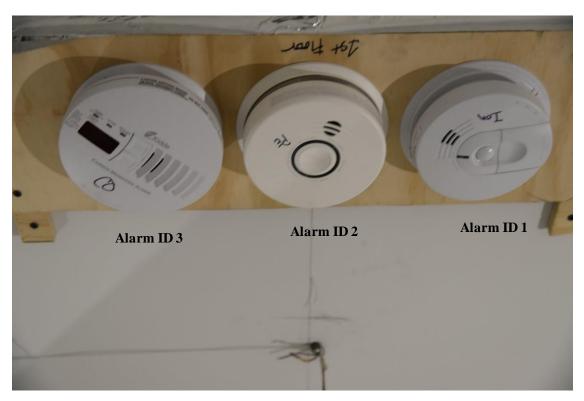
Figure 16. AC powered alarms – image annotated (360079_1304666.jpg)

Both AC powered and battered powered smoke alarms and CO alarms were used in the experiments. A summary of each alarm is provided in Table 2. Photographs of the alarms are shown in Figure 16 and Figure 17.

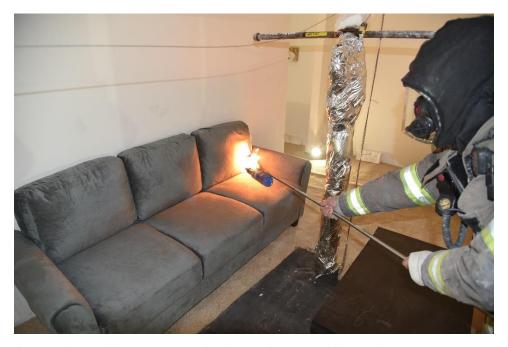
Figure 18. Ignition package ignited using open flame from butane torch (360086_1305186.jpg)

The door on the 1st floor was sealed shut was tape. The ignition package was placed on the right side of the sofa. The test was then started when the ignition package was ignited with a butane torch, as shown in Figure 18. Test personnel then exited the structure through the door on the 2nd floor and closed the door behind them. The test proceeded for approximately 45 minutes, at which point the door on the 2nd floor was opened and the fire, which had been limited to the sofa, was suppressed. The door on the 1st floor was then opened and the test was stopped.

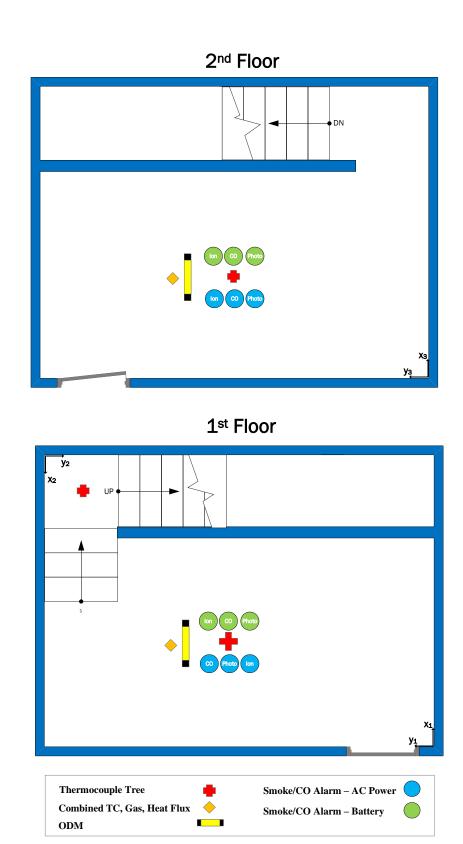
Figure 19. General Instrumentation Layout

A variety of instrumentation was used during the experiments and included thermocouples (TC) for temperature measurement, heat flux transducers for heat flux measurement, gas analyzers to measure the concentrations of oxygen, carbon monoxide, and carbon dioxide within the structure, optical density meters (ODM) to measure the optical density of the smoke, and a weather station to measure the atmospheric conditions in the laboratory (pressure, temperature, and relative humidity. Figure 19 provides the general location of the instrumentation, which is based on a Cartesian coordinate system (x, y, z). Location x and location y are both located in the horizontal plane. Location z is the vertical distance from the floor to the centerline of the instrument. The specific location of each instrument is provided in the following sections for the individual instrumentation.

For the smoldering tests (Tests 1 and Test 2), two additional thermocouples (TCs) were used during the tests. The thermocouples were placed within the cotton batting: one TC was placed near the cartridge heater to verify the heater was working properly, and the second TC was placed in a location remote from the cartridge heater. For the flaming fire tests (Test 3 and Test 4), the battery powered smoke/CO alarms were not used on the upper floor, nor was the ODM.

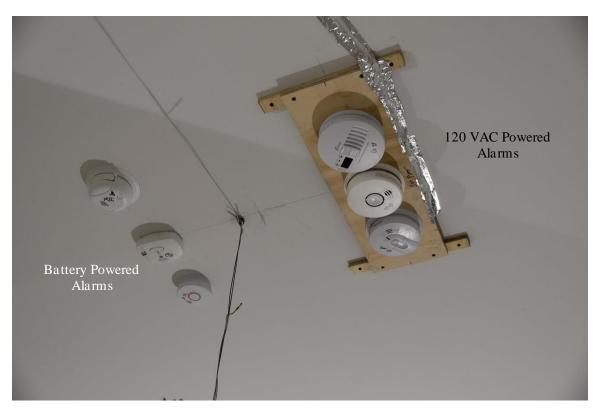
Figure 20. Alarms mounted on first floor ceiling – image annotated (360082_1304945.jpg)

The smoke alarms and CO alarms were mounted directly to the ceiling. The exception to this were the 120 VAC powered alarms on the first floor. These alarms were mounted slightly off of the ceiling so that wires for power and data could be run along the ceiling, instead of through the ceiling joist, as shown in Figure 20. These alarms were offset from the ceiling by approximately 2.54 cm (1 inch). The general location of each type of alarm is shown in Figure 19. Note that for Test 3 & 4, the AC powered ion smoke alarm and CO alarm were switched in positions.

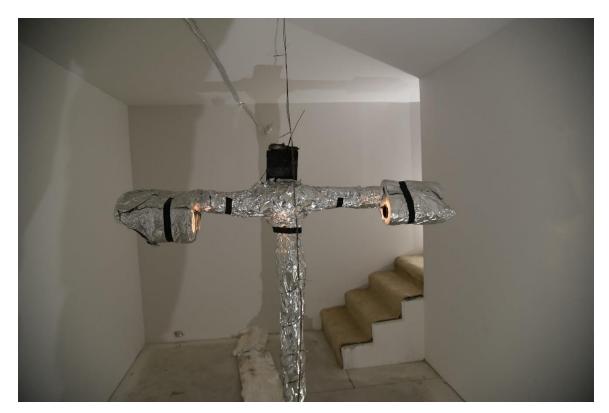
Figure 21. Instrumentation stand for tenability measurements (360086_1305132.jpg)

The tenability conditions in each room were determined by measuring the smoke density, the ambient temperature, the radiant heat flux, and the gas concentrations of carbon monoxide (CO), carbon dioxide (CO₂), and oxygen (O₂). Measurements were obtained approximately $1.52 \, \mathrm{m}$ (5 ft) above the floor and the equipment was mounted to an instrumentation stand, as shown in Figure 21. The smoke density was measured using a white light source, which can be seen in Figure 21.

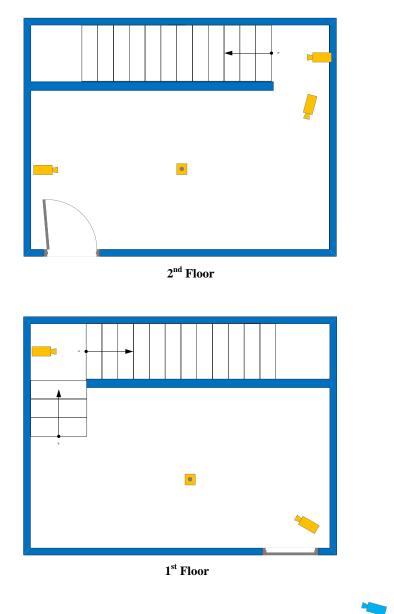
Figure 22. General layout of video cameras

The experiments were also documented using a still camera and video cameras. A high definition (HD) video camera was located outside of the structure and multiple standard definition (SD) video cameras were used inside the structure. Figure 22 shows the general layout of the cameras. For the flaming combustion tests (Test 3 and Test 4), the video camera that had been pointed up at the alarms on the 2nd story ceiling for Test 1 and 2 was instead focused on the origin of the fire, which was on the sofa.

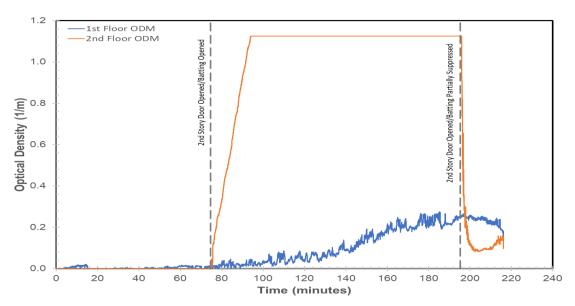
Figure 29. Optical Density

Description	Average Optical Density (1/m)	Maximum Optical Density (1/m)
1st Floor ODM	0.09	0.28
2nd Floor ODM	0.60	1.12

The following chart provides a time dependent representation of the optical density measured during the experiment.

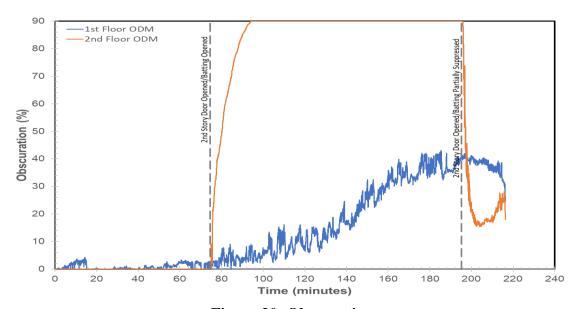
Figure 30. Obscuration

The following chart shows the obscuration during the experiment.

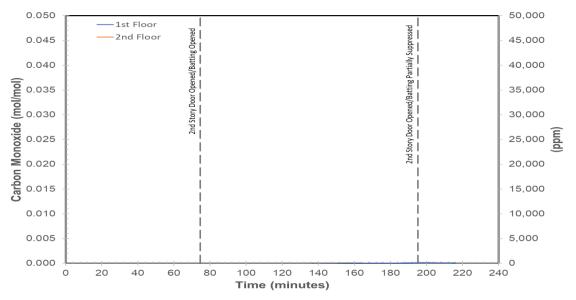
Figure 32. Carbon Monoxide Concentration(s)

The following chart shows the carbon monoxide concentration(s) measured during the experiment.

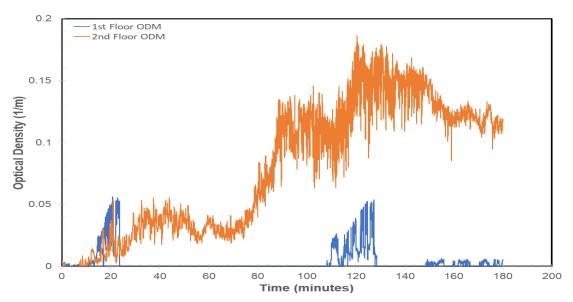
Figure 537. Optical Density

Average Optical Density	Maximum Optical Density
Description	(1/m)	(1/m)
1st Floor ODM	0.00	0.06
2nd Floor ODM	0.08	0.19

The following chart provides a time dependent representation of the optical density measured during the experiment.

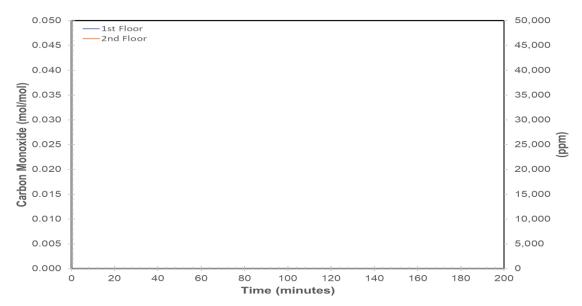
Figure 540. Carbon Monoxide Concentration(s)

Description	Full Scale Range (mol/mol)	Maximum Value (mol/mol)	Average (mol/mol)
1st Floor	0.25	-0.0001	-0.0004
2nd Floor	0.25	0.0004	0.0000

The following chart shows the carbon monoxide concentration(s) measured during the experiment.

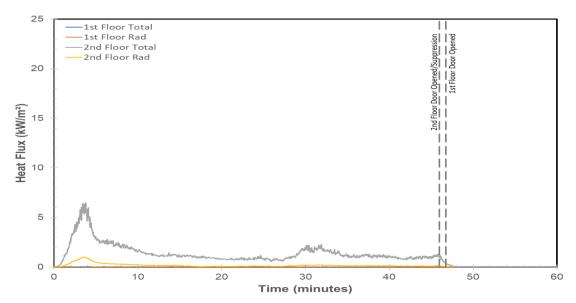
Figure 880. Heat Flux

Description	Time of Initial Change (s)	Initial Change Value (kW/m²)		Maximum	30 Second Maximum Average (kW/m²)			10 Minute Maximum Average (kW/m²)
1st Floor Total	SC	1	0.0	0.0	0.0	0.0	0.0	0.0
1st Floor Rad	SC	1	0.0	0.0	0.0	0.0	0.0	0.0
2nd Floor Total	74	1	6.5	6.1	6.0	5.7	3.7	2.8
2nd Floor Rad	215	1	1.0	1.0	1.0	0.9	0.6	0.4

The following chart(s) shows a time dependent representation of the baseline corrected instantaneous heat flux measured during the experiment.

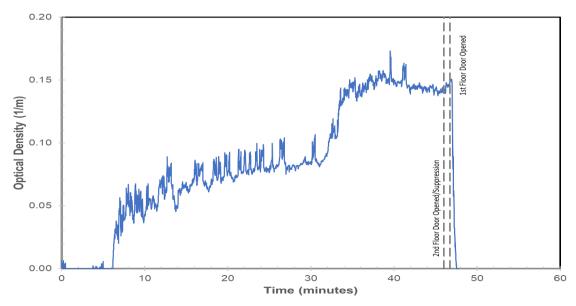
Figure 881. Optical Density

Description	Average Optical Density (1/m)	Maximum Optical Density (1/m)
1st Floor ODM	0.08	0.17

The following chart provides a time dependent representation of the optical density measured during the experiment.

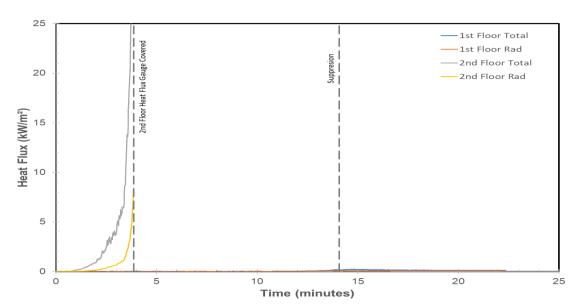
Figure 1280. Heat Flux

The following chart(s) shows a time dependent representation of the baseline corrected instantaneous heat flux measured during the experiment.

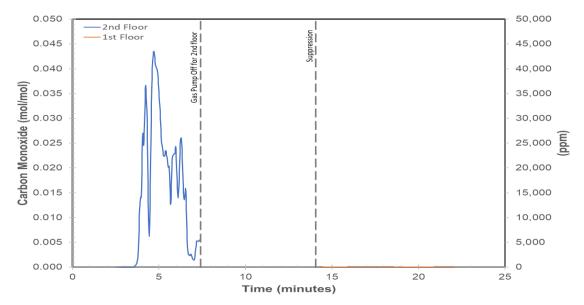
Figure 1284. Carbon Monoxide Concentration(s)

The following chart shows the carbon monoxide concentration(s) measured during the experiment.
