Jointed Concrete Pavement Faulting Collection and Analysis:
TPF-5(299)

Final Report

U.S. Department of Transportation

Federal Highway Administration

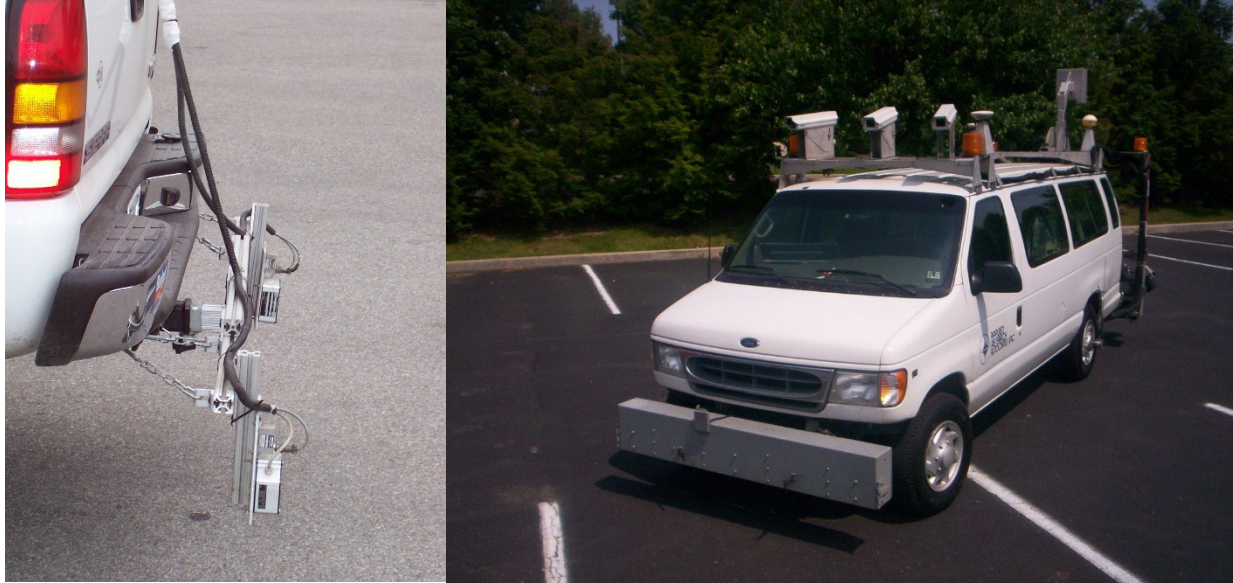
Figure 3. Photo. 2D Automated Fault Measurement (AFM) equipment based on High-Speed Inertial Profiler (HSIP).

The limitations of the manual fault meters mentioned above were the primary motivations to develop the Automated Fault Measurement (AFM) methods based on High-Speed Inertial Profiler (HSIP) data (Figure 3) which is collected primarily for pavement roughness evaluation in terms of the International Roughness Index (IRI). AASHTO R 36 provides the current standards for evaluating JCP faulting from the HSIP data.

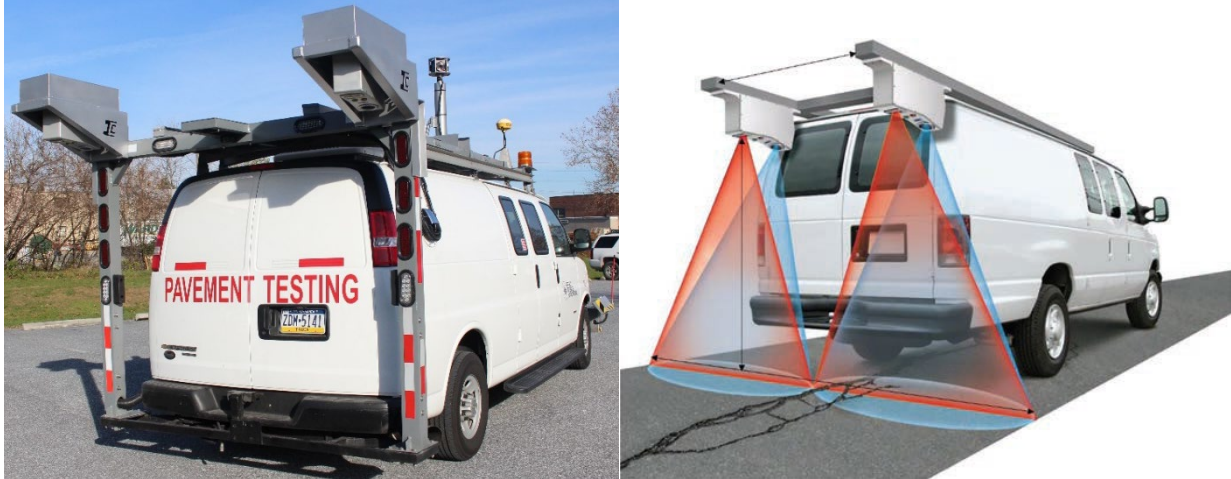
Figure 7. Photo and Illustration. 3D Automated Fault Measurement (AFM) equipment.

Three-dimensional (3D) technologies have become more widely used to collect faulting data (Tsai et. al., 2012; Wang et. al., 2014; Geary et. al., 2018). Modern-day high-speed devices with laser/camera technologies (Figure 7) and software are mature enough to collect dense data for characterization of transverse profiles. The 3D technologies have the potential to overcome the joint detection issues encountered with 2D HSIP data.

An important consideration is that 3D technologies (with wide-field lasers/cameras with overlap and vehicle motions removed by inertial measurement units) are generally able to collect data across the entire pavement width, while HSIP generally only collects two longitudinal profiles in the wheelpaths. Therefore, measurements may not be at the same location across a transverse joint/crack, resulting in different values for faulting. Furthermore, in-lane wander of survey vehicles creates further challenges for the correlation between HSIP and 3D devices. A field experimental study conducted by Wang and Lin (2014) compared the fault values obtained from 3D pavement texture using a template-matching algorithm to those from ProVAL. They found that fault values across the transverse joint were fluctuating/non-uniform and the presence of joint spalling may increase the difference between the fault magnitudes obtained from 2D and 3D systems.

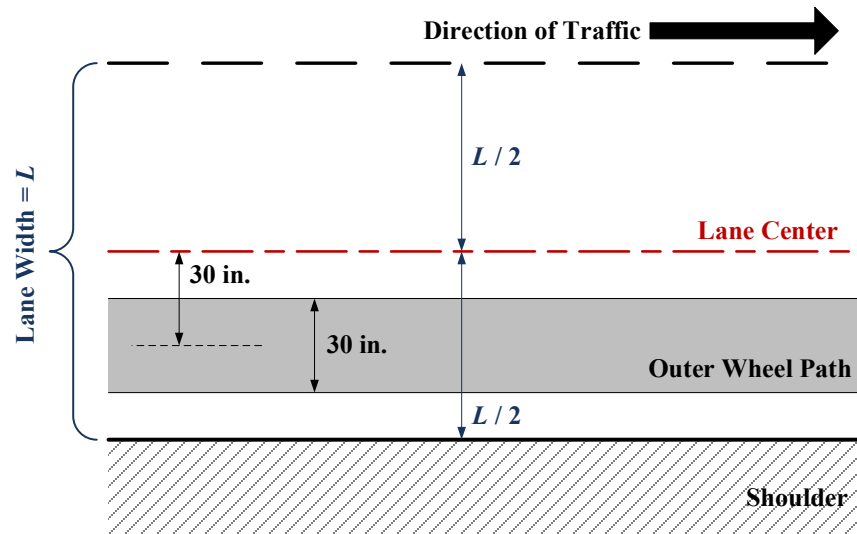
Figure 9. Illustration. Wheelpath for joint faulting calculation.

The outer wheelpath for faulting is defined as the area within 15 in. to 45 in. from the lane center (i.e., center of wheelpath is 30 in. from the lane center and the width of wheelpath is 30 in.), regardless of the lane width. Figure 9 shows a schematic of the outer wheelpath for faulting.

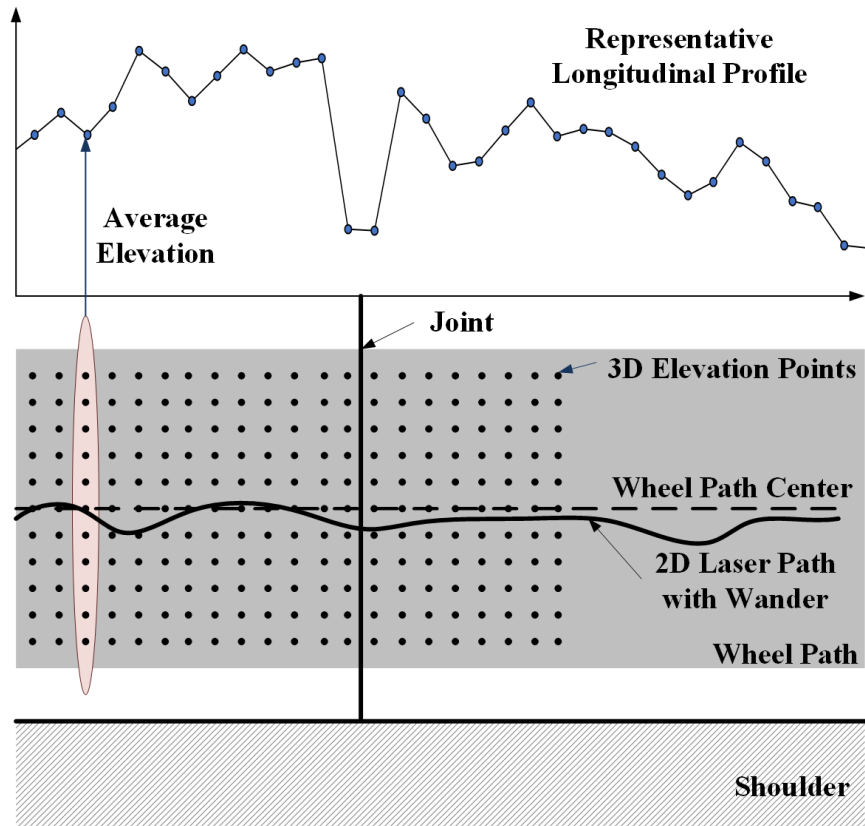
Figure 10. Illustration. Representative Longitudinal Profile.

- a. In case of 3D data where elevations are measured longitudinally and transversely, the representative longitudinal profile is obtained by averaging the elevations within the wheelpath in the transverse direction. The averaging is done in the transverse direction regardless of the joint skew (Figure 11). This is in recognition of the direction of traffic being independent of the joint skew and the tire contact area occupying both the approach and leave slabs when travelling over the skewed joint.
- b. For 2D profile data, the representative longitudinal profile is simply the longitudinal profile collected by the HSIPs. It is noted that the 2D representative longitudinal profile may be subject to wander and increased level of noise, and thus lower precision.

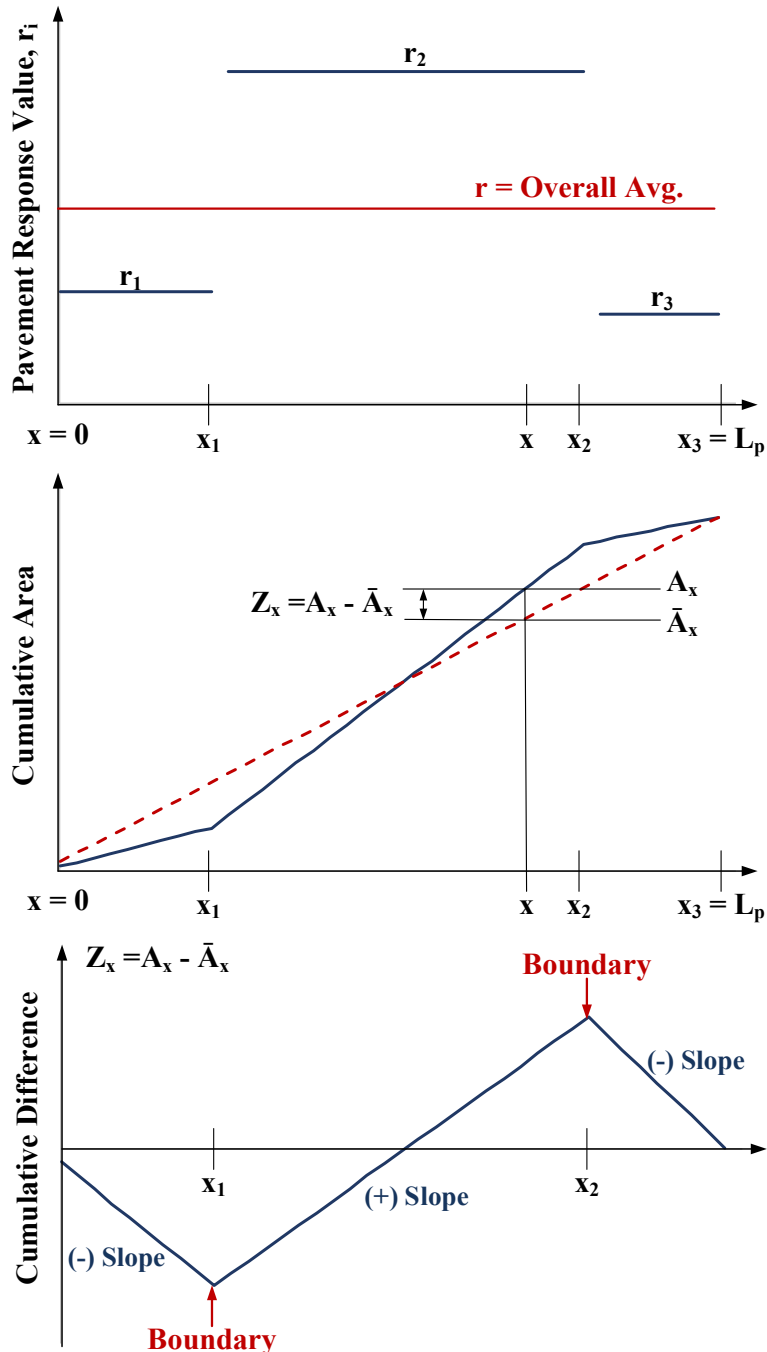
Figure 15 (middle) shows the plot of cumulative areas while Figure 15 (bottom) shows the cumulative difference plot. The original CDA method identifies the section boundaries as the locations where the slope of the cumulative difference (Z_x) changes algebraic signs (from positive slope to negative slope, or vice versa).

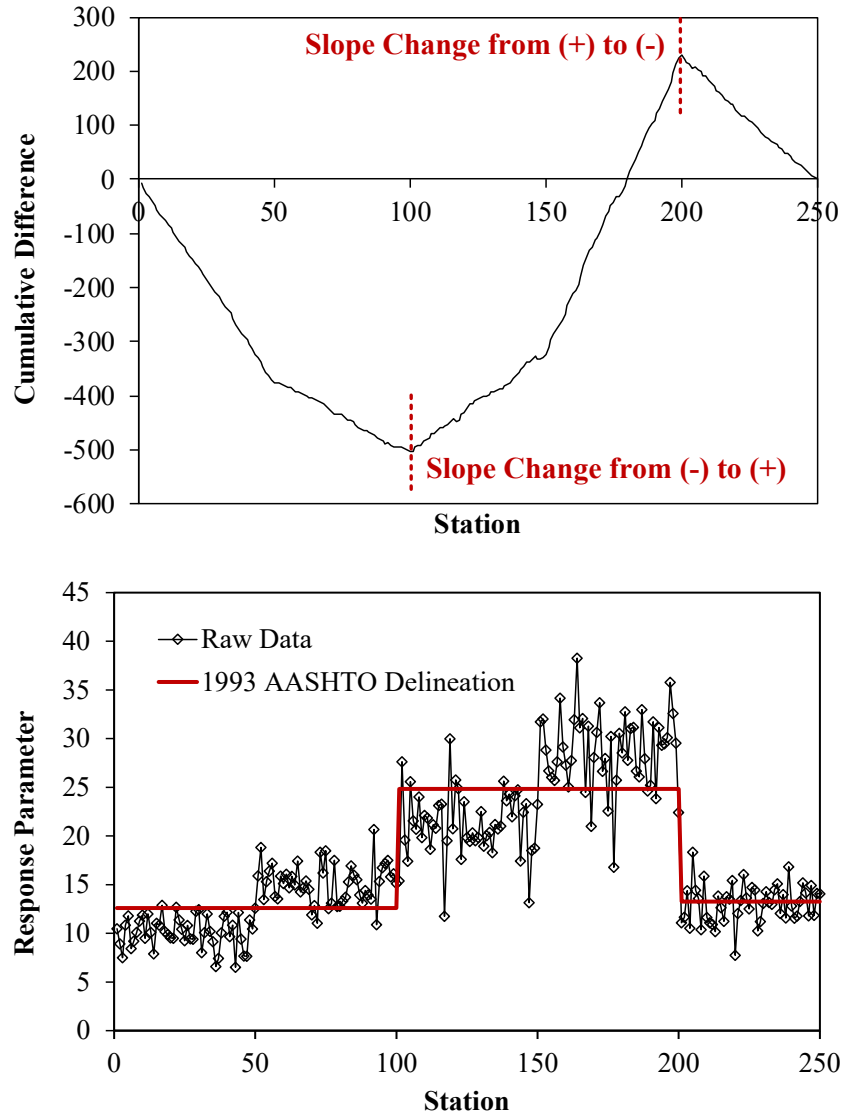
Figure 17. Charts. (a) Cumulative difference plot and (b) delineated uniform pavement sections using the original CDA method.

It is seen from Figure 17 (top) that although the cumulative difference did not change its arithmetic sign, its slope has changed at the boundaries between sections 1 and 2, and sections 3 and 4. To overcome such limitation of the original CDA method, Haider and Varma (2015) developed the Enhanced Cumulative Difference Approach (ECDA) which is capable of identifying the boundaries based on the changes in slope of the cumulative difference. Figure 18 (top) shows the cumulative difference plot and the boundaries identified from ECDA while Figure 18 (bottom) shows the means obtained from the delineated sections that are in agreement with the true values shown in Table 3.

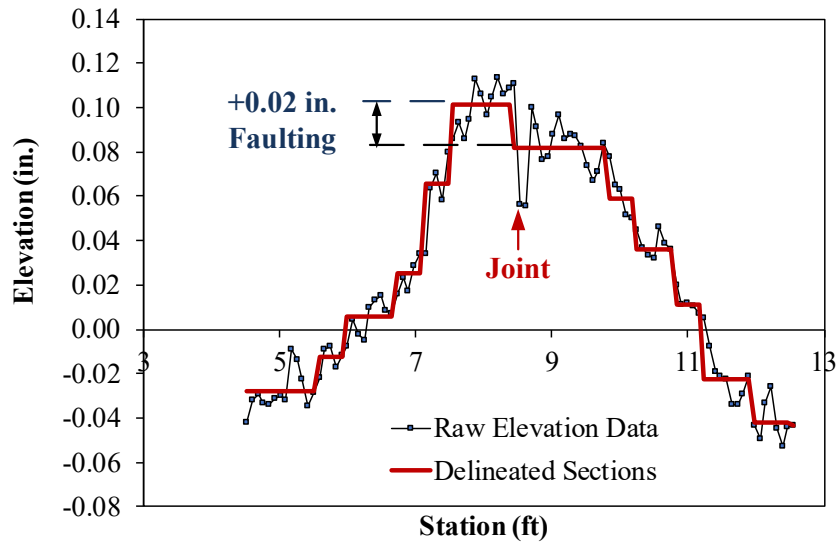
Figure 19. Chart. Option 1 Faulting calculation. LTPP Section 04-0215. Joint at Station 8.5 ft.

To demonstrate the use of ECDA for faulting calculation, a couple of pavement profiles were extracted from LTPP database. The first profile was collected in 2002 from section 04-0215 in Arizona. This section primarily showed upward curling of the slabs but no major spalling at the joints. The other profile was collected in 1999 from section 27-4040 in Minnesota. All the slabs in this section showed downward curling. In addition, approximately 5 to 10 percent of the joints suffered severe joint spalling and few joints showed severe faulting.

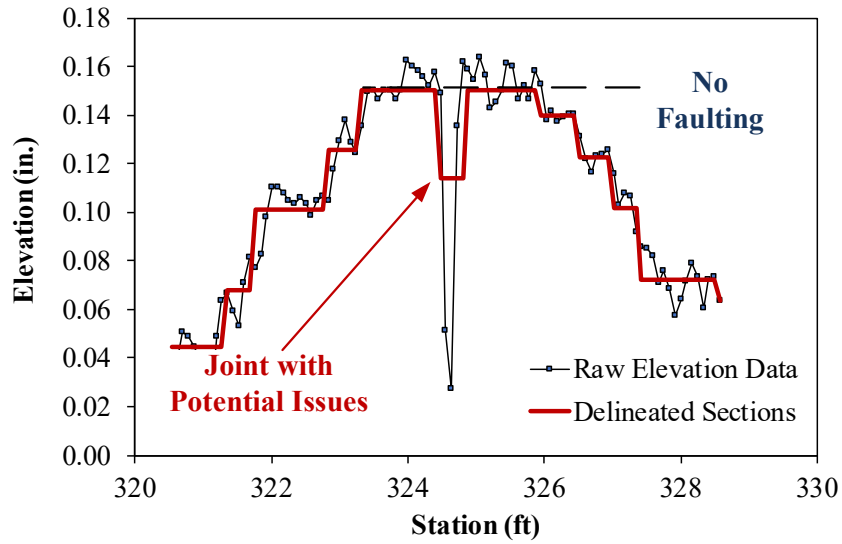
Figure 20. Chart. Option 1 Faulting calculation. LTPP Section 04-0215. Joint at Station 324.6 ft.

On the other hand, Figure 20 shows that the ECDA method delineated the joint location as a separate segment, i.e., the joint is wide enough and its elevation is deep enough to be separated from the slab elevations. It is hypothesized that this may be an indication of other joint issues such as spalling and/or wide joint opening. If this joint elevation is excluded from the analysis, no faulting is observed from this joint based on average elevations before and after the joint. Figure 21 shows another situation where the joint may have other issues (spalling or wide opening) with minimal faulting (0.004 in.).

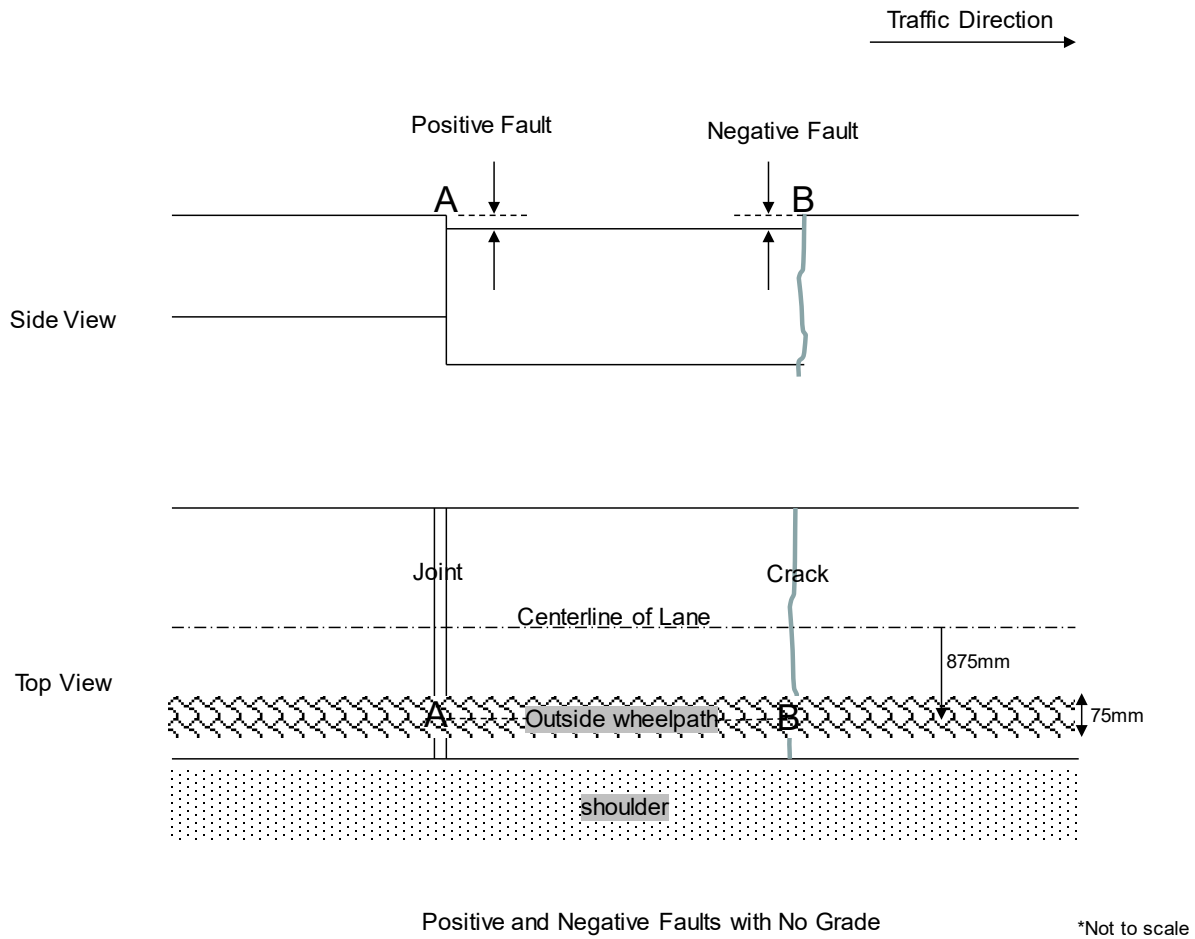
Figure 31. Illustration. Positive and negative faults with no grade.

the projected planes, between 0 in. to 9 in. offset from the center of a joint/crack in the traffic direction, are shown in Figure 31 to Figure 35.

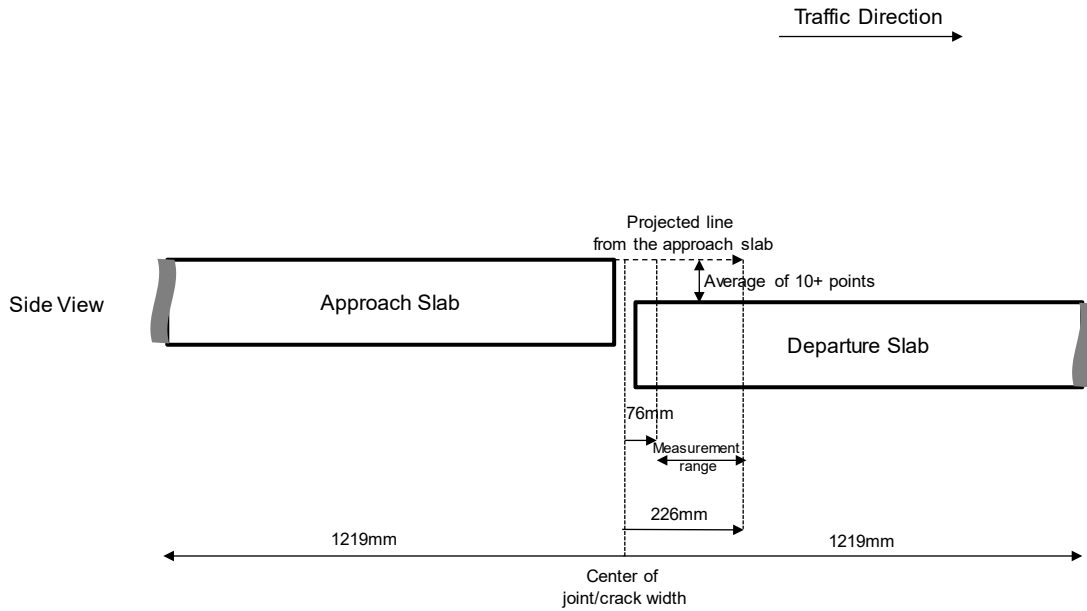
Figure 32. Illustration. Measurement of positive fault with no grade.

Measurement of Positive Fault with No Grade

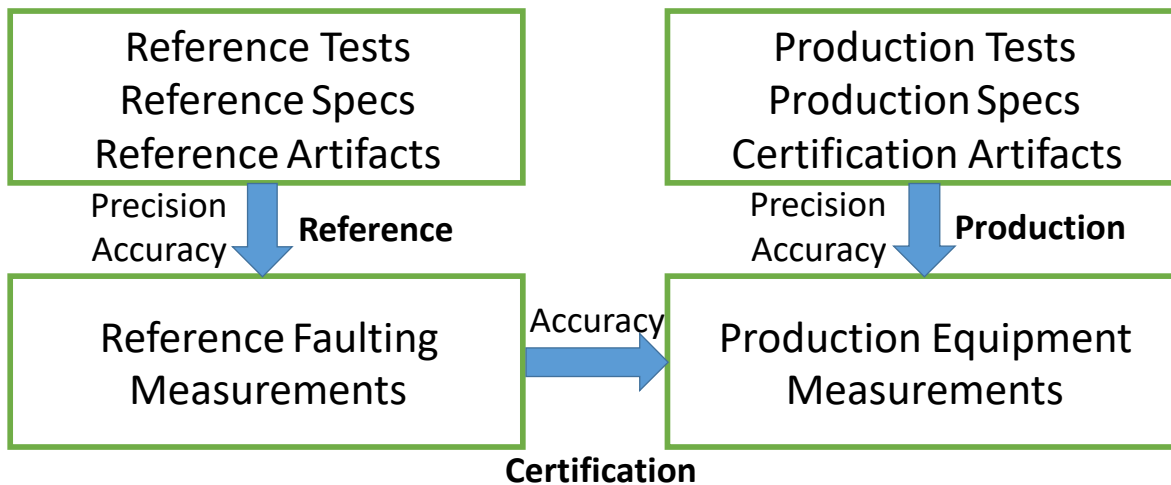
Figure 49 conceptually outlines the certification procedure for faulting. Similar to the certification process developed under TPF-5(299) for TPP, the fundamental concept behind the faulting certification is to ensure that the production devices can produce the required data for reasonable and realistic faulting results (within the specified accuracy level) when compared to those from a more advanced (i.e., higher accuracy and precision) reference measurement.

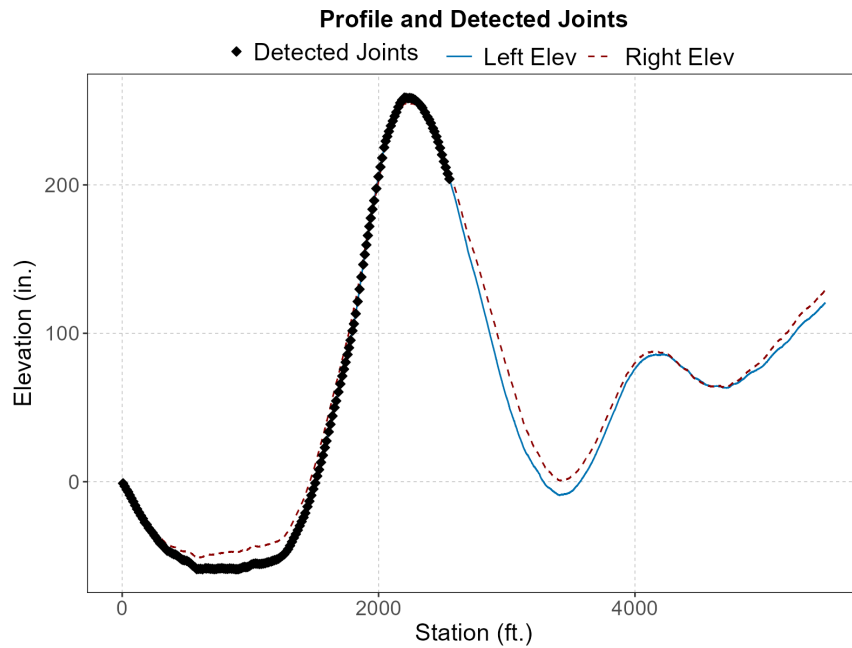
Figure 63 shows the joints detected using the Downward Spike Method implemented by the research team during Phase I. Although a lot of joints were detected along the first 2,500 ft. of the profile, this method was not capable of detecting the joints for the full length of the profile. Furthermore, it is also possible that the detected joints may include a lot of false alarms.

One of the issues seen from Figure 62 and Figure 63, is the long wavelength content included in the pavement profiles. As such, the pavement profile was processed through a high-pass filter using a base filter length of 300 ft. (i.e., the long wavelength content was removed). Figure 64 shows the filtered pavement profile, along with the joints detected using the Downward Spike Method.

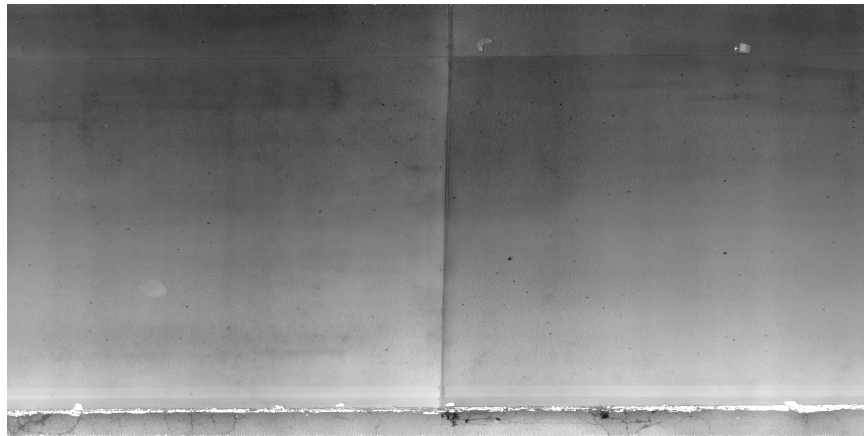
Figure 70. Image. Sample 3D elevation image.

Due to the limitations of the downward spike method in detecting the joints from the 3D representative profiles, a new method for joint detection has been developed and proposed herein. To demonstrate the new methodology for joint detection, the csv files provided by the agency were used to generate 3D elevation images of the pavement surface. An example of the 3D image is shown in Figure 70.

of the detected by the algorithm from the input image shown in Figure 70. The edges of the joint are visible in the figure, along the center of the figure. However, the figure also shows many small and random edges detected from the pavement surface, likely due to the surface texture of the rigid pavement slabs.
