# **Inverted Pavements Synthesis**

**FHWA-HIF-24-023**

**February 2024**

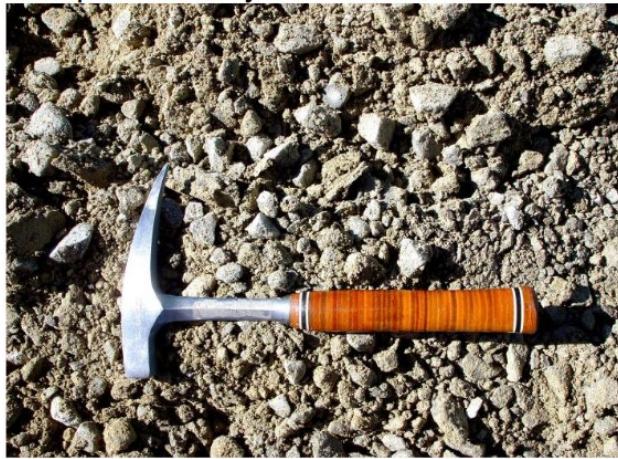
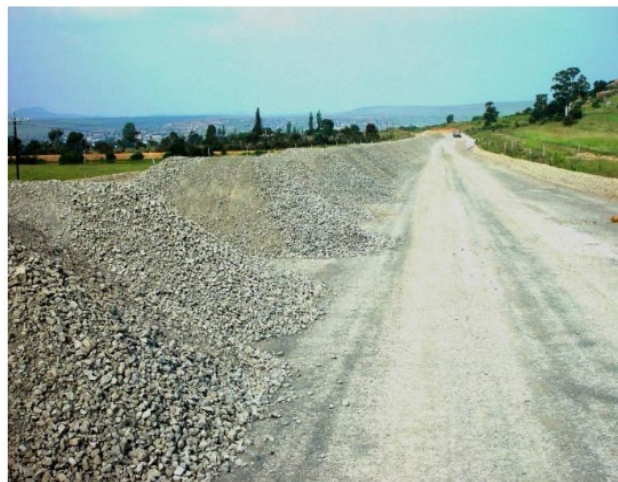
**Figure 5. Photo. G1 base course material (Kleyn 2012).**

Figure 5 shows the high-quality G1 base course material provided from a crusher onto a prepared site without the danger of being contaminated/degraded and stockpiled directly along the road (Kleyn 2012). Varying truck sizes, which may cause variations in dump spacing and material movement, should be avoided to control potential aggregate segregation and layer thickness variation. Spreading of damp material on the day of construction is done with a motor grader by gently moving successive, fully laden blade-sized loads off the stockpiles to the subbase across the full width of the available cement-stabilized subbase. The layer should be shaped, excess material should be removed, and all layer corrections should be done just prior to compaction. The aggregate should be watered while fines are well distributed to ensure proper material placement and compaction and achieve optimum moisture content (OMC).

A. Loose G1 unbound aggregate base course material.

B. G1 material stockpiled along the road.

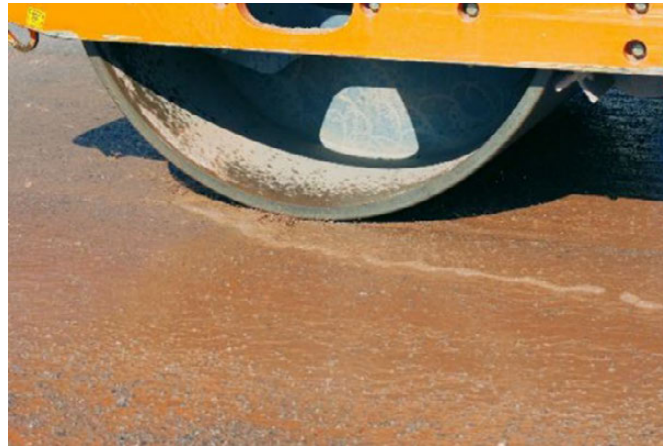
A. Excess fines being expelled as slush from layer.

B. Brooming and spreading initial slush/fines to deficient areas.

The second phase of compaction involves consolidating the material under saturated conditions by expelling or “slushing” out the excess fines from the matrix, allowing the larger particles to interlock into a superdense matrix. According to Kleyn (2012), the slushing process is initiated by thoroughly wetting and rolling 131- to 197-ft (40 to 60 m) sections of the layer at a time with heavy static rollers (figure 7). The water should be applied at the highest points of the cross section or gradient and used as it runs down to the lower points. The fines (passing number 200 sieve, or less than 0.075 mm) expelled should be broomed to areas deficient in fines—and eventually off the road (figure 7).

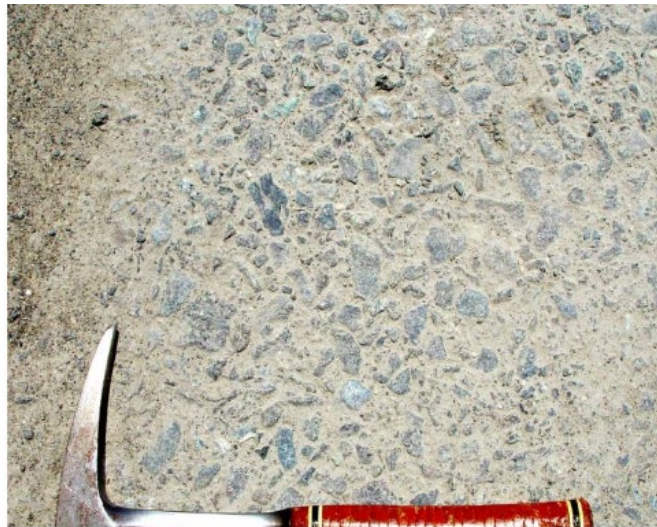
A. Slush compacted G1 layer at an HVS site.

Steyn and Kleyn (2016) recommended observing the following signs that suggest optimal interlock has been reached: (1) no air bubbles escaping during slushing, (2) expelled water clearing up substantially, (3) well-knit mosaic visible through surface water, (4) road surface does not heave under heavy roller, and (5) confirmation through an interlock and density acceptance control. The final mosaic surface should look like that shown in figure 8. According to Kleyn (2012), the particle interlock should result in an aggregate matrix that when tapped with a geological pick or similar object results in a “ringing” sound.

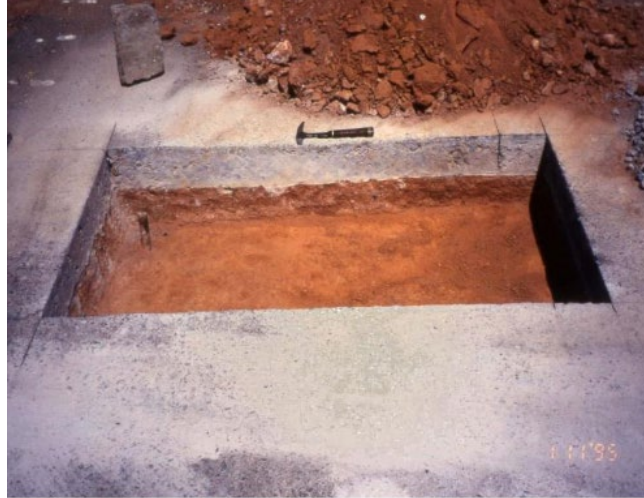
**Figure 8. Photo. Final mosaic surface (Kleyn 2012).**

B. Constructed G1 base layer cut like concrete.

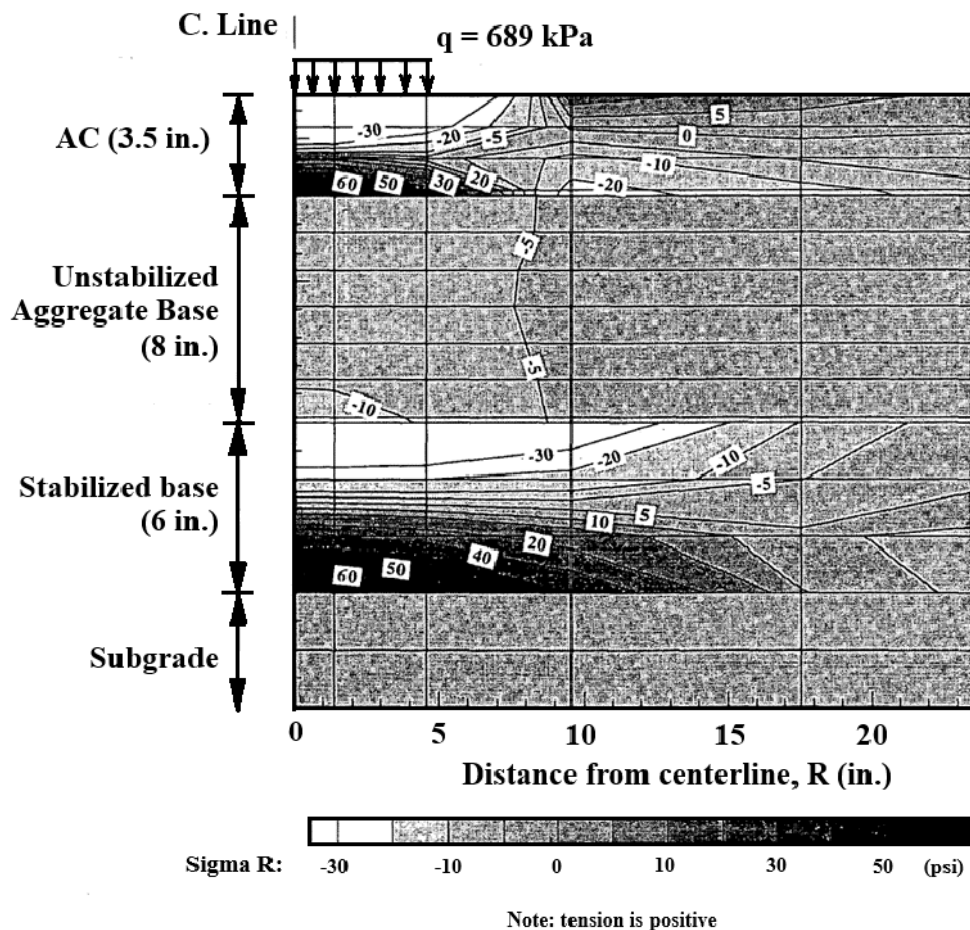
**Figure 12. Graph. Horizontal compressive stresses predicted in unbound aggregate base of the inverted pavement section with crushed stone cement-stabilized subbase (Tutumluur and Barksdale 1995).**

- From sensitivity analyses conducted using the GT-PAVE FE tool, it was noted that an optimal and economical IP section constructed over a weak subgrade would consist of a 6-inches-thick (150 mm) unstabilized aggregate base, and a 6-to 8-inches-thick (150 to 200 mm) cement-stabilized subbase.

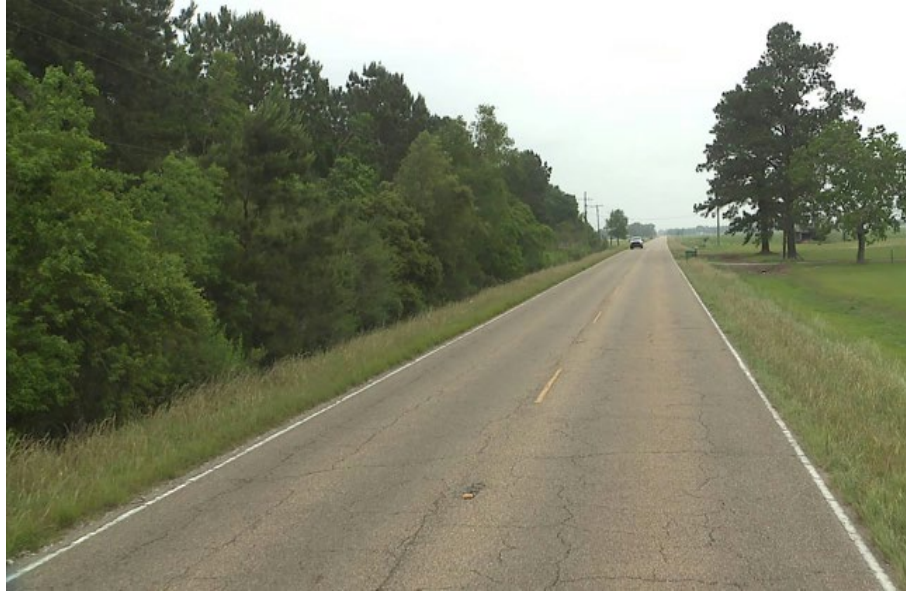
**Figure 14. Photo. Reflective shrinkage cracks in the form of block cracking on LA-97 (LaDOTD).**

Thousands of miles of highway pavements with soil-cement bases have been installed in Louisiana, some of which have been in service for more than 40 years (Titi et al. 2003). However, the use of soil-cement bases with a high percentage (typically 10 percent) of cement causes shrinkage cracking in the base, which reflects into the AC layers and forms block cracking that significantly affects pavement performance (figure 14).

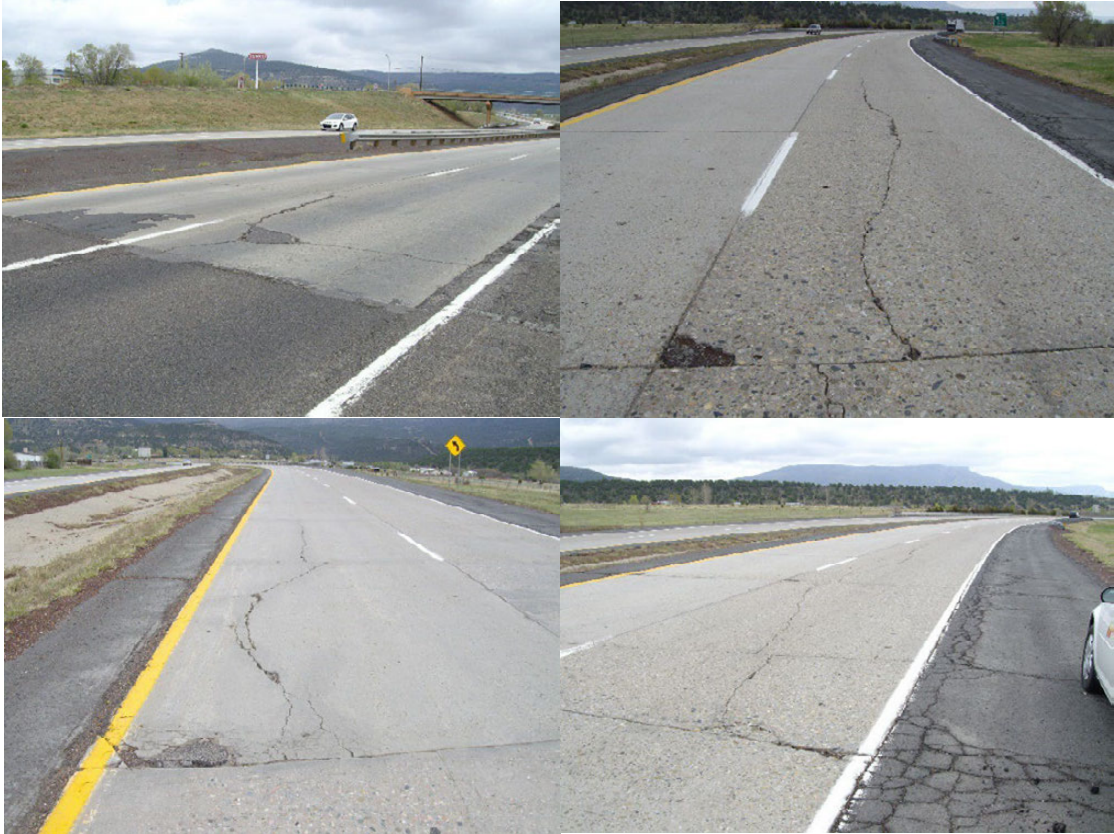
**Figure 21. Photo. Previous concrete pavement, I-25, Colfax County, New Mexico (credit: New Mexico DOT).**

The existing pavement prior to construction of these sections consisted of two 12-foot (3.7 m) portland cement concrete pavement lanes with 8-foot (2.4 m) AC shoulders. The composition of the previously existing concrete pavement is summarized in table 7. Figure 21 includes photos showing the condition of the previous pavement.

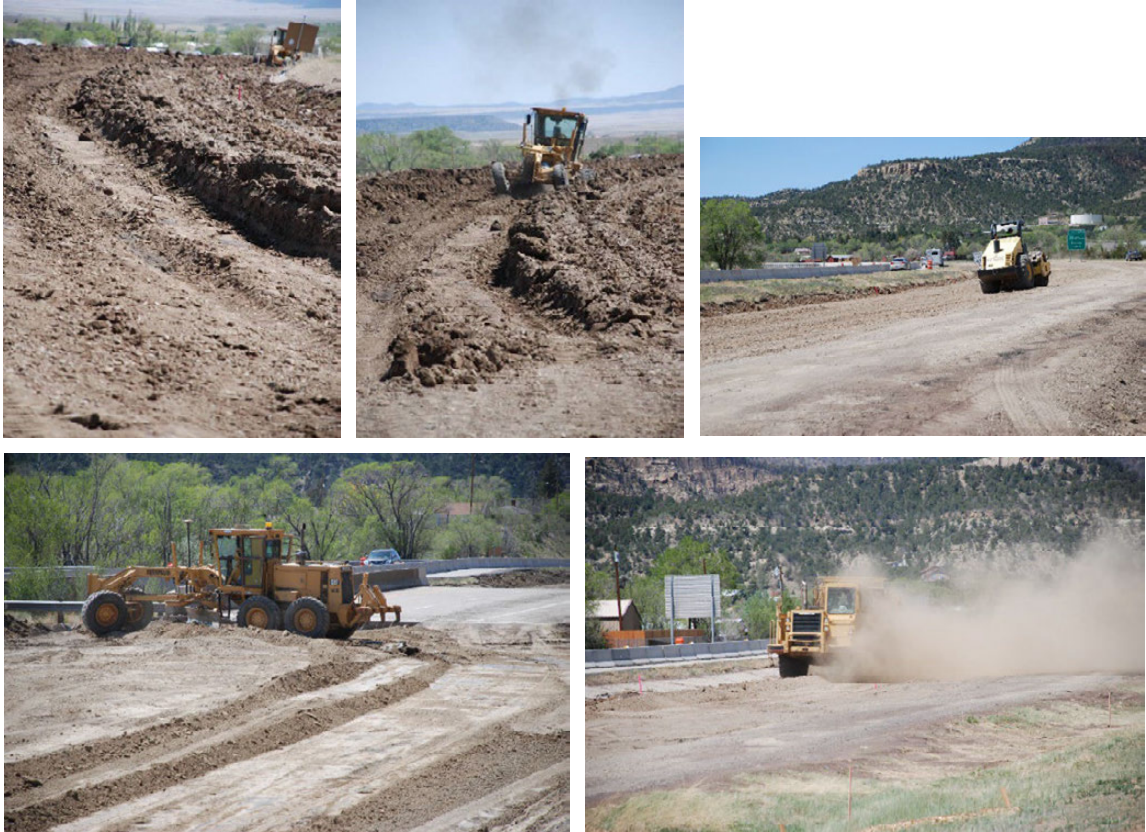
**Figure 22. Photo. Subgrade preparation at I-25, Colfax County, New Mexico (credit: Bryce Simons).**

The initial plan was to reutilize the existing pavement by pulverizing and treating the existing subbase to turn it into a new CTB. However, to minimize risks, NMDOT decided to remove the existing pavement, stabilize the subgrade with lime, and construct the CTB layer with new materials. Figure 22 shows the subgrade preparation.

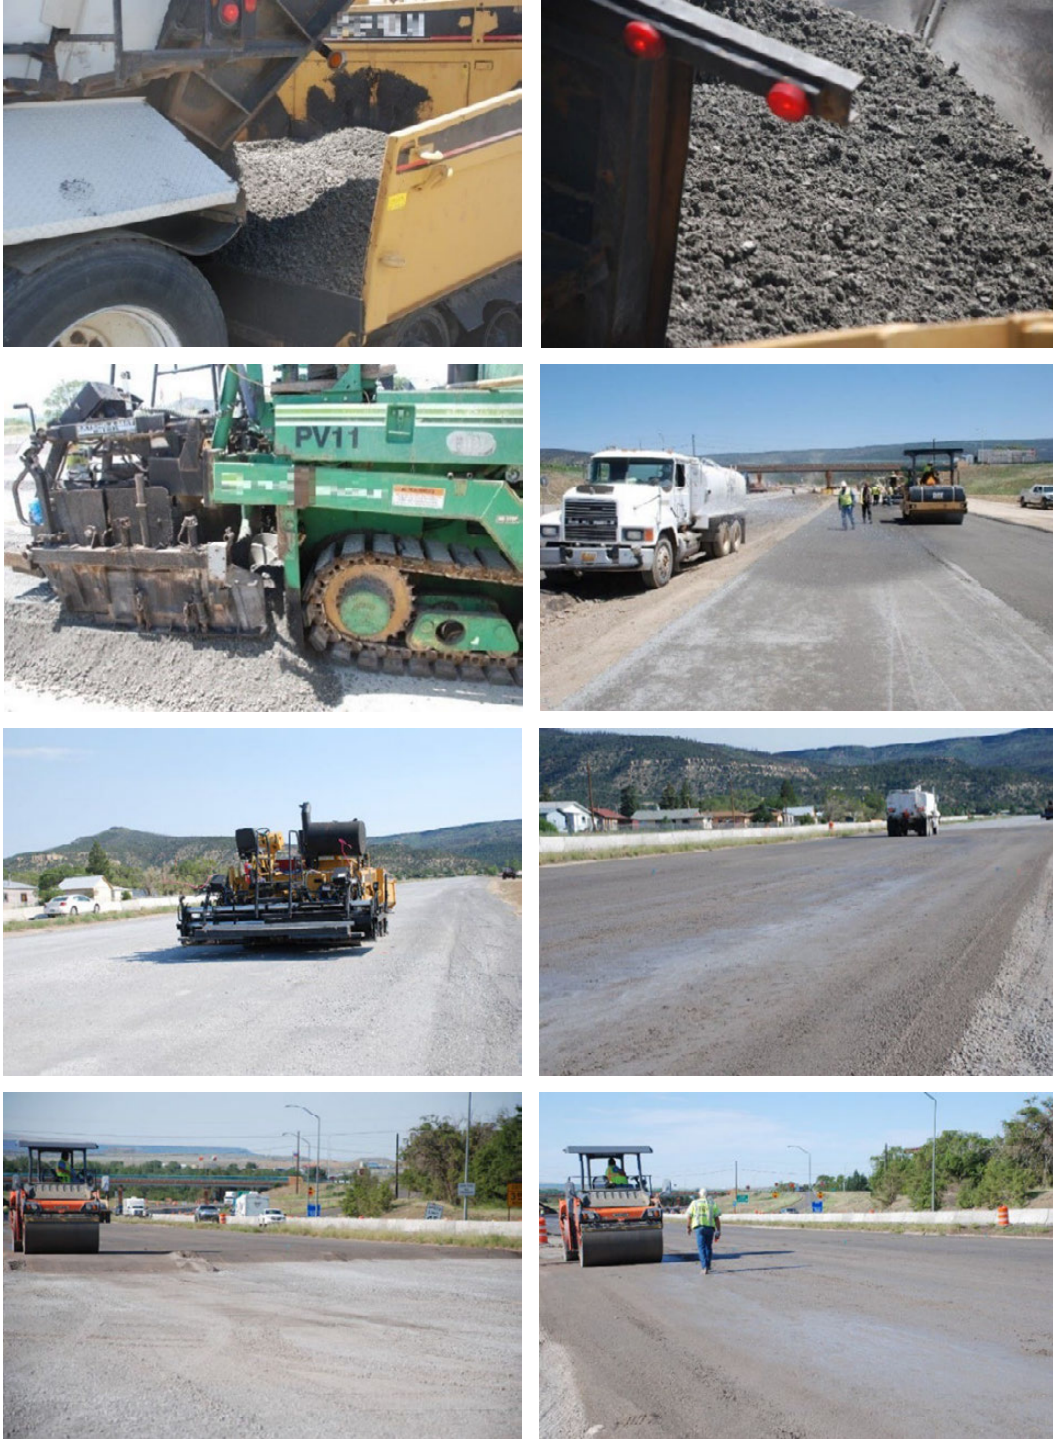
**Figure 23. Photo. Cement-treated base construction; I-25, Colfax County, New Mexico (credit: Bryce Simons).**

The CTB layer incorporated Type III cement without fly ash and was constructed in one single lift (Simons 2016). Figure 23 shows the CTB construction, the required CTB minimum compressive strength measured at 28 days was between 850 and 1,000 psi (5.9 to 3.9 MPa). According to documentation provided by NMDOT, a 5.0 percent cement content was recommended for an anticipated compressive strength of 904 psi (6.2 MPa). Construction records provided by NMDOT indicate that an average cement content of 4.85 percent was used. The project contract specified that the CTB be placed in one lift and kept moist for a curing period of no fewer than five days. The CTB was required to achieve a minimum of 97 percent of maximum density as determined by AASHTO T 180. Achieved field compactions on the SB and NB pavements are summarized in figure 24. Higher values were generally achieved in the SB section, with an average of 102.4 percent of maximum dry density (MDD), whereas the NB pavement achieved an average compaction value of 99.1 percent of MDD. It is possible that the lower compaction levels in the NB pavement were related to the thicker CTB layer (10 inches [250 mm], as opposed to 8 inches [200 mm] for the SB pavement).

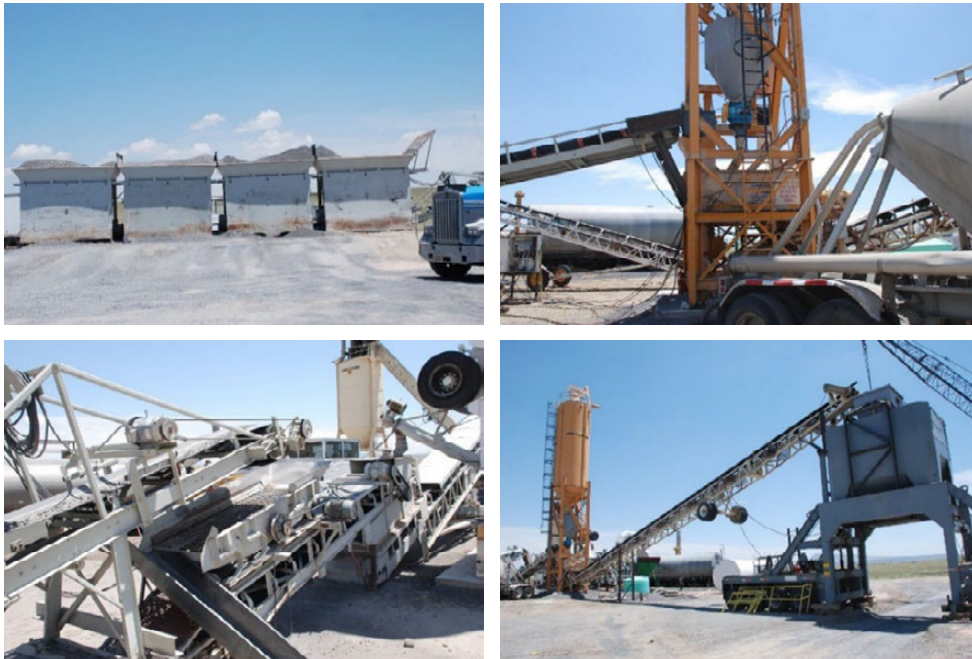
**Figure 26. Photo. Granular base course batch plant for I-25, Colfax County, New Mexico (credit: Bryce Simons).**

The NB unbound granular base course consisted of a well-graded material with no gaps. Multiple stockpiles were used to allow for a uniform consistent gradation. The individual stockpiles were managed to prevent segregation, with the materials mixed to provide the required gradation and then loaded into trucks (Simons 2016). Figure 25 shows the granular base course production, and figure 26 shows the batch plant.

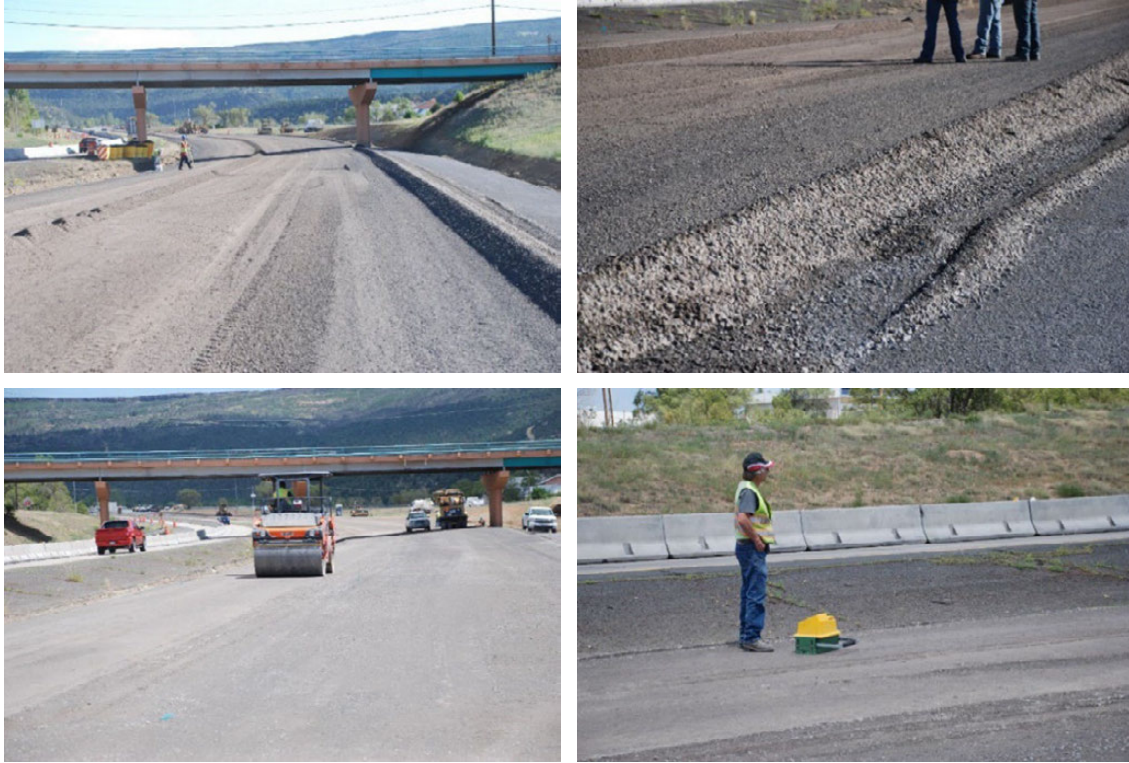
**Figure 28. Photo. Granular base course construction at I-25, Colfax County, New Mexico (credit: Bryce Simons).**

The South African slushing technique was adopted to finalize the NB granular base course (Simons 2016). The base course was saturated and rolled with static vibratory rollers, steel-wheeled rollers, and pneumatic-tired rollers to expel the excess fines and form a dense, interlocked matrix. Figure 28 shows the granular base course construction, and figure 29 shows the slushing technique being applied. Contract specification requirements included the following details for when the base course would be considered sufficiently slushed: (1) air bubbles would no longer appear behind roller wheels; (2) no more movement of the layer under the roller wheels, pneumatic-tired rollers leave no more indentations on the surface, and no more fines are extracted; (3) expelled water loses its coloration and becomes clear; and (4) no final material on the surface with the base course, showing a firmly interlocked mosaic. The length of each slushing operation was specified at a maximum of 600 ft. (183 m), with the exact length depending on equipment and worker availability.

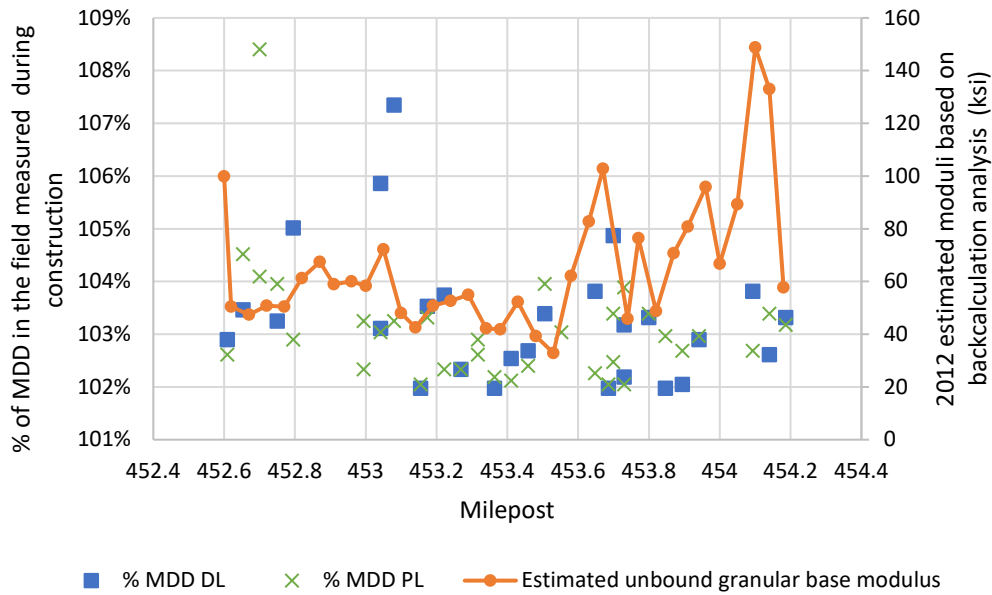
**Figure 30. Graph. Compaction levels and 2012 backcalculated moduli in the inverted pavement unbound granular base course; I-25, New Mexico (based on data provided by New Mexico DOT).**

Field construction test data indicated that the required compaction level (102 percent of MDD) was achieved throughout the project, with an average of 103.2 percent and a standard deviation of 1.2 percent. Field moisture conditions of the unbound granular base course layer during construction in the IP varied from about 20 to 80 percent of OMC, with an average of 53.1 percent and a standard deviation of 16.4 percent. Figure 30 shows the variation in the achieved NB unbound granular base's relative compaction and its 2012 backcalculated moduli.

Figure 31 presents the variation in field moisture conditions measured during construction and the same backcalculated moduli. Although figure 30 does not show any clear trend regarding variation in compaction levels with backcalculated moduli, it is possible to observe from figure 31 that lower backcalculated moduli generally corresponded to locations where moisture content as measured during construction was higher. In other words, the plot generally indicates that higher moisture conditions in the unbound granular base lead to lower moduli.

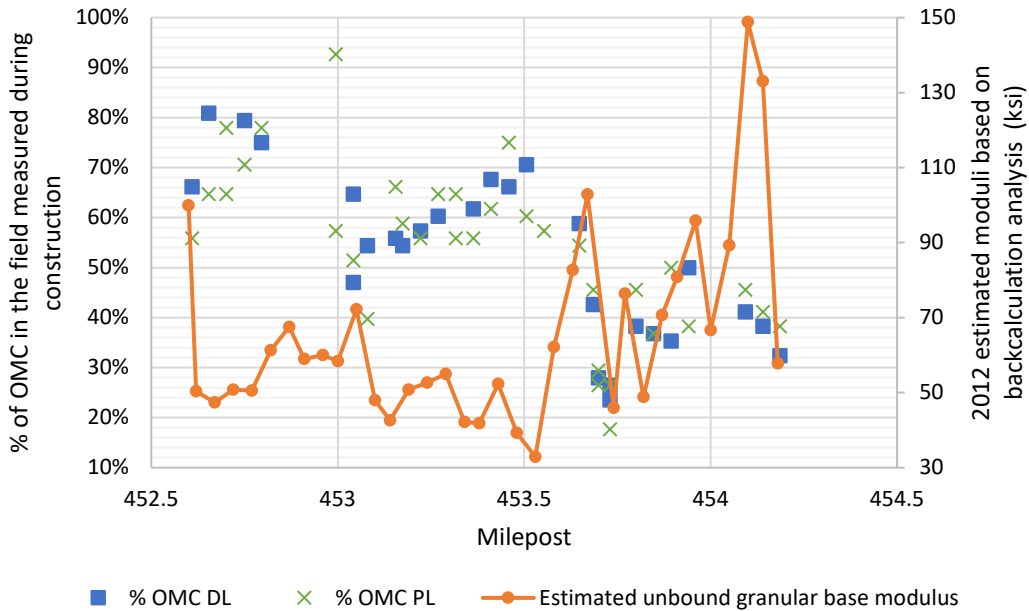
**Figure 31. Graph. Moisture levels and 2012 backcalculated moduli in the inverted Pavement unbound granular base course; I-25, New Mexico (based on data provided by New Mexico DOT).**

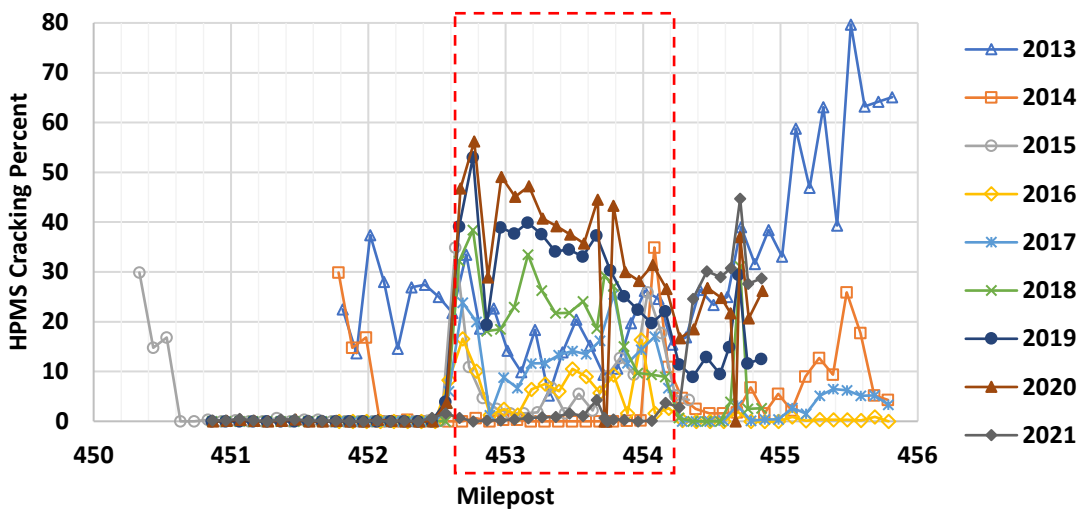
B. Northbound; inverted pavement.

Figure 37. Graph. Highway performance monitoring system cracking; I-25, Colfax County, New Mexico (based on data provided by New Mexico DOT).

Figure 34, figure 35, figure 36, figure 37, and figure 38 show, respectively, the pavement condition rating (PCR), roughness index, rutting index, highway performance monitoring system (HPMS) cracking, and international roughness index (IRI) for the SB CP section and the NB IP sections from 2013 through 2021. The project section (MP 452.606 to 454.199) is the area marked with the red rectangle. Data for other mileposts were included to show the performance of the pavement before and after the project. The pavement south of the project (from approximately MP 448 to 452.606) is believed to be comprised of 6 inches (150 mm) CTB, 8.5 inches (215 mm) of AC (SP-III), and 3.5 inches (90 mm) of AC (SP-III), with the last maintenance activity comprising a 3.5-inches (90 mm) stone matrix asphalt (SMA) mill and inlay completed in 2015. The pavement north of the project (MP 454.199 to 455.214) is believed to be a 4-inches (150 mm) CTB, a 4-inches (100 mm) untreated base course, a 6-inches (150 mm) AC, and a 2.5-inches (38 mm) AC (SP-III), with the last maintenance activity comprising a 5.5-inches (140 mm) overlay completed in 2007.

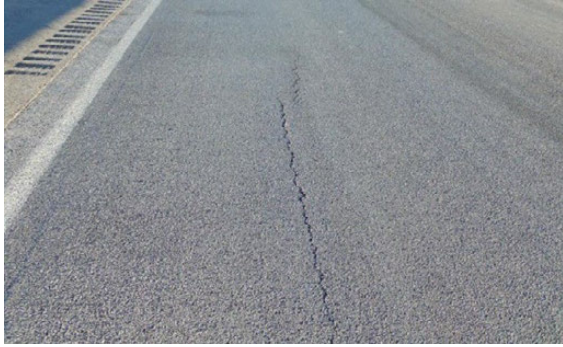
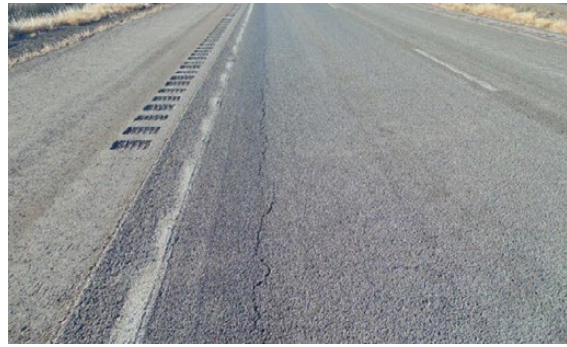
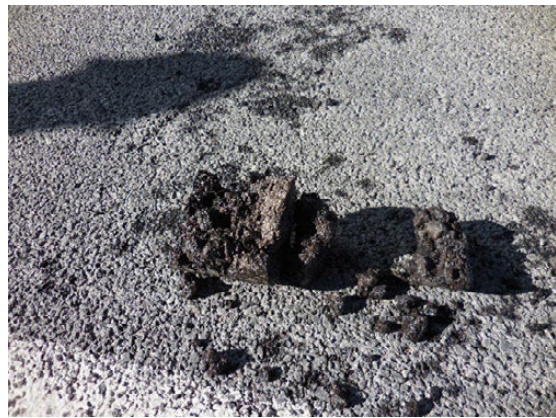
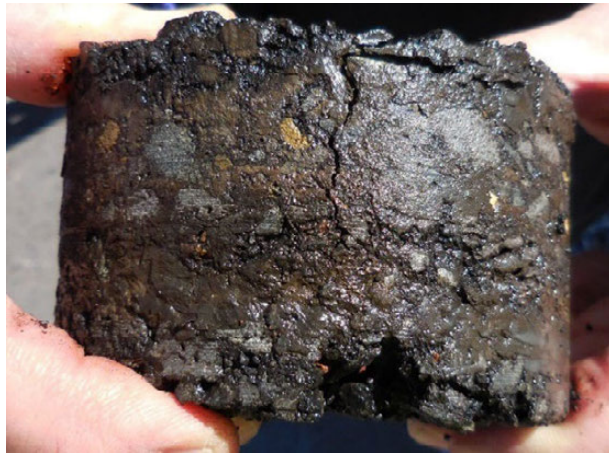
**Figure 40. Photo. (2015 photos) I-25 northbound inverted pavement, Colfax County, New Mexico (photos provided by New Mexico DOT).**

Figure 40 includes photos of the NB IP taken in 2015, showing longitudinal cracks outside and within the wheel path, as well as a core indicating AC stripping (figure 40(d)) and a core indicating top-down cracking (figure 40(e)).

A. Longitudinal cracking outside wheel path.

B. Longitudinal cracking within wheel path.

D. Pavement core showing AC stripping.

E. AC core showing top-down cracking.

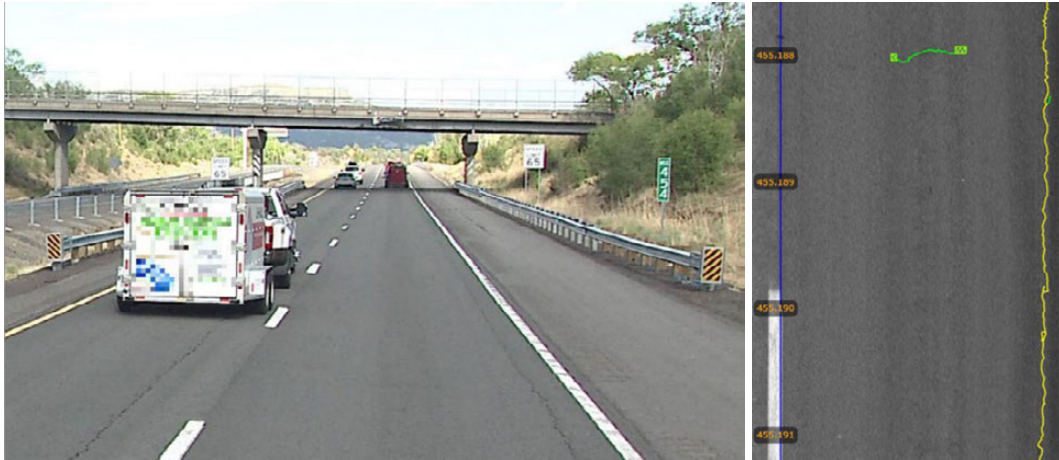
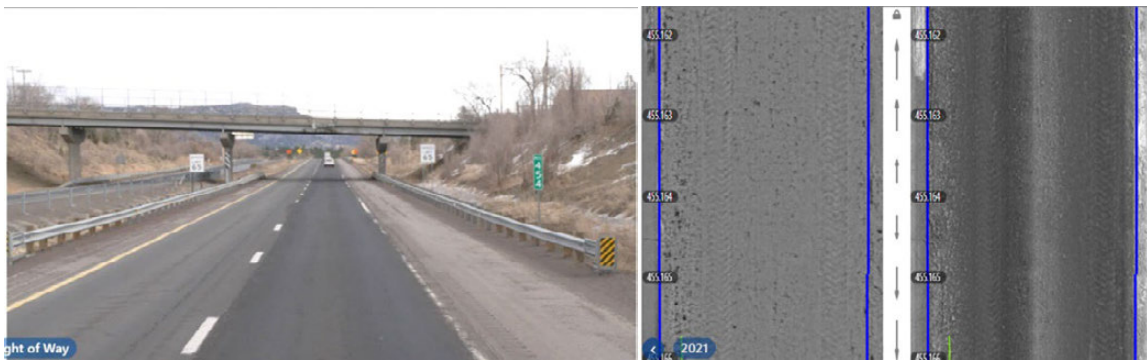
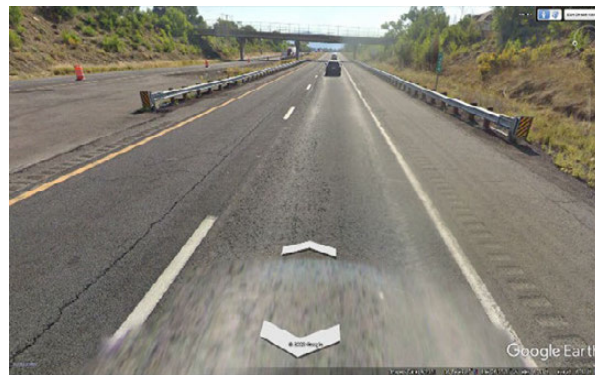
**Figure 41. Photo. Fugro and Google® Earth™ Street View images; MP 454.0, I-25 southbound control pavement, Colfax County, New Mexico (Fugro images provided by New Mexico DOT).**

Figure 41 through figure 46 are photos of the SB directions in 2020, prior to patch blading the DL, and in 2021, following patch blading. Figure 47 through figure 51 are photos of the NB

- Green indicates low cracking severity (approximately 1/4-inches [6.3 mm] or smaller cracks)
- Yellow indicates medium severity (generally 1/4- to 3/4-inches [6.35 to 19 mm] cracks)
- Red indicates high severity (3/4-inches [19 mm] and larger cracks or if pumping is present).
- (Note that the numbers on the right side images correspond to mile points rather than mile posts. The mile points on the NB direction are 1.163 miles [1.872 km] ahead of the mile posts and on the SB direction are 1.189 miles [1.913 km] ahead.)
- The bottom image at each location was taken from Google® Earth™. Images were collected in July and September 2021, after patch blading of the DLs. The condition of the left lanes is more visible from the Google Earth images.

A. 2020 Fugro images.

B. 2021 Fugro images: forward image on the left and downward image on the right.

C. 2021 Street View image.

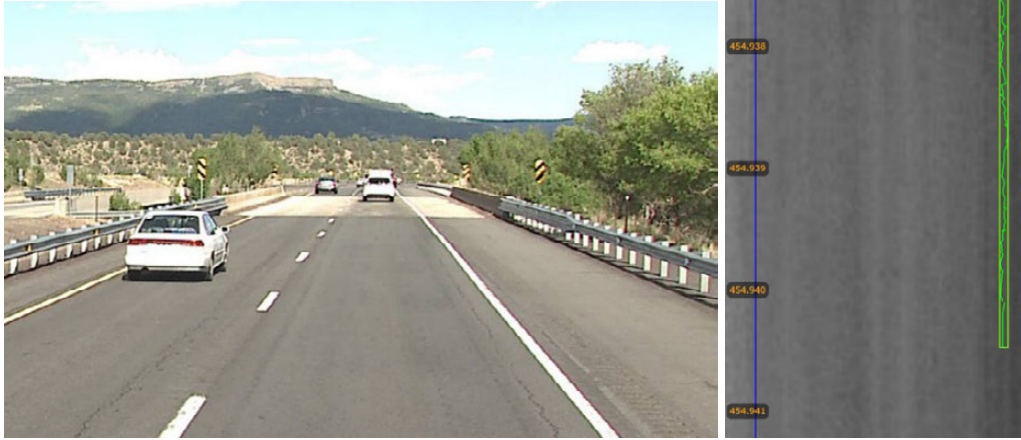
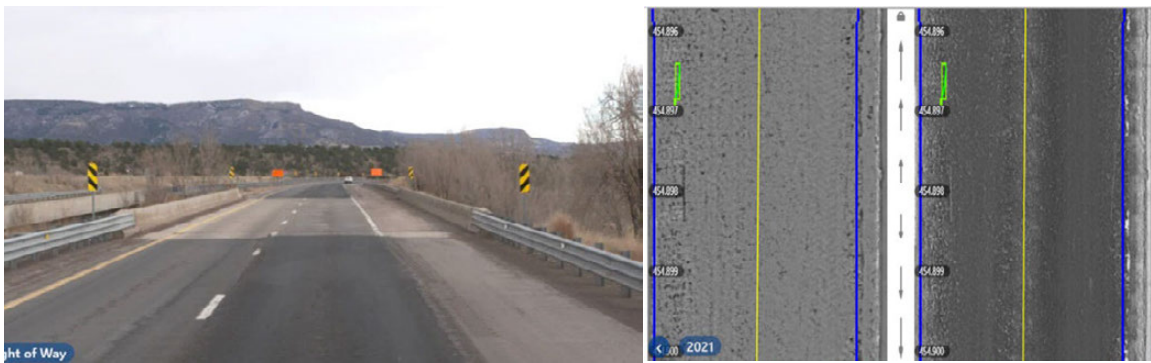
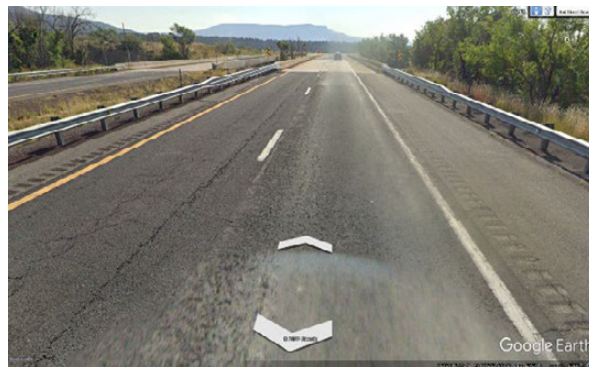
**Figure 42. Photo. Fugro and Google® Earth™ Street View images; MP 453.7, I-25 southbound control pavement, Colfax County, New Mexico (Fugro images provided by New Mexico DOT).**

A. 2020 Fugro images.

B. 2021 Fugro images: forward image on the left and downward image on the right.

C. 2021 Street View image.

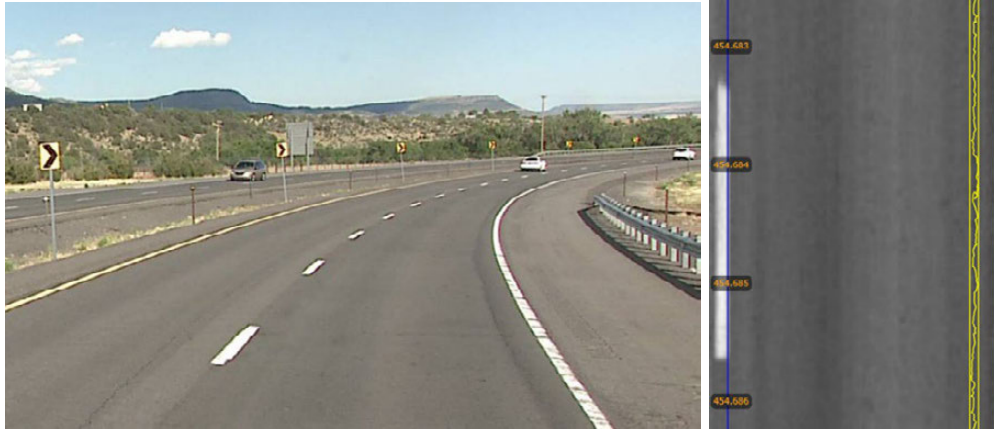
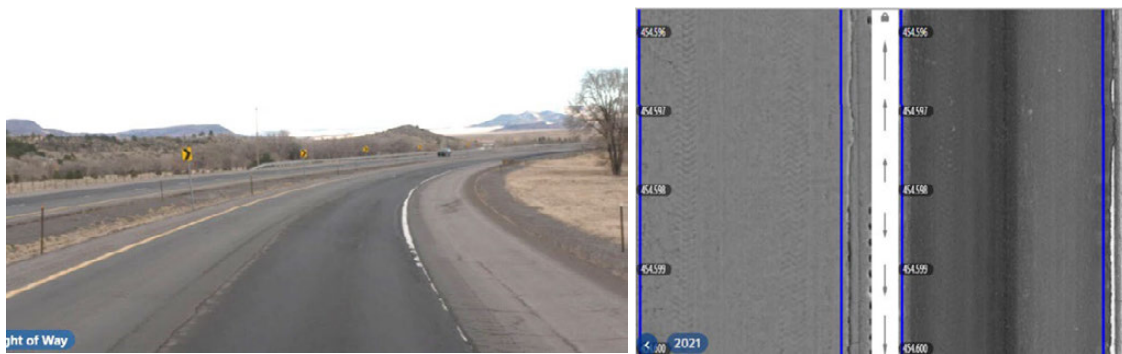
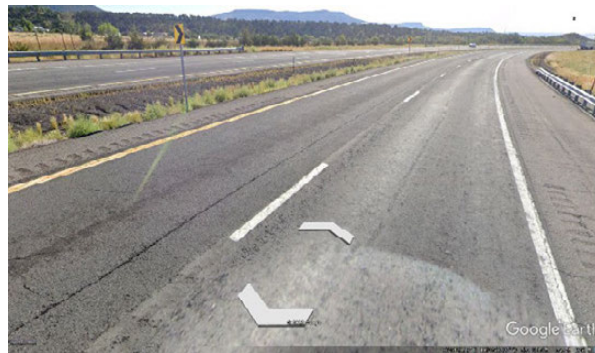
**Figure 43. Photo. Fugro and Google® Earth™ Street View images; MP 453.4–453.5, I-25 southbound control pavement, Colfax County, New Mexico (Fugro images provided by New Mexico DOT).**

A. 2020 Fugro images.

B. 2021 Fugro images: forward image on the left and downward image on the right.

C. 2021 Street View image.

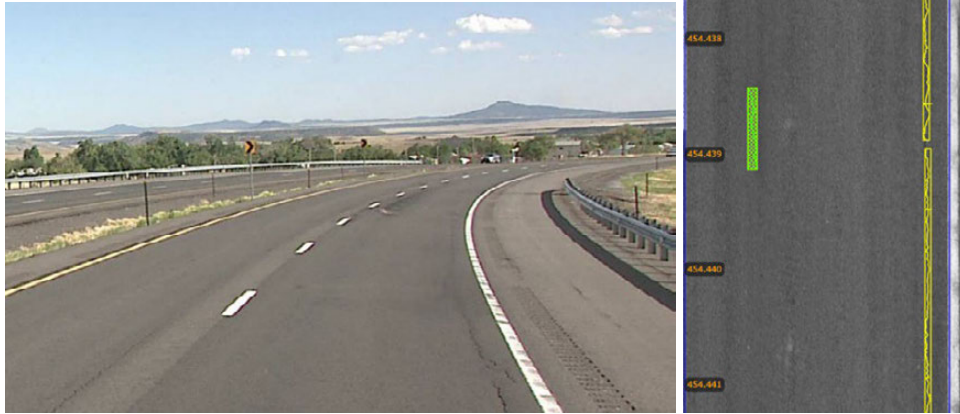
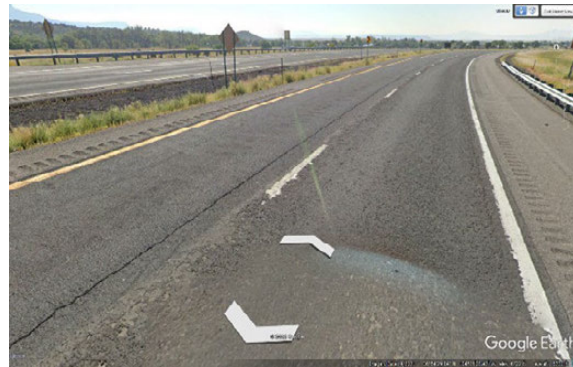
**Figure 44. Photo. Fugro and Google® Earth™ Street View images; MP 453.2–453.3. I-25 southbound control pavement, Colfax County, New Mexico (Fugro images provided by New Mexico DOT).**

A. 2020 Fugro images: forward image on the left and downward image on the right.

C. 2021 Street View image.

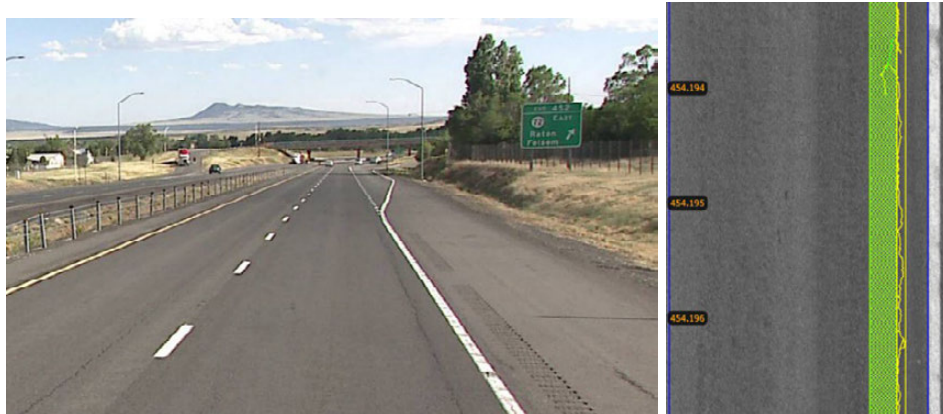
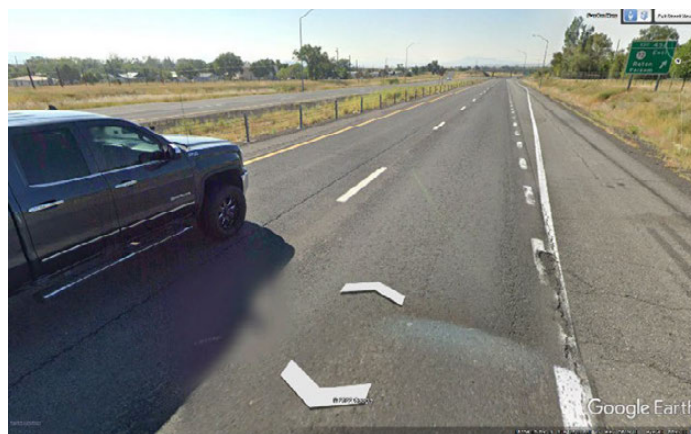
**Figure 45. Photo. Fugro and Google® Earth™ Street View images; MP 453.0, I-25 southbound control pavement, Colfax County, New Mexico (Fugro images provided by New Mexico DOT).**

A. 2020 Fugro images: forward image on the left and downward image on the right.

C. 2021 Street View image.

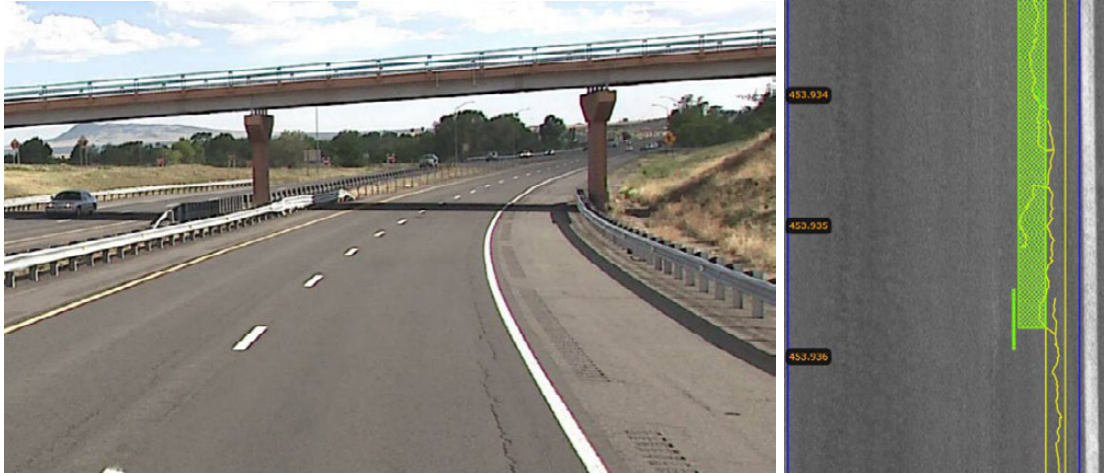
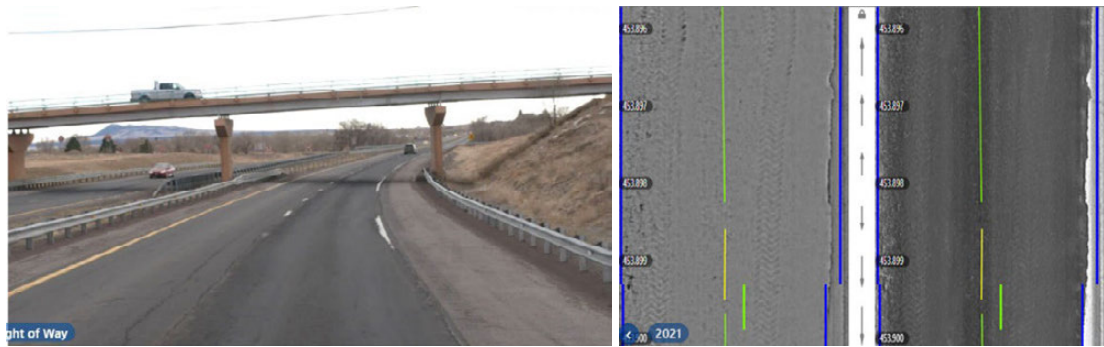
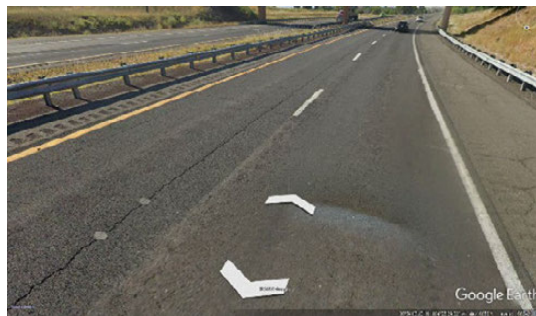
**Figure 46. Photo. Fugro and Google® Earth™ Street View images; MP 452.9, I-25 southbound control pavement, Colfax County, New Mexico (Fugro images provided by New Mexico DOT).**

A. 2020 Fugro images: forward image on the left and downward image on the right.

B. 2021 Fugro images: forward image on the left and downward image on the right.

C. 2021 Street View image.

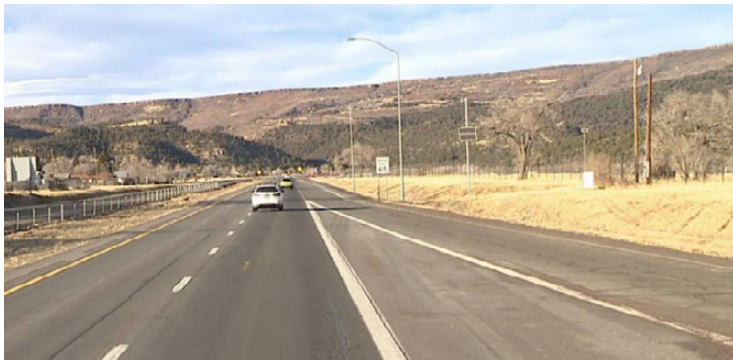
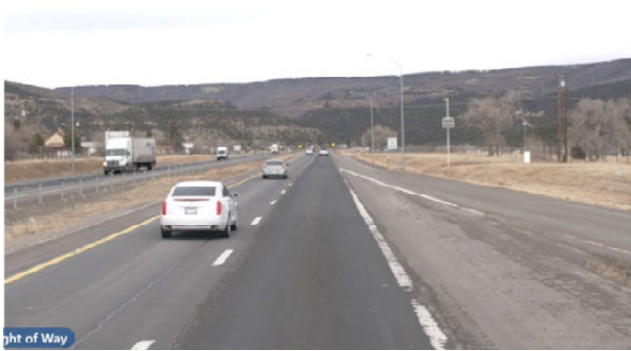
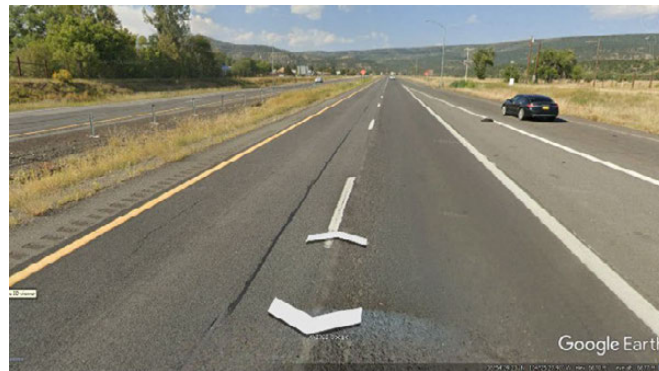
**Figure 47. Photo. Fugro and Google® Earth™ Street View images; MP 453.1, I-25 northbound inverted pavement, Colfax County, New Mexico (Fugro images provided by New Mexico DOT).**

A. 2020 Fugro images: forward image on the left and downward image on the right.

B. 2021 Fugro images: forward image on the left and downward image on the right.

C. 2021 Street View image.

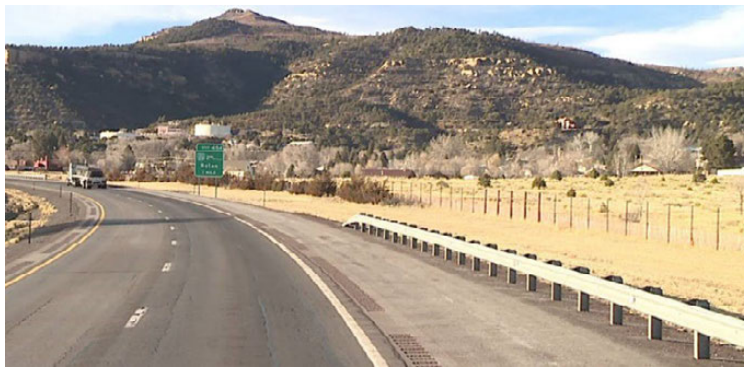
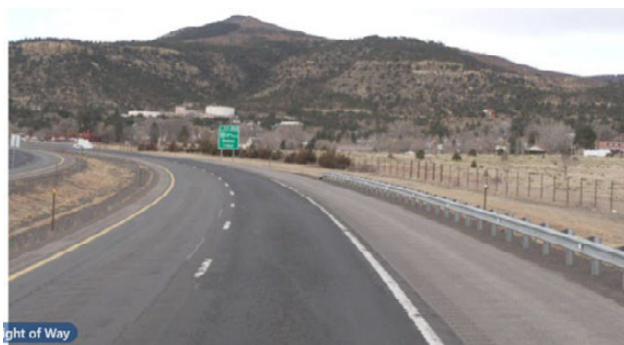
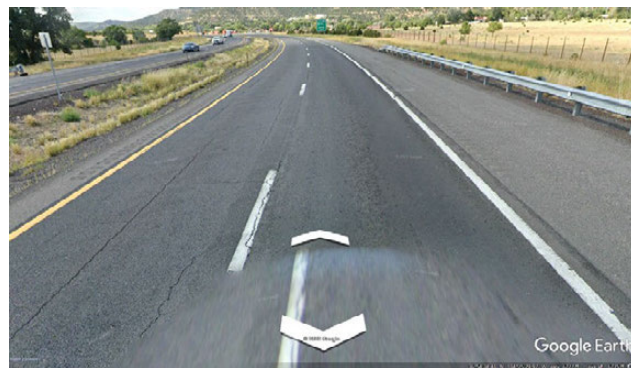
**Figure 48. Photo. Fugro and Google® Earth™ Street View images; MP 453.3, I-25 northbound inverted pavement, Colfax County, New Mexico (Fugro images provided by New Mexico DOT).**

A. 2020 Fugro images: forward image on the left and downward image on the right.

B. 2021 Fugro images: forward image on the left and downward image on the right.

C. 2021 Street View image.

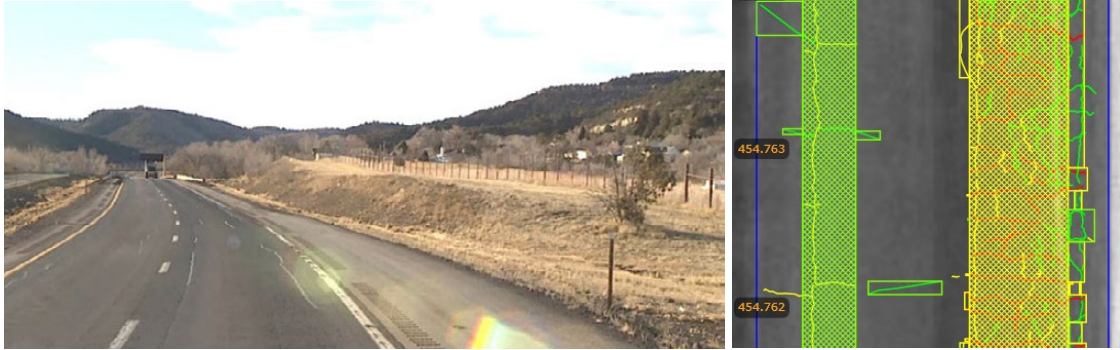
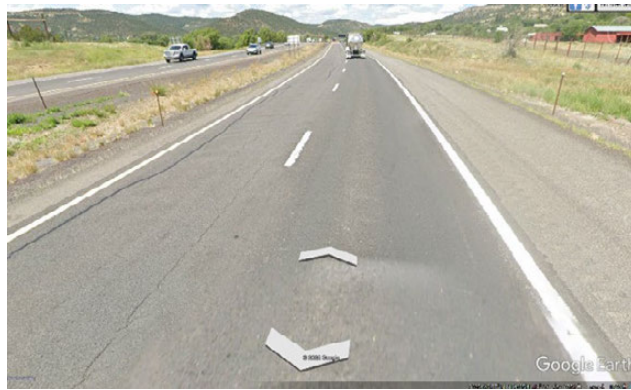
**Figure 49. Photo. Fugro and Google® Earth™ Street View images; MP 453.6, I-25 northbound inverted pavement, Colfax County, New Mexico (Fugro images provided by New Mexico DOT).**

A. 2020 Fugro images: forward image on the left and downward image on the right.

B. 2021 Street View image.

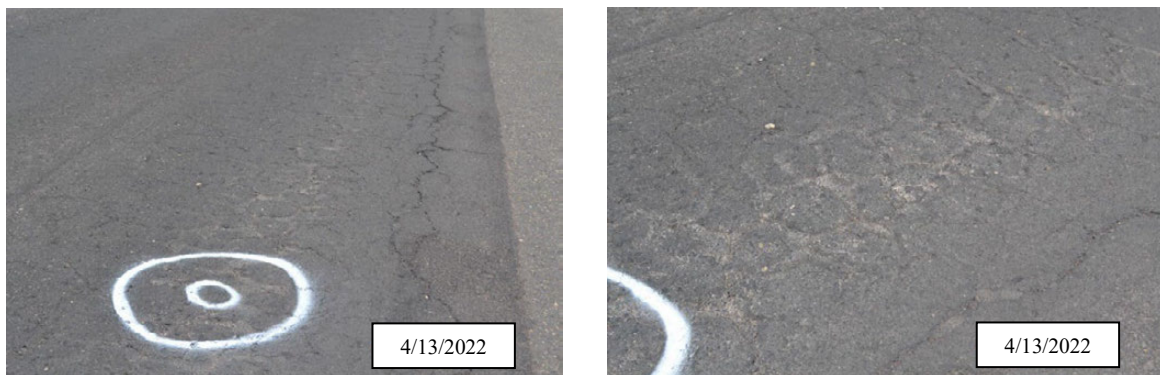
**Figure 65. Photo. Northbound inverted pavement section patched lane showing reflecting wheel path fatigue cracks; I-25, Colfax County, New Mexico.**
