# **Inverted Pavements Synthesis**

**FHWA-HIF-24-023**

**February 2024**

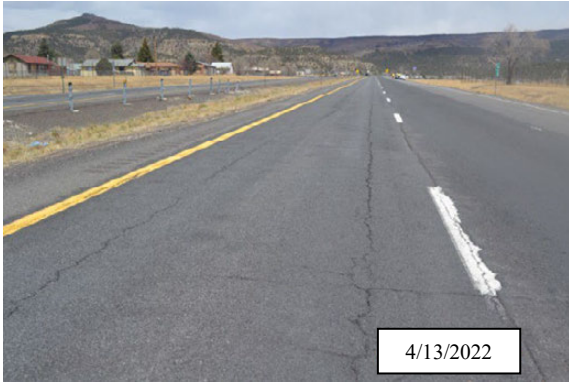
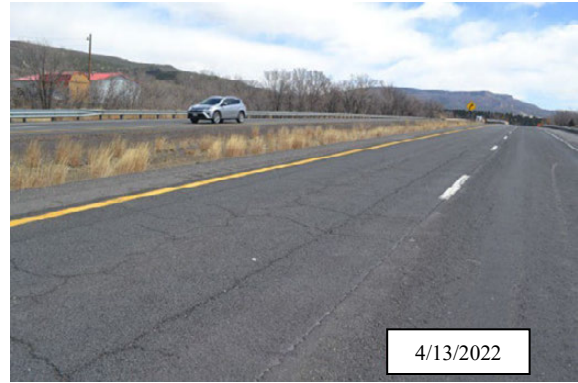
**Figure 66. Photo. Longitudinal construction joint cracking in the northbound (left) and southbound (right) lanes; I-25, Colfax County, New Mexico.**

The overall condition of the unpatched passing lane was consistent for both NB and SB. A longitudinal construction joint crack was running the entire test section in both sections (figure 66). In addition to longitudinal construction joint cracks, there was secondary longitudinal cracking appearing in the majority of the sections in the NB and SB lanes close to the shoulder of the passing lane. High-severity and -frequency transverse thermal cracks were observed in the NB and SB lanes (figure 67). In some areas, transverse and longitudinal cracks started to connect to form block cracking (figure 68).

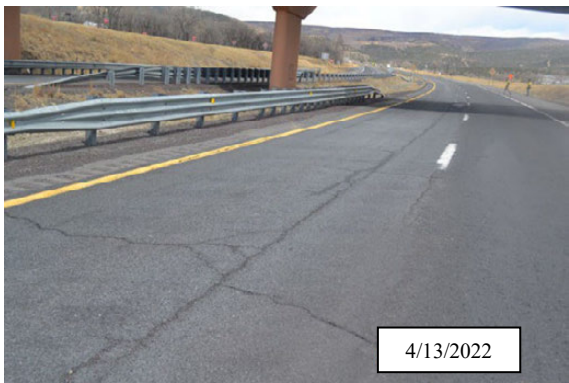
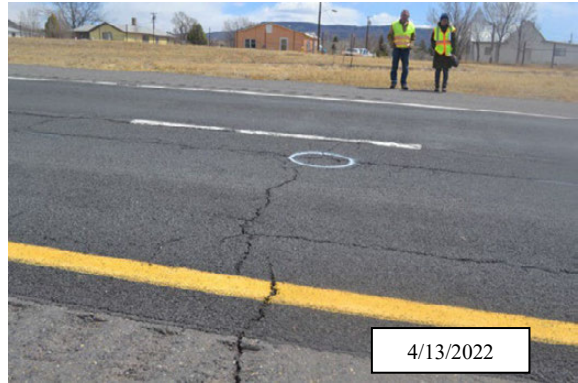
**Figure 67. Photo. Transverse thermal cracks in the passing lane of the northbound section; I-25, Colfax County, New Mexico.**

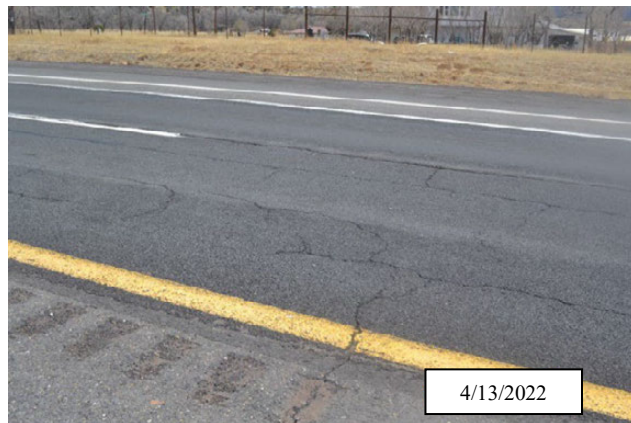
**Figure 68. Photo. Transverse and longitudinal cracks connecting to form block cracking pattern; I-25, Colfax County, New Mexico.**

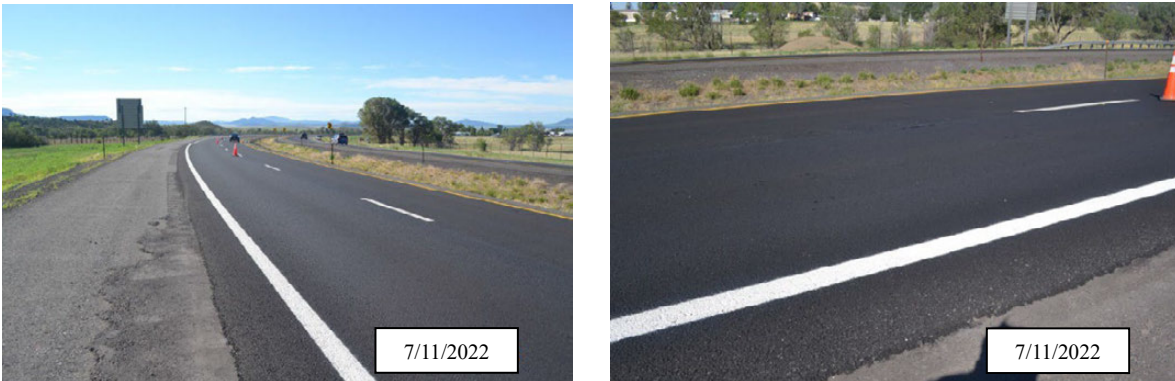
**Figure 69. Photo. Northbound lanes after the overlay; I-25, Colfax County, New Mexico.**

The second visit took place on July 11, 2022. The main goal of the site visit was to observe the field coring. Upon arrival, it was noted that most of the study section, both in the NB and SB lanes, had been recently overlaid (figure 69). Only about 0.25 mi (0.4 km) at the north of the study sections had not yet received the overlay (figure 70), which was planned to be finalized in July 2022. Field exploration continued as planned.

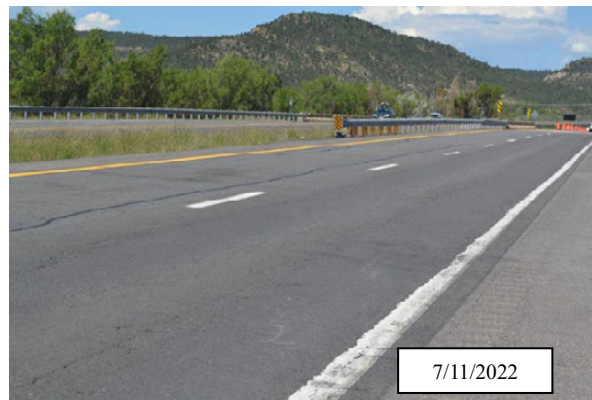
**Figure 70. Photo. Part of the northbound section left with the blade patch; I-25, Colfax County, New Mexico.**

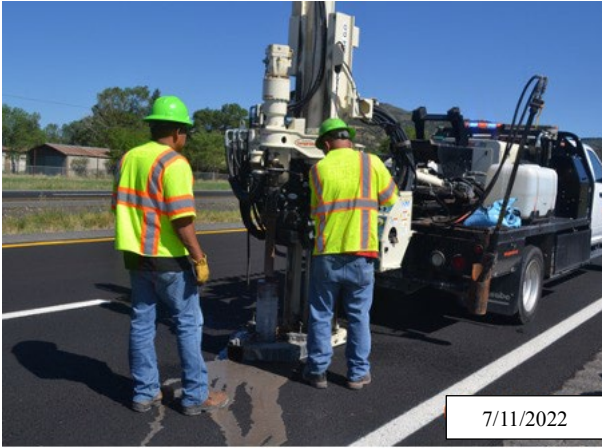
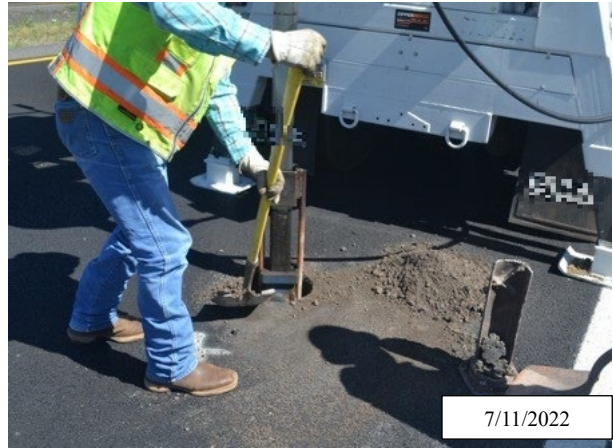
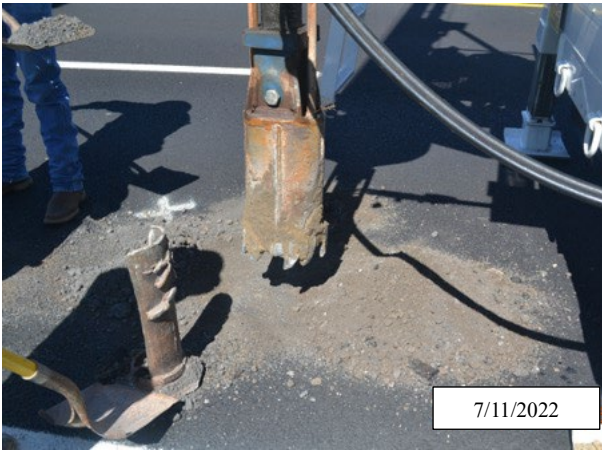
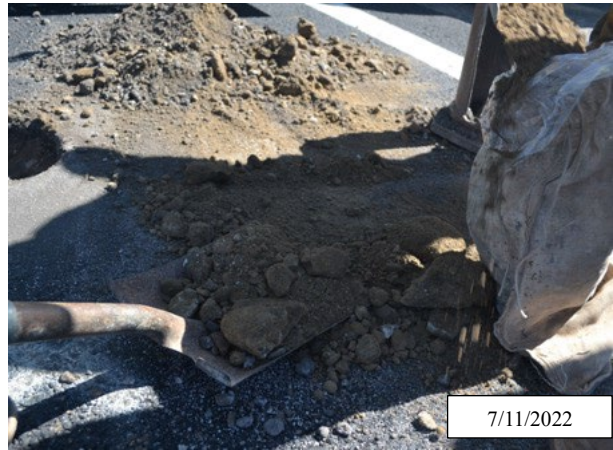
**Figure 71. Photo. Boring operation and sampling of the cement-treated and granular base layers; I-25, Colfax County, New Mexico.**

Boring was conducted at the center of the NB and SB right DL. Figure 71 shows the steps during the boring operation along with a typical boring hole (figure 72). Boring depths varied from 36 to 48 inches (915 to 1220 mm) and involved collecting granular base course, cement-treated subbase, and subgrade layer samples.

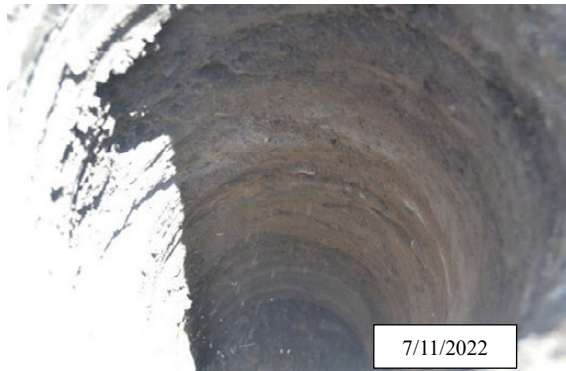
**Figure 72. Photo. Boring hole; I-25, Colfax County, New Mexico.**

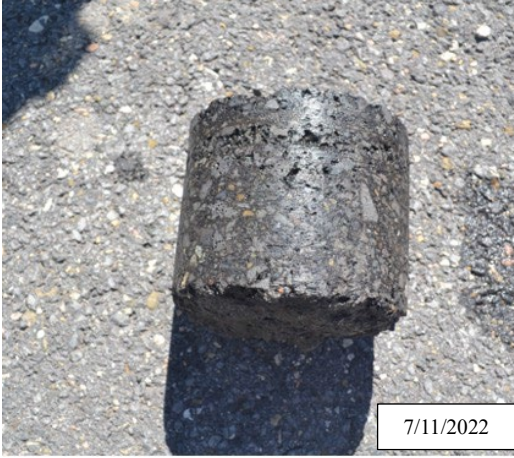
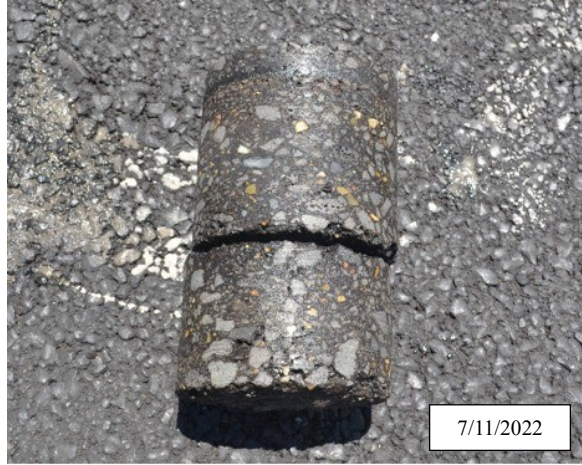
A. Northbound.

B. Southbound.

**Figure 73. Photo. Surface asphalt concrete layer cores; I-25, Colfax County, New Mexico.**

Six pavement cores were taken in the NB IP. According to Mann and Giron’s (2023) field investigation report, the AC layer thickness varied from about 4.5 to 9.0 inches (115 to 230 mm), the granular base course thickness from about 4 to 7.5 inches (100 to 190 mm), and the cement-treated layer from about 3 to 7 inches (75 to 180 mm). These thicknesses varied considerably from the designed thicknesses.

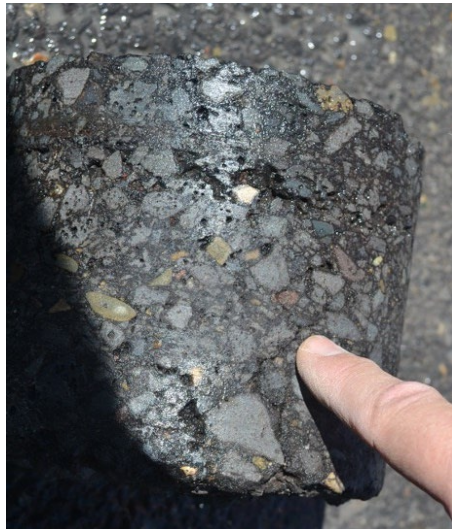
**Figure 74. Photo. Bottom-up cracking observed in a field core obtained from northbound lane; I-25, Colfax County, New Mexico.**

Most of the AC layer cores were taken from outside of the wheel path. In general, these cores were intact and did not show any sign of cracking except for one core in the NB lane, shown in figure 74. At two locations, the coring team was instructed to take cores from the wheel path where fatigue cracking was observed and recorded. These cores could not be obtained intact, as shown in figure 75.

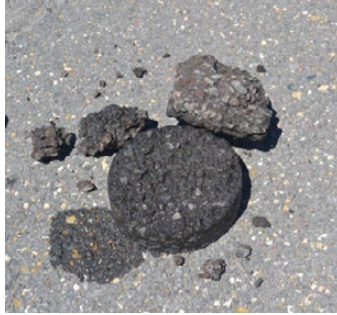
**Figure 75. Photo. Asphalt concrete layer cores taken from wheel path; I-25, Colfax County, New Mexico.**

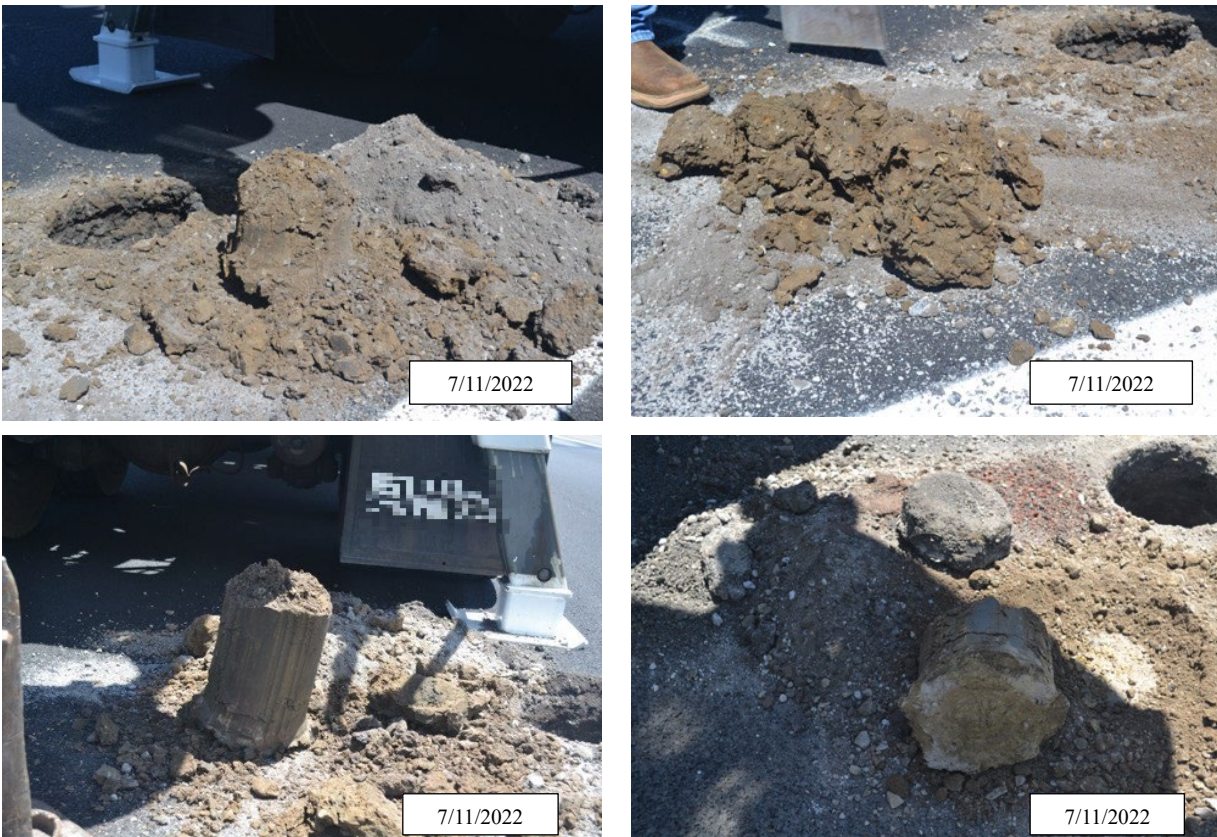
**Figure 76. Photo. Subgrade samples collected from both directions; I-25, Colfax County, New Mexico.**

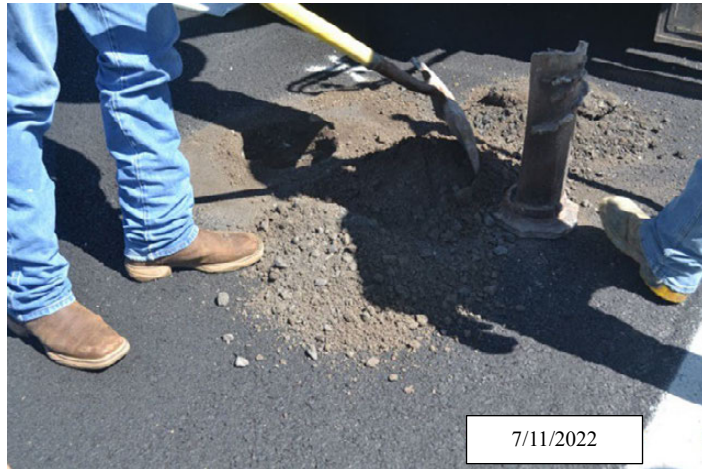
**Figure 77. Photo. Unbound granular layer extracted from the northbound lane; I-25, Colfax County, New Mexico.**

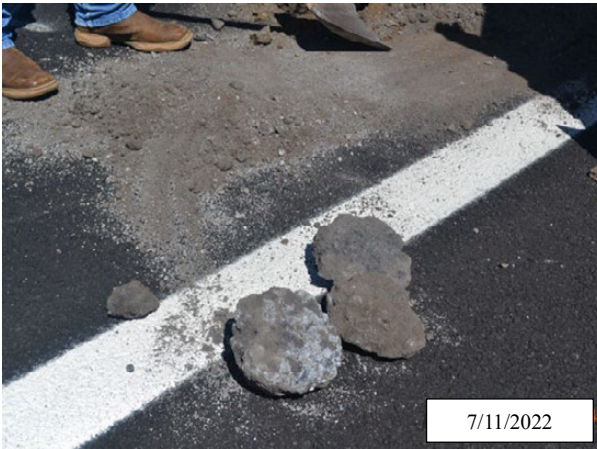
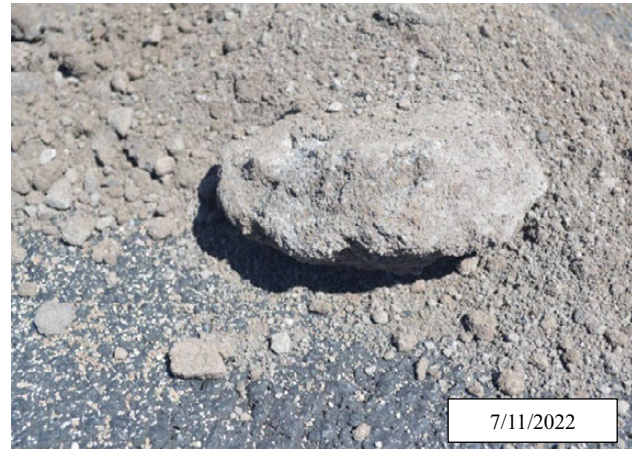
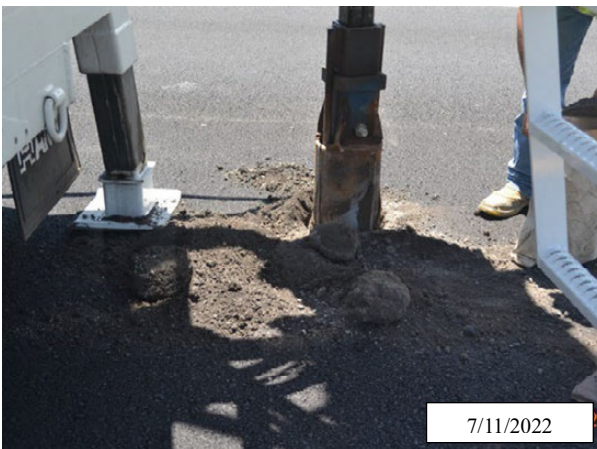
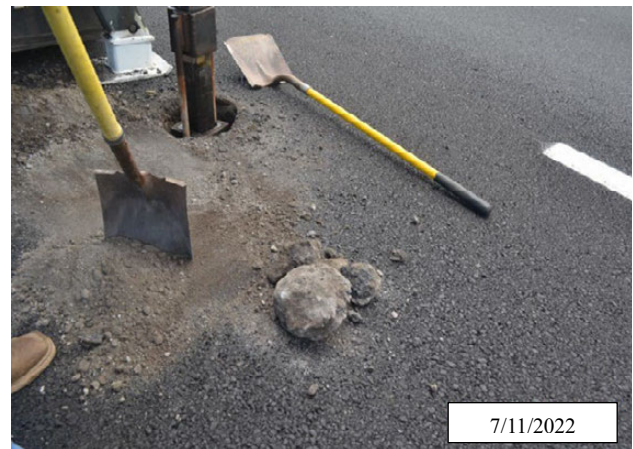
**Figure 78. Photo. Cement-treated base layer materials extracted from both directions; I-25, Colfax County, New Mexico.**

Loose, unbound crushed granular layer materials are shown in figure 77. The CTB layer was observed in both directions. Chunks of CTB, 4 to 6 inches (100 to 150 mm) in diameter were retrieved at almost all coring locations, as shown in figure 78.

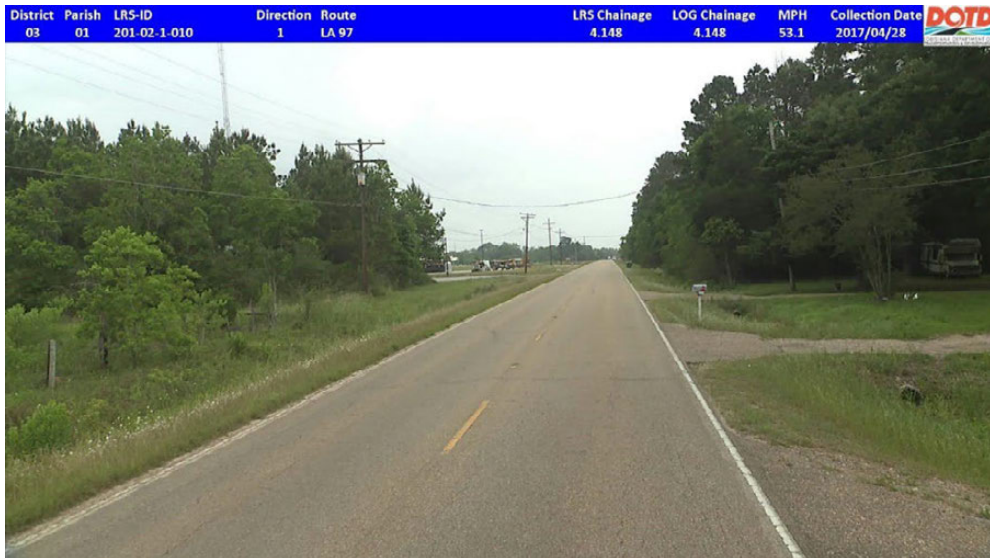
**Figure 90. Photo. Inverted pavement section in 2017; LA-97 (provided by LaDOTD).**

FWD testing carried out in 2008 and 2009 showed that the IP had a relatively higher deflection than the control section. The average maximum deflection for the IP was 7.9 mils (0.2 mm) with a COV of 26.8 percent, whereas for the control section, the average was 4.7 mils (0.12 mm) with a COV of 45 percent (Chen, Zhang, and Lambert 2014). Figure 90 shows a photo of the IP section taken in 2017.

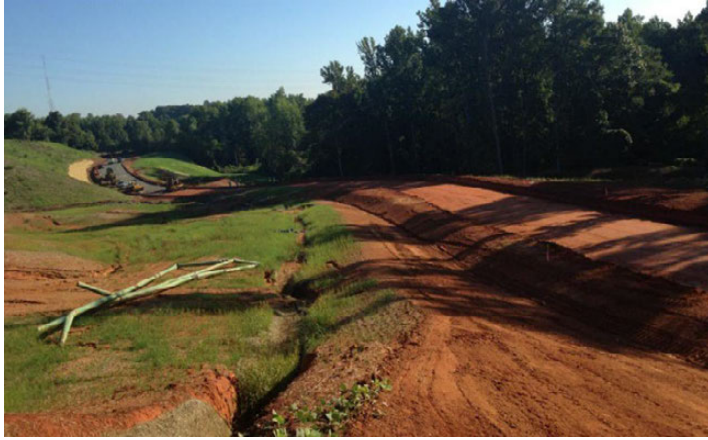
**Figure 105. Photo. Subgrade; Quarry Access Road, North Carolina (left photo from Vaughan 2017).**

The road profile is shown in figure 104, where the left half represents the IP section and the right side the CP section. The pavement has a longitudinal slope up to about 6 percent within the IP section and more than 7 percent in the CP section. The IP level is closer to the existing ground level, except in the proximity of an existing gas pipeline at Station 7+00, where the road is on fill. The CP section, on the other hand, is located mostly in cut, with the deepest cut surpassing 30 feet (9.1 m) in height. Figure 105 shows the subgrade and an aerial image of the site during subgrade preparation.

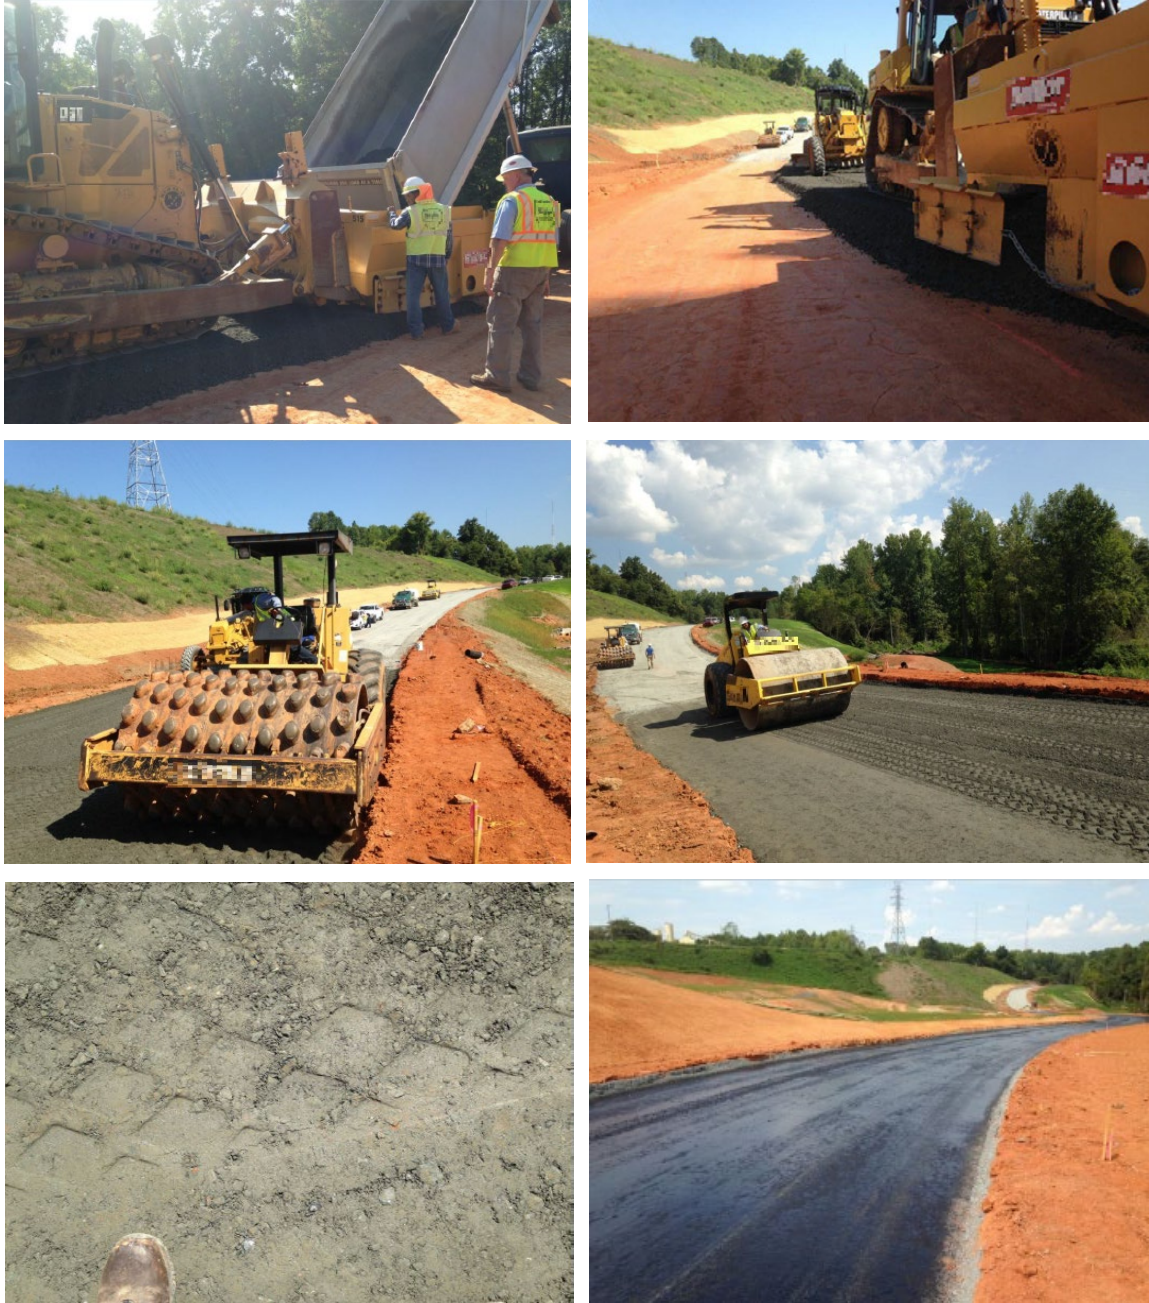
**Figure 106. Photo. Cement-treated base construction; Quarry Access Road, North Carolina (Vaughan 2017).**

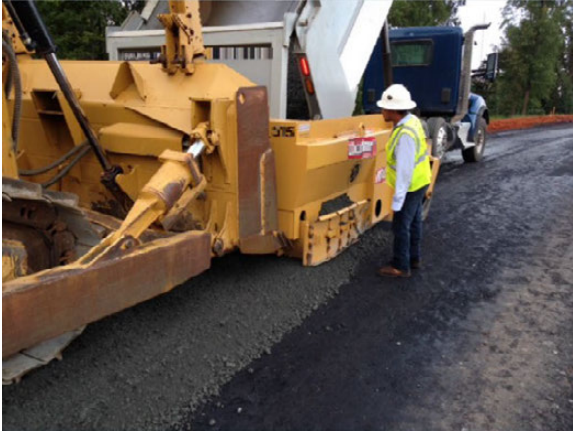
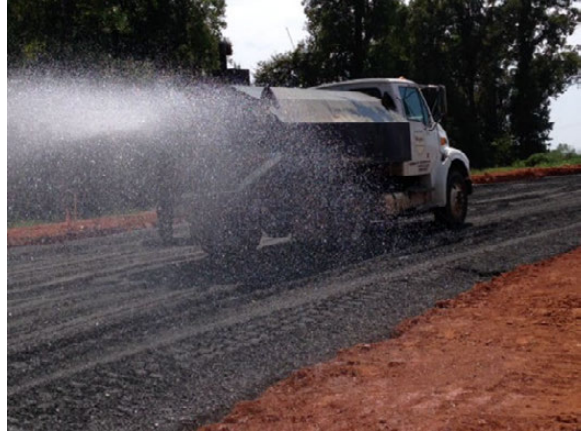
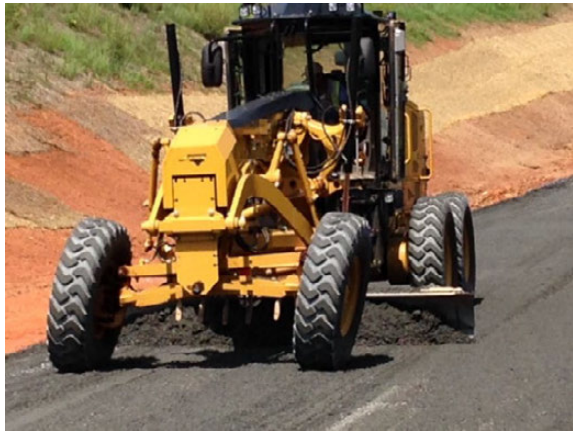
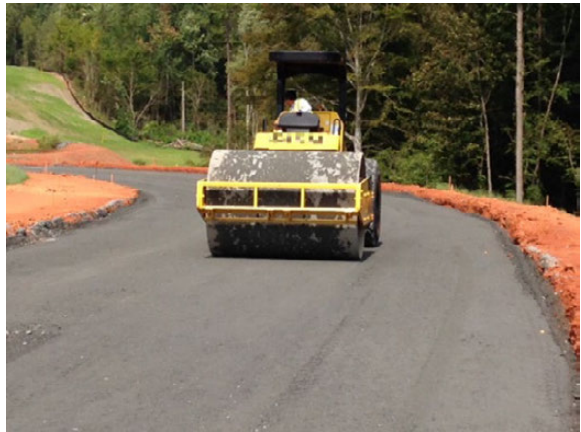
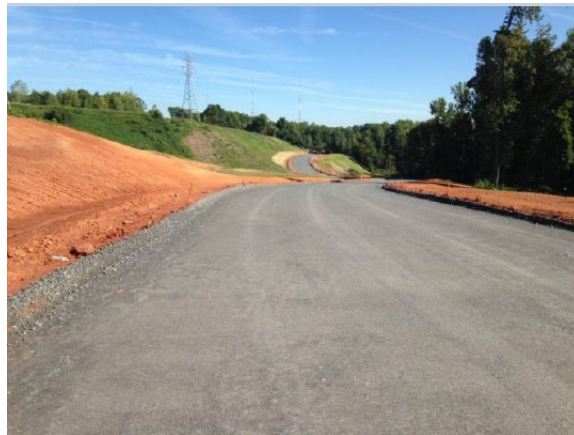
**Figure 107. Photo. Unbound granular base construction; Quarry Access Road, North Carolina (Vaughan 2017).**

The unbound base course layer for the IP and CP sections was compacted at the same time using the same compaction technique. It was noted that compacting the unbound granular base in the IP section was “bouncier” when using vibratory mode. This was thought to be due to the presences of the stiff cement treated layer which didn’t absorb the vibrations like the soil subgrade in the CP section. The granular layer in the IP achieved a density of 103.4 percent of the modified Proctor, whereas in the CP, it achieved 99.8 percent. The South African slushing technique was not used (Vaughan 2017). Figure 107 shows photos of the construction of the UAB.

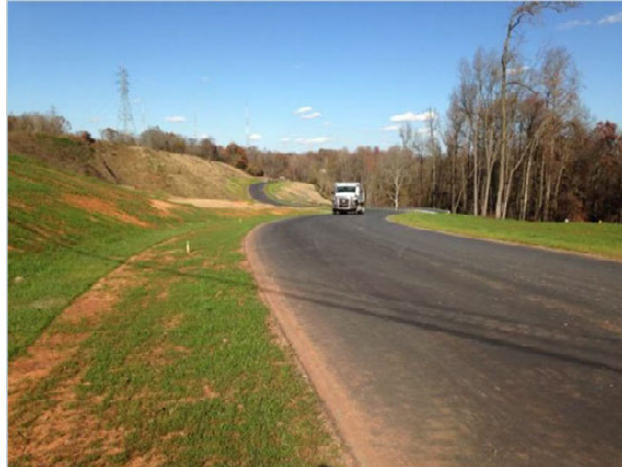
**Figure 108. Photo. AC; Quarry Access Road, North Carolina (Vaughan 2017).**

The AC layers were constructed following NCDOT standards, with the IP AC achieving better density on the aggregate base course, 103.4% in comparison to 99.8% on the CP. Figure 108 shows the AC surface.

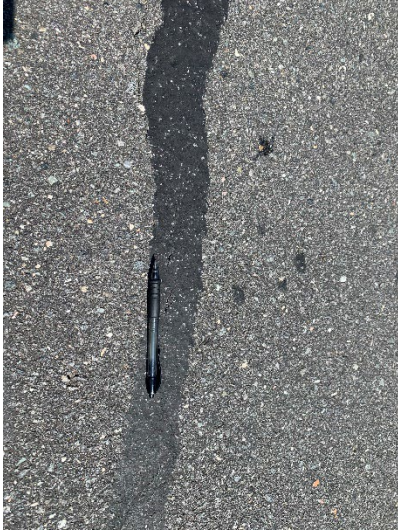
A. Transverse crack (IP, Station 4+91).

**Figure 110. Photo. Cracks observed during a 2021 site visit; Quarry Access Road, North Carolina (provided by Shane Underwood).**

A subsequent visit performed in August 2021 by Shane Underwood and his team found that cracking had started appearing in the CP as well, as shown in figure 110 and detailed in table 29. The cracks in the IP section were mostly transverse cracks (probably reflected from the CTB), with the NB section presenting slightly more transverse cracks than the SB. The cracking in the CP was more diverse, with signs of transverse, longitudinal, fatigue, edge, and random cracking reported. Fatigue cracks from low to medium severity was reported in the SB CP section.

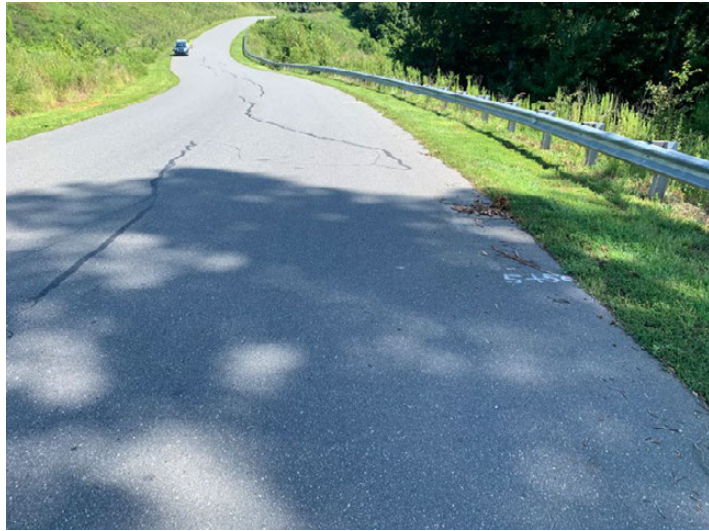
B. Longitudinal crack (IP, Station 5+50).

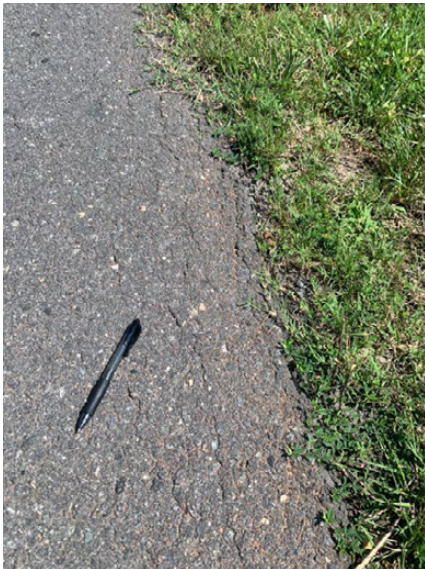
C. Edge cracking/deterioration (CP, Station 10+00).

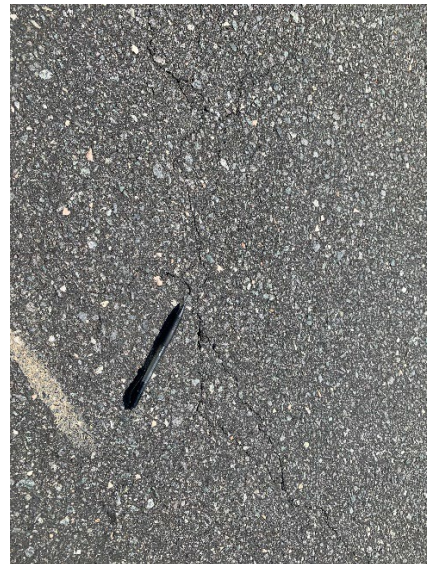
D. Fatigue cracking (CP, Station 14+50).

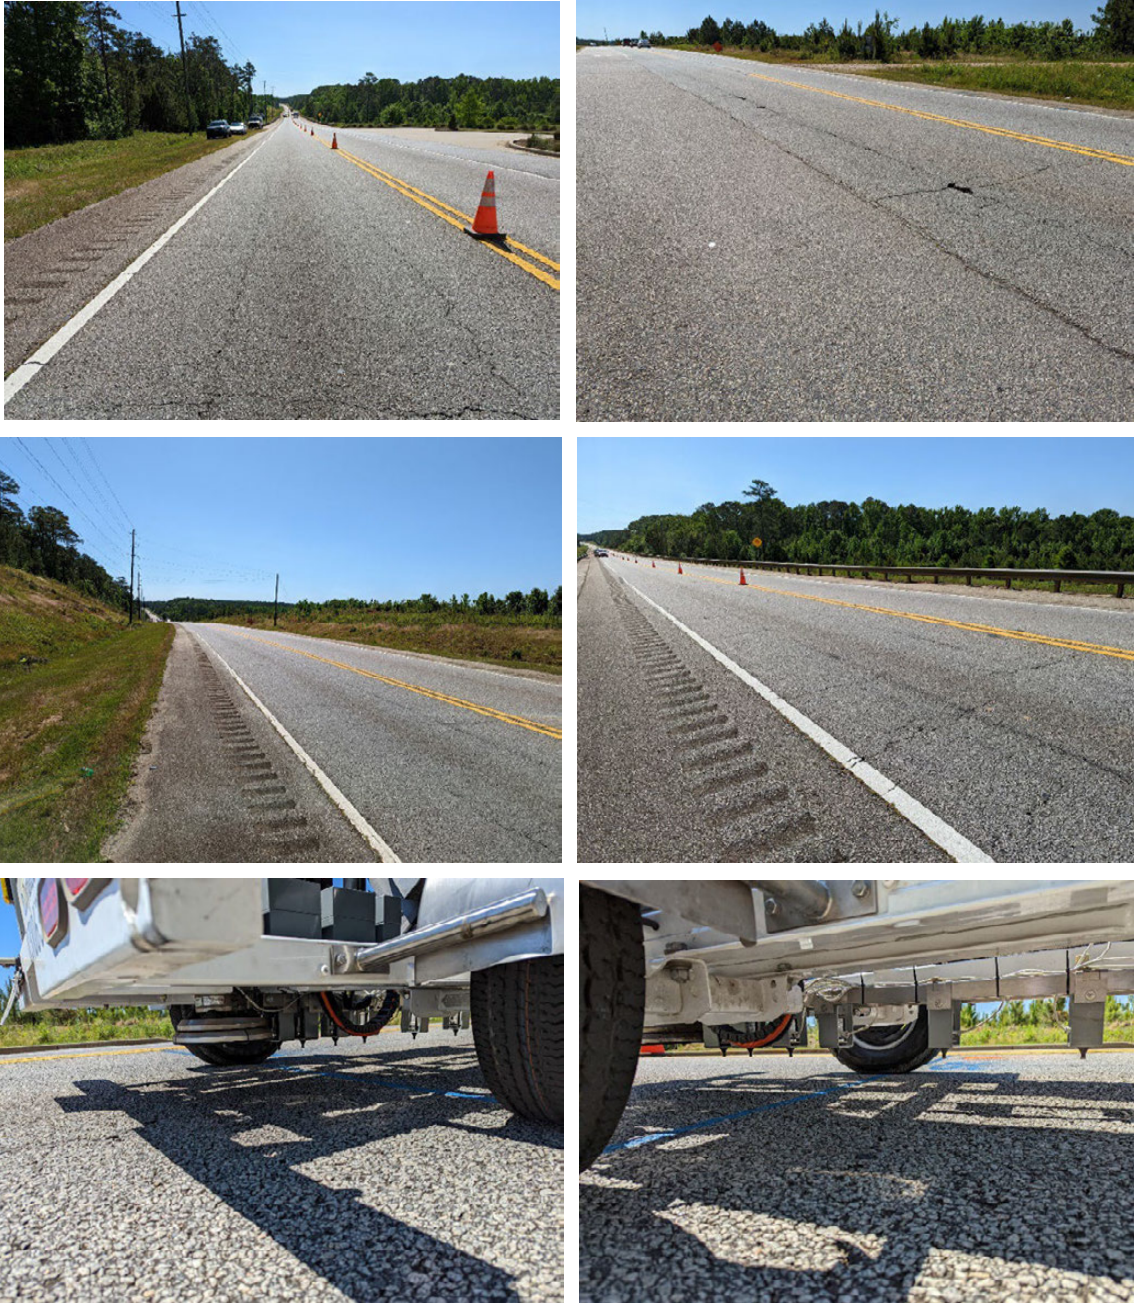
**Figure 129. Photo. Inverted pavement westbound lane also showing FWD test setup in May 2022; LaGrange Bypass Road, Georgia.**

Figure 128 shows photos taken from the EB lane side, and figure 129 shows photos taken from the WB lane side.

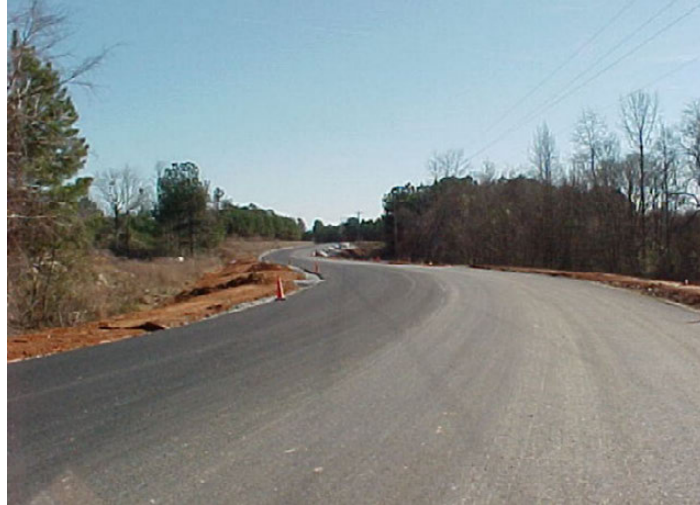
**Figure 135. Photo. Inverted pavement section constructed in Morgan County, Georgia, in 2001 (TRB Webinar 2016).**

The road was constructed in 2001. In the South African IP, the slushing technique was employed by wetting the pavement and compacting it using common construction equipment. The pavement was compacted until air bubbles could no longer be seen behind the roller (Lewis et al. 2012). Both IP sections, with and without the slushing technique, achieved similar compaction levels. Figure 135 shows the constructed road in 2001.

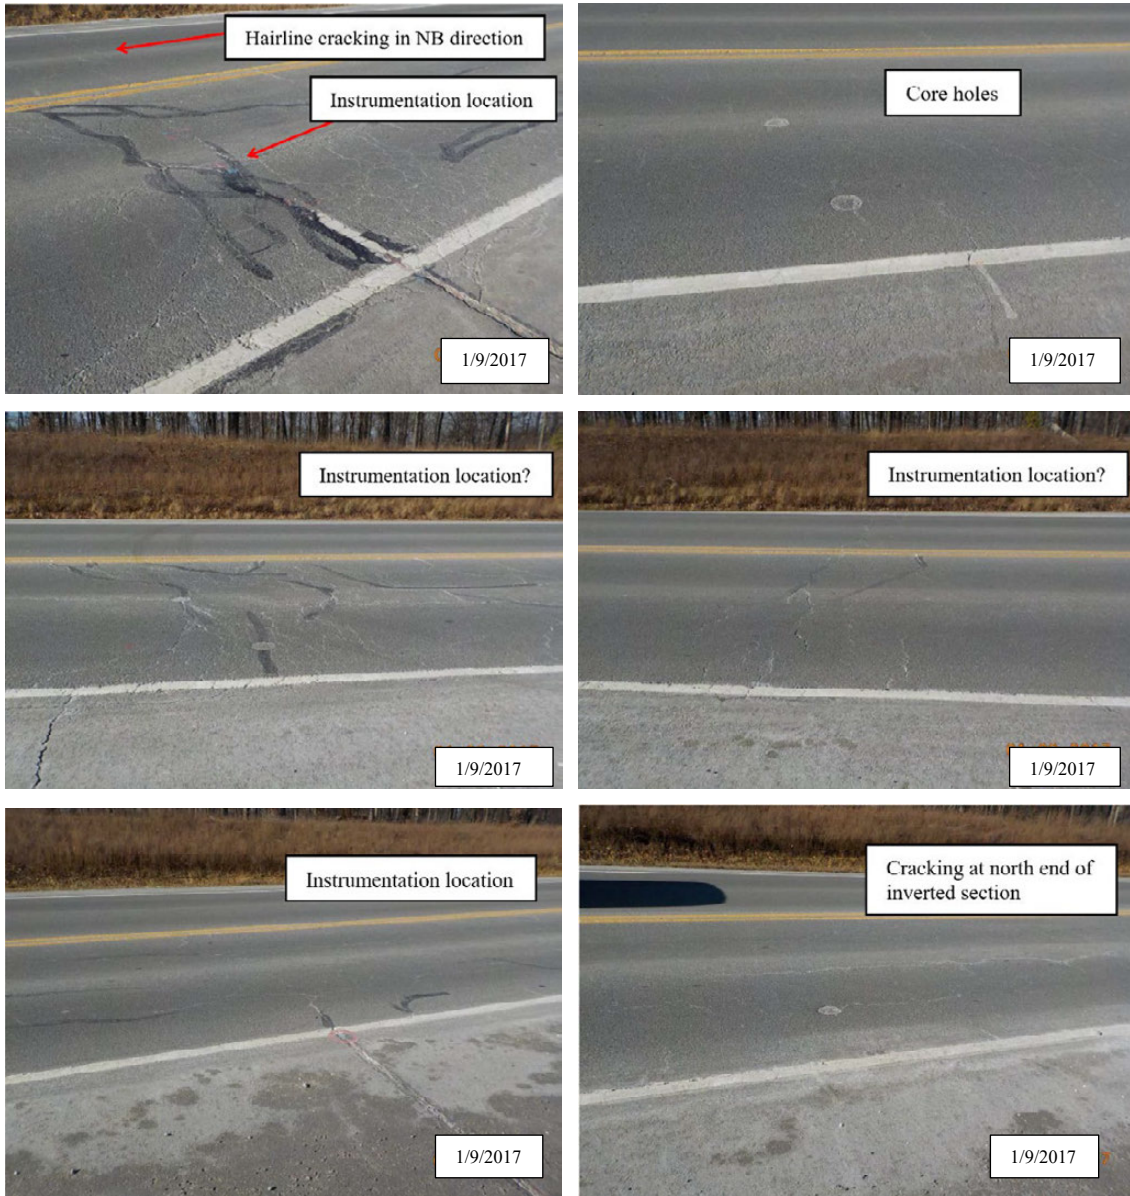
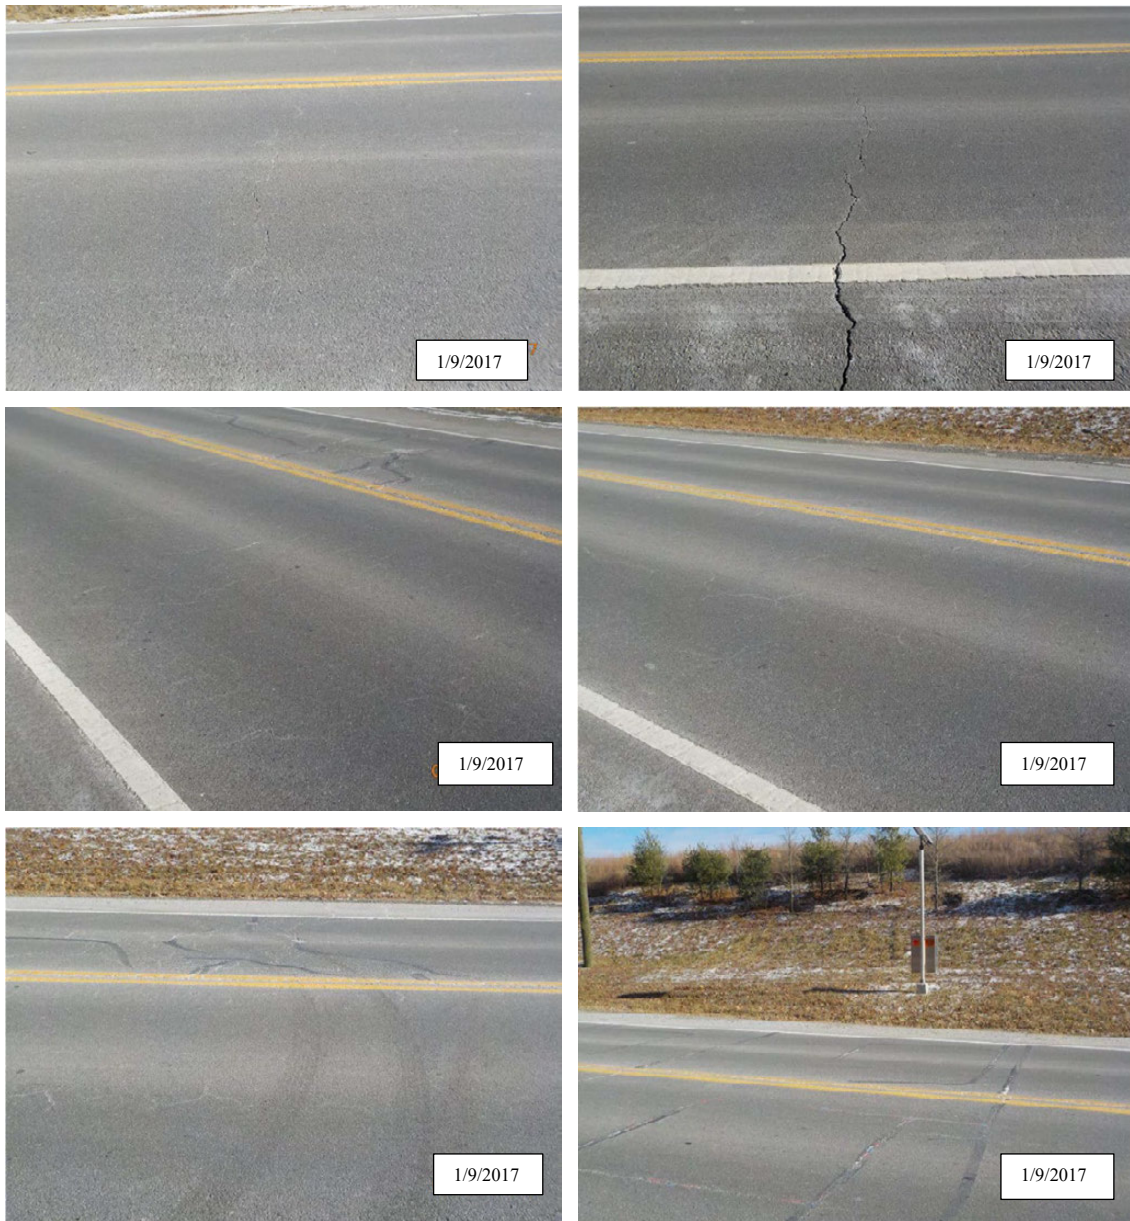
**Figure 153. Photo. VA-659, Virginia (inverted pavement photos from 2017, provided by Virginia DOT).**

Figure 153 and figure 154 show, respectively, photos of the IP and CP sections taken in 2017, the fifth year of pavement life. The photos indicate that both pavement sections presented extensive

cracking, with very limited crack sealing applied. The crack sealing in the photos appeared to be old and worn off, no longer providing a functional seal to the pavement cracks.

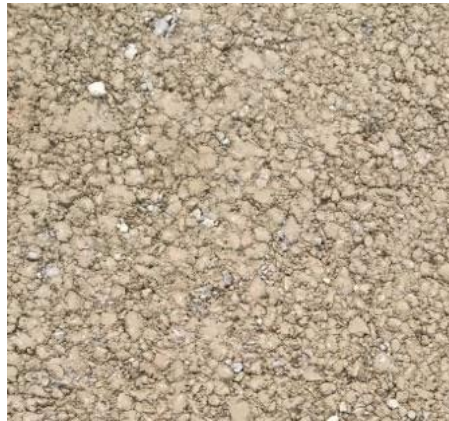
**Figure 157. Photo. Dense-graded unbound dolomite aggregate layer construction in Cell 3 (Qamhia 2019).**

Figure 157 shows the dense-graded unbound dolomite aggregate used as base layer in the two IP sections (C3S2 and C3S3).

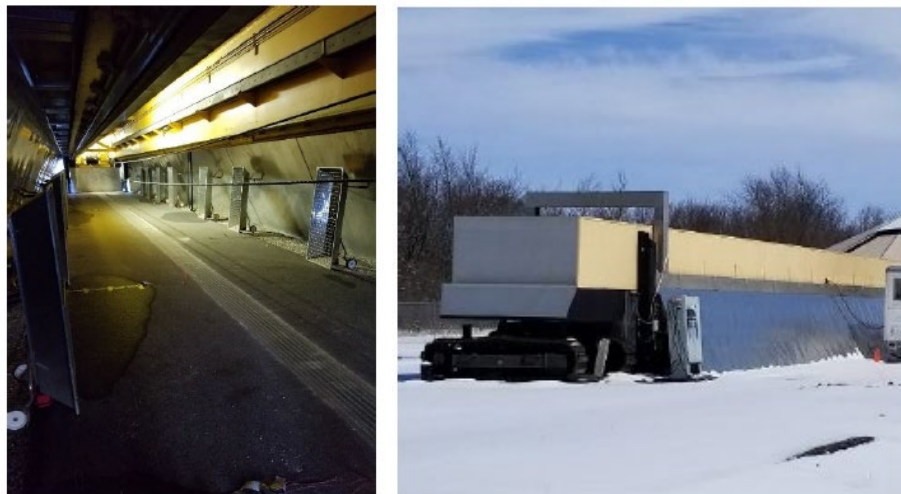
**Figure 160. Photo. Insulation panels and heaters; ICT (Qamhia 2019).**
