U.S. Department
of Transportation
**Federal Railroad
Administration**

RR 21-23 | November 2021

LINE-OF-SIGHT ANALYSIS USING DRONES AND PHOTOGRAMMETRY

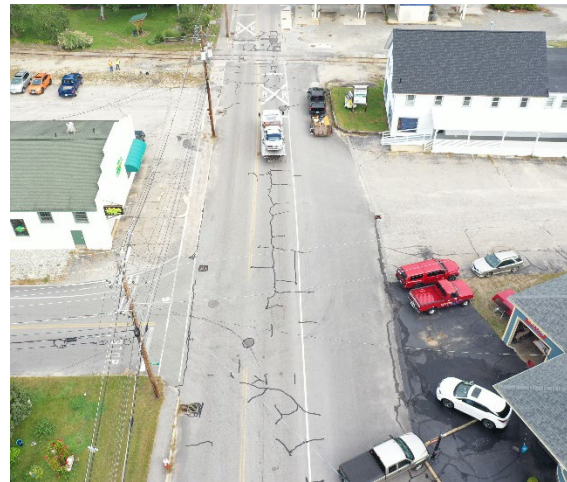
Figure 1. South St. Crossing in Milford, NH

Volpe identified two crossings in Milford, New Hampshire, that had these conditions. A team of Volpe researchers used a drone to capture a set of aerial photographs of these crossings. One of these images, taken at the South Street crossing, is shown in [Figure 1](#). These images were later processed into orthomosaic images,
