12 April 2021

## Saki Drill Pad and Trench Site Inspections Ahead of Fieldwork

Frontier Resources Limited (**Frontier** or the **Company**) is pleased to announce the completion of a geotechnical site investigation of the proposed drilling pads at Saki Gold Prospect. The field investigation was conducted by Frontier's consultant geologist and field technical engineer to assess the surface conditions and slope stability of proposed drill pads (Figure 1) to ensure their safety against potential landslides. A number of the drill pads were relocated to safer sites (Figure 2).

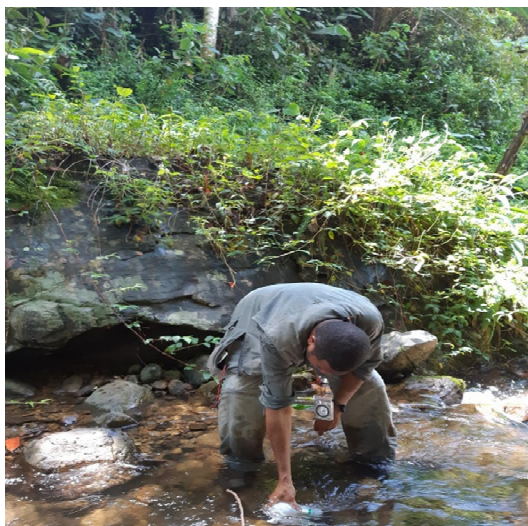
**Photo 4: Container Rinsed in Mandi Creek**

Samples were mainly taken in a pool area where the water is deeper so any fine solid particles have settled to the bottom (Photos 4 and 5). Prior to sampling the water, the plastic water container is rinsed with the in-situ water first and then sampled and returned to the camp and stored in the esky supplied by SGS laboratory for dispatch back to the laboratory.
