March 19, 2024

MIR-24-06

Contact of *Susan K* Tow with Natchez-Vidalia Bridge

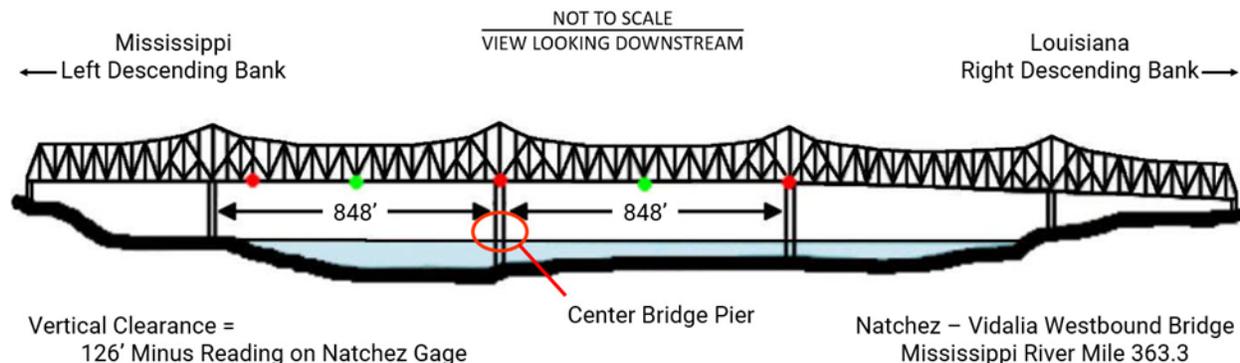
Near the cities of Natchez, Mississippi, and Vidalia, Louisiana, the Mississippi River makes a gradual bend to the southwest (see figure 2). The Natchez-Vidalia Bridge crosses the river after the bend. The bridge has twin cantilever-style bridges that connect the two cities. The upriver span is for westbound vehicular traffic, and the downriver span is for eastbound traffic. Both spans have six concrete piers—structures designed to support the spans—as pictured in figure 4. Three of the piers

on each span form two main channels for vessels to navigate, the left descending channel and the right descending channel. The US Army Corps of Engineers chart for the Lower Mississippi River lists the horizontal distance between the main channel piers as 848 feet.

Figure 4. Natchez-Vidalia Bridge. (Background source: US Army Corps of Engineers)
