April 15, 2024

MIR-24-08

Capsizing of Dredging Vessel *WB Wood*

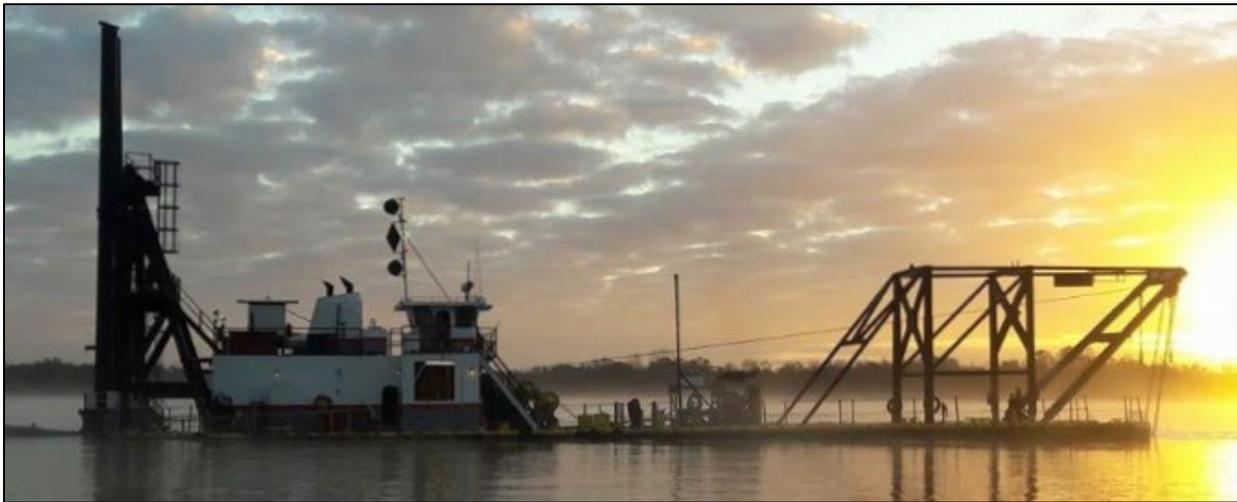
Figure 1. Dredging vessel *WB Wood* engaged in dredging operations (with its spuds up) before the casualty. (Source: Wood Resources)

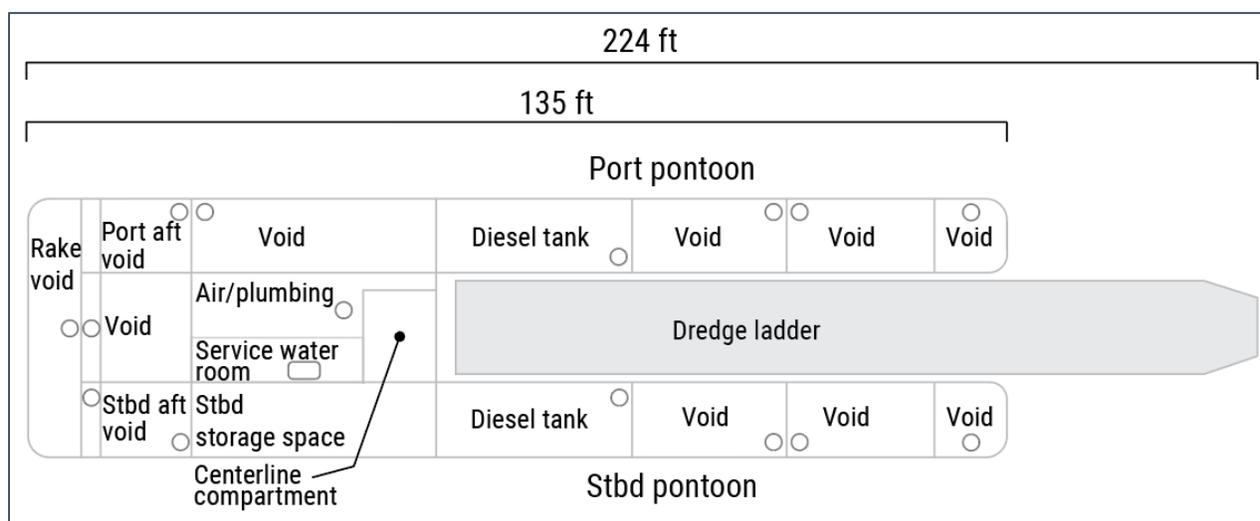
The non-propelled, 135-foot-long, 35-foot-wide uninspected dredge *WB Wood*, owned and operated by Wood Resources, LLC., was built in 1983 (see figure 1). The vessel consisted of two welded-steel, single-skinned, pontoon-type hulls with a deck structure aft. A 165-foot-long open-suction dredge ladder ran between the hulls from the deck structure to forward of the pontoons. The ladder was capable of being raised and lowered but could not be moved from side to side (see figure 3).

Figure 3. Approximate plan view of the *WB Wood*'s hull below the main deck (not to scale). Hatches on the main deck are depicted as circles.

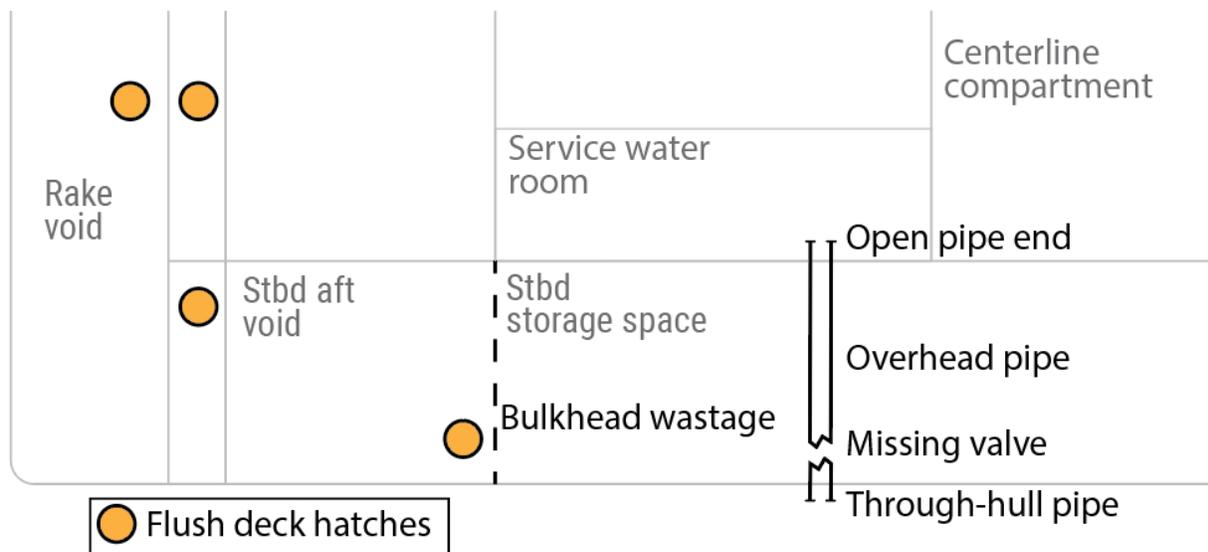
In the starboard aft void, along the forward transverse bulkhead separating that space from the starboard storage space, there was rust and scale extending from the bilge up about 10 inches across the entire bulkhead. At the bottom of the bulkhead, investigators found multiple small wastage holes at the weld joining the transverse bulkhead and the floor plate (figure 8). There were no observable signs of damage or deteriorated steel to the exterior hull plating in this space.

In the starboard storage space, investigators found an open 2-inch through-hull pipe on the starboard-side hull plating, near the top of the space. The center of the through-hull pipe was measured about 5 inches below the main deck. The pipe threading showed rust, scale, and dirt accumulation on the inboard side. Nearby, a 2-inch pipe in the overhead of the space led athwartships from the storage space through the longitudinal bulkhead into the adjacent service water room (see figures 9 and 10). In the starboard storage space, this pipe's threading, near the through-hull, was fractured. According to the day leverman, the pipe "needed work" so it was taken out of service at an unknown point and an overboard check valve was put in place. Investigators found a 2-inch check valve in the bilge in the bottom of the compartment.

In the service water room, the pipe with the missing overboard check valve ended in a threaded elbow that angled downward.

Figure 9. Compartment layout of the starboard aft quarter of the vessel below the main deck.
