MODEL BD-700-2A12 (BD-700)

ATA 26-22

SPECIAL CHECK – BAGGAGE-COMPARTMENT FIRE EXTINGUISHERS – INSPECTION OF THE BAGGAGE BAY PUSH-TO-DISCHARGE SWITCH

Basic Issue: Feb 10/2023 700–26–7505

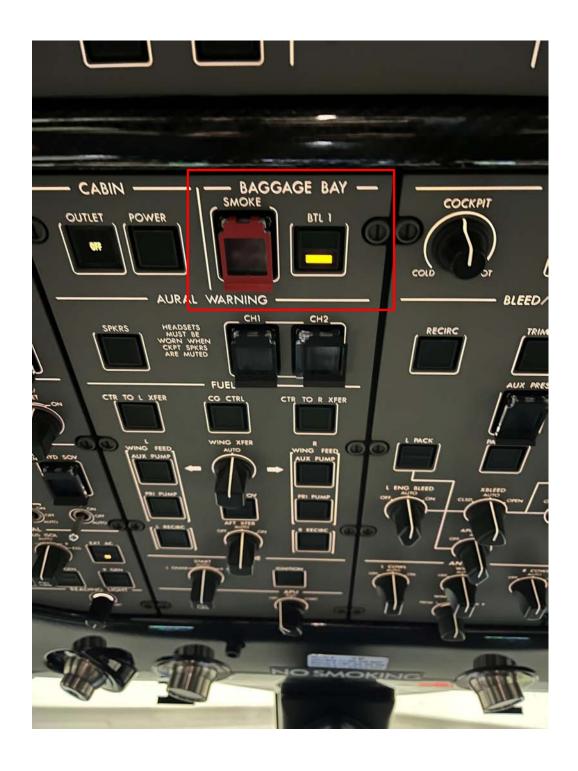
Baggage Bay PBA Disconnected SQUIB Configuration Figure 9

NOTE: A BAGGAGE SQUIB FAIL (ADV) message will be posted on the EICAS. Also on the overhead baggage bay control panel, the

EICAS. Also on the overhead baggage bay control panel, the BTL1 PBA amber line will be illuminated. This is a normal condition due to the system configuration (connector disconnected). Refer to Figure 9 and Figure 10.
