Contact of Yacht *Atlantis* with Floating Dredge Pipe Pump-Out Cube

On May 25, 2024, about 1130 local time, the yacht *Atlantis* was transiting north in the Atlantic Ocean about 1.5 miles east of St. Augustine Beach, Florida, when the vessel struck a floating dredge pipe pump-out cube associated with a beach renourishment project (see figure 1 and figure 2).¹ The contact compromised the hull, causing the yacht to flood and eventually sink. There was one minor injury, and no pollution was reported. The damage to the pump-out cube was estimated at \$20,000. The *Atlantis*, with an estimated value of \$2 million, was declared a total loss.

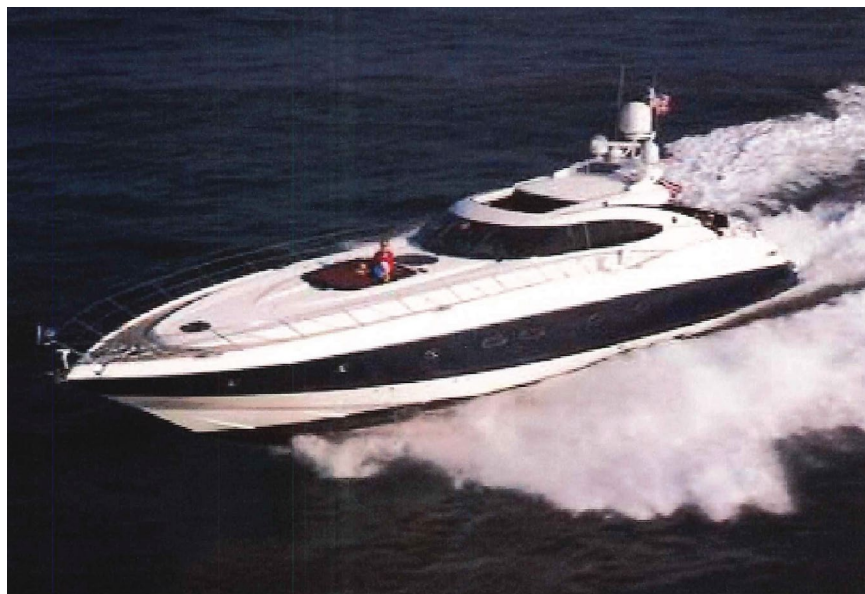
Figure 3. *Atlantis* in undated photo before the contact. (Source: *Atlantis* owner)

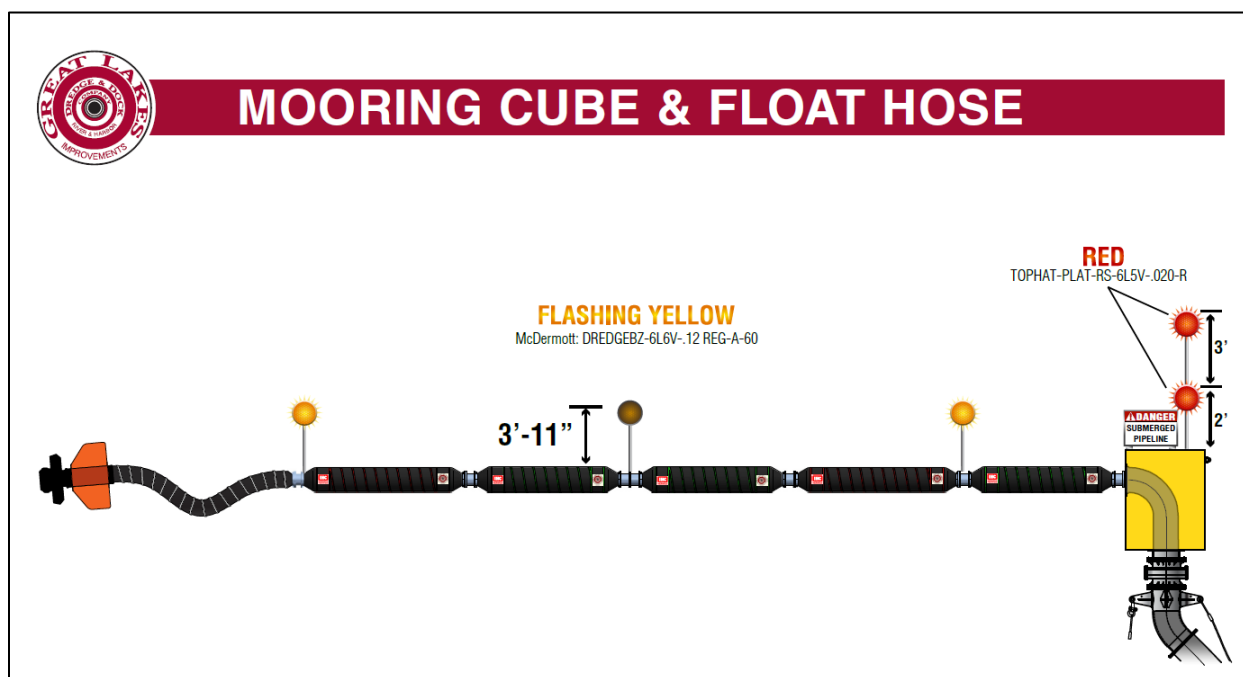
Figure 5. Sample arrangement of a mooring cube (pump-out cube) and floating hose. (Source: Great Lakes Dredge & Dock Company)

The pump-out cube dimensions were 10 feet by 11 feet (equivalent in size to a small boat) with an approximately 3-foot freeboard, and the float hose with a connector was 200 feet in length. The underwater dredge pipe that transported the sand/water mixture toward the beach was about 9,000 feet long.
