MIR-24-24

Contact of *Danny Terral* Tow with Port of Lake Charles Pier

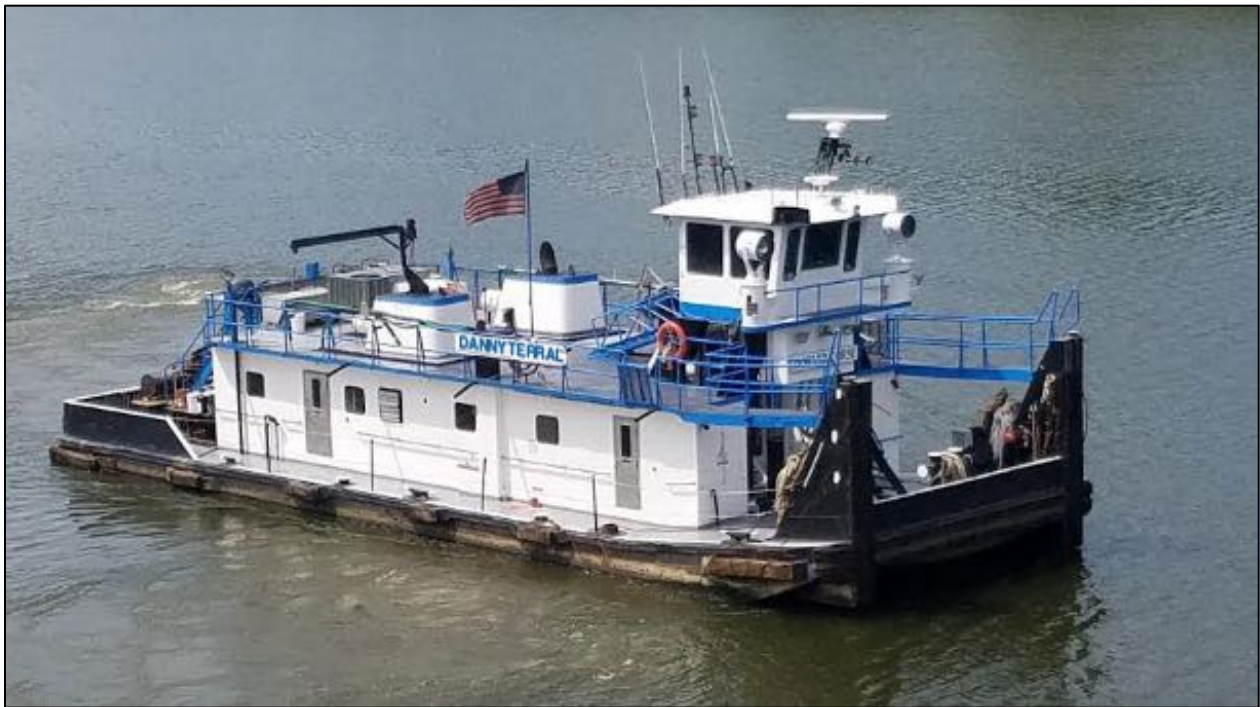
Figure 1. *Danny Terral* underway at unknown date before the contact. (Source: Terral River Service)

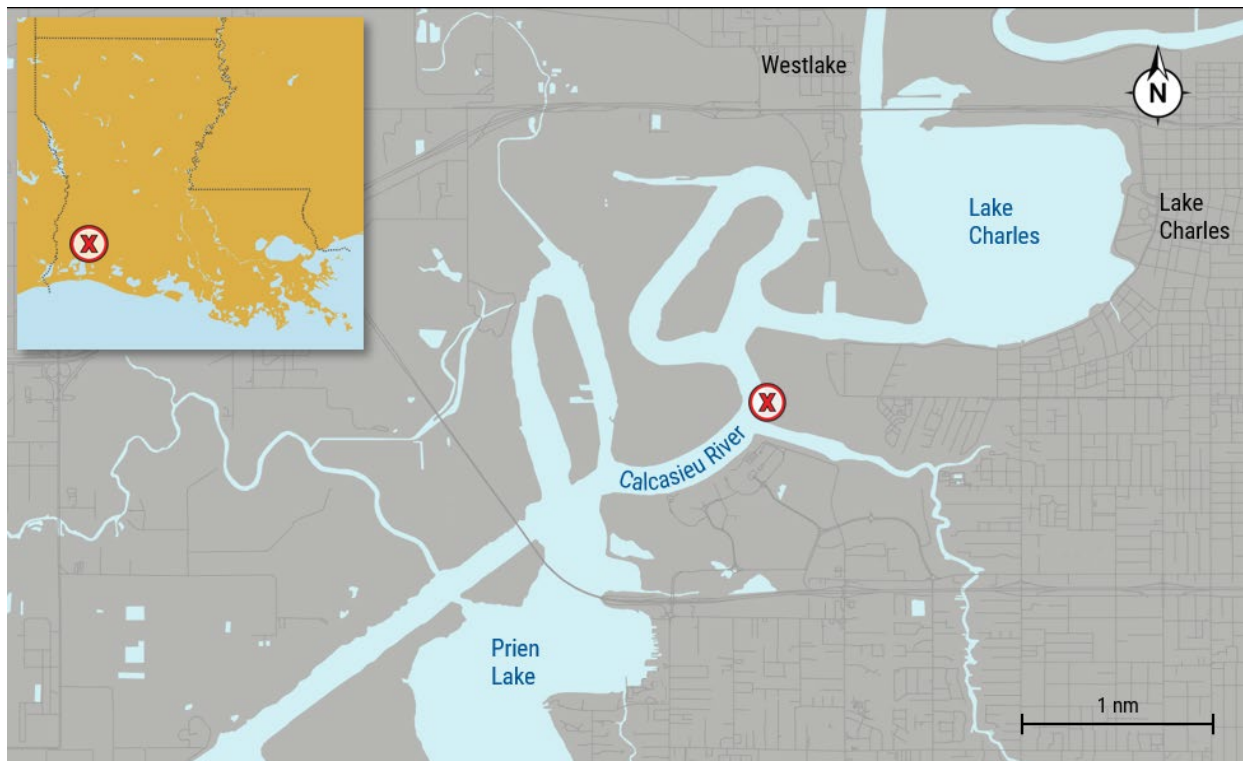
On July 8, 2023, at 2326, the towing vessel *Danny Terral* was pushing six loaded barges on the Calcasieu River when the starboard lead barge contacted a pier while docking at the Port of Lake Charles (see figure 1 and figure 2).¹ There were no injuries, and no pollution was reported. Damage to the pier was estimated to be about \$1 million. The tow remained intact, and there was no reported damage to the barges or towing vessel.

Figure 2. Area where the *Danny Terra* contacted the Port of Lake Charles pier, as indicated by a circled X. (Background source: Google Maps)
