MIR-24-34

Fire aboard Fishing Vessel *Whiskey Business*

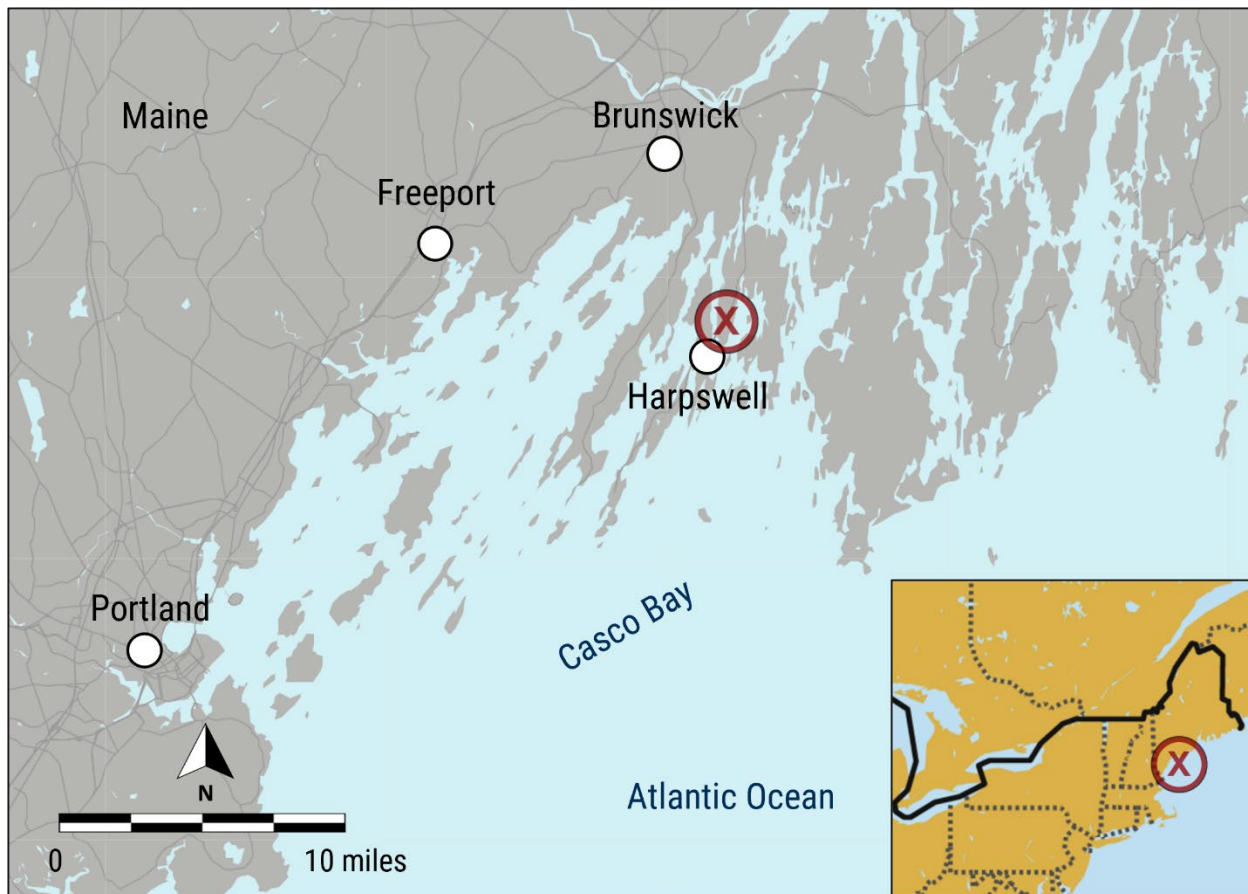
Figure 2. Area where the fire broke out aboard the *Whiskey Business*, as indicated by a circled X. (Background source: Google Maps)
